**Pigeon Bay Community Hall
Detailed Engineering Evaluation
Quantitative Report**

Christchurch City Council

Date: 1 August 2012
Reference: 6-QUCCC.76
Status: Final

Pigeon Bay Community Hall Building
BU 3583-001 EQ2

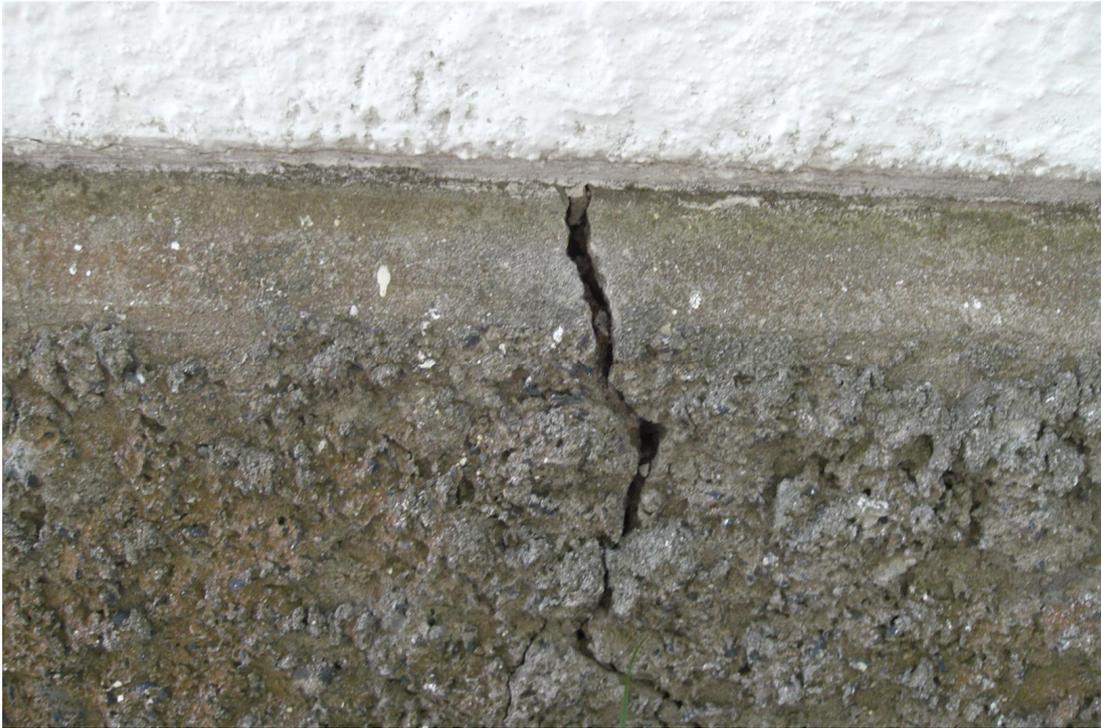
- A 10mm wide crack is located on the perimeter strip footing (unknown location on building). Refer to Photo 5 in Appendix A.
- Multiple cracks on the north-west corner of the building (assumed). One of these cracks propagates down into the perimeter strip footing. Refer to Photo 6 in Appendix A.

The natural ground elevation changes by 6m over the length of the building. No evidence of differential settlement has been reported. The existing foundations appear to have performed satisfactorily in the recent seismic events. Cracking appears to be associated with shaking damage rather than ground performance. No liquefaction has been observed on the site. No site investigation data is available at this site. If the Christchurch City Council wishes to more accurately understand the liquefaction hazard at this location, site specific investigations are recommended.

Photo 5: 10mm crack in the concrete perimeter strip footing.

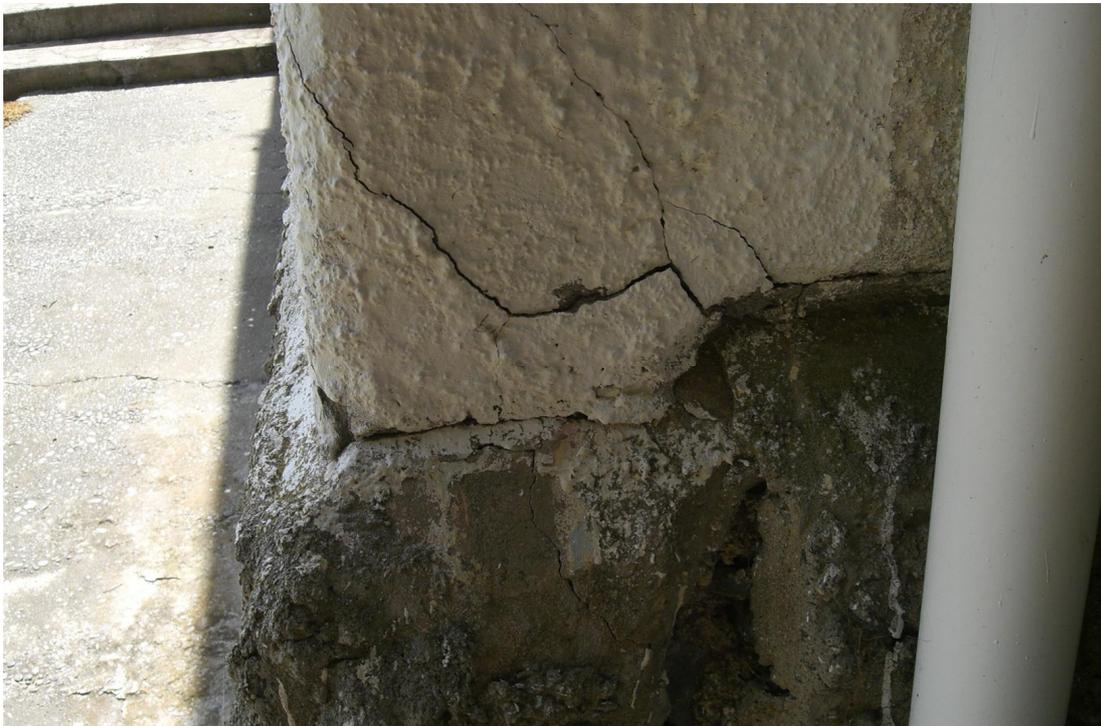
Photo 6: Multiple cracks on the north-west corner.

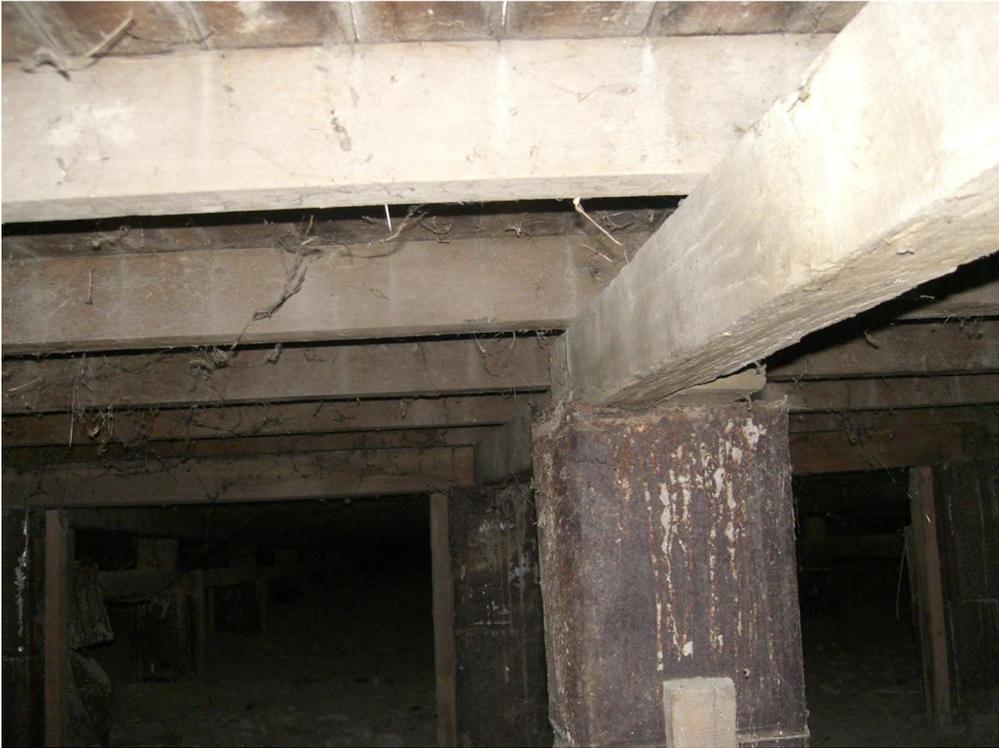
The subfloor consists of tongue and groove timber floor boards on suspended timber framing sitting on square concrete piles, and a concrete foundation wall to the full perimeter of the building. The floor is a sprung floor under the main hall. The piles do not appear to be attached to the subfloor framing.

The subfloor bracing capacity will be provided by the perimeter foundation wall. There was no sign of hold down connections between the piles and bearers.

Photo 7: View of the subfloor and foundations
