**Pioneer Recreation and Sports Centre
Detailed Engineering Evaluation
Stage Two Quantitative Assessment Report**

**75 Lyttelton Street, Somerfield, Christchurch
Christchurch City Council**

Date: 18 November 2011
Reference: 6-QUCCC.29
Status: Final

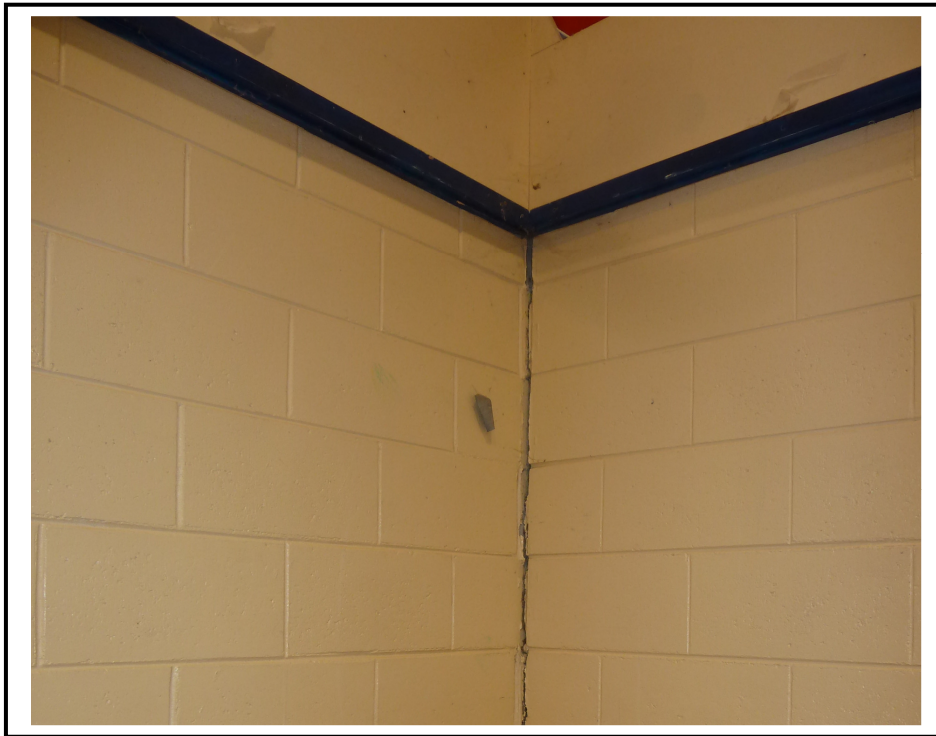
- a) Cracking to reinforced concrete masonry in one location along the north, adjacent to a column. The crack had been most covered by plywood and was not able to be thoroughly inspected.
- b) Opening of the joint between the reinforced concrete masonry walls in the north west corner.

Photo 4 – Opening of joint in north west corner of Stadium

- a) Minor repair works should be carried out on cracking to reinforced concrete masonry walls in the Stadium and opening of the slab joint in the foyer.
