**Port Levy Community Hall
Detailed Engineering Evaluation
Quantitative Report**

Christchurch City Council

Date: 11 July 2012
Reference: 6-QUCCC.70
Status: Final

Port Levy Community Hall Building
BU 3575-002 EQ2

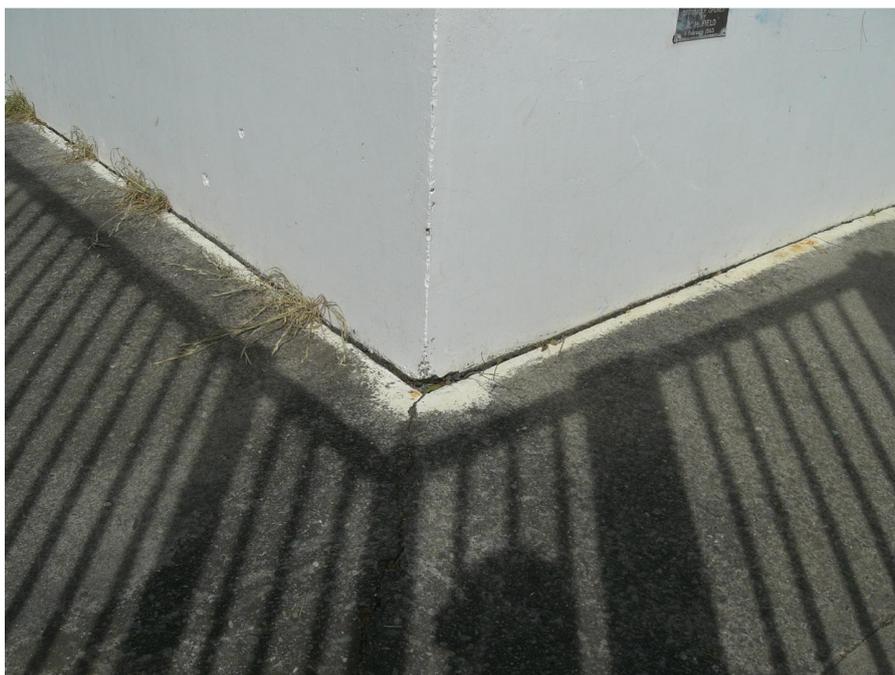
Photo 2: 10mm of pavement settlement around the north east corner of the swimming pool.

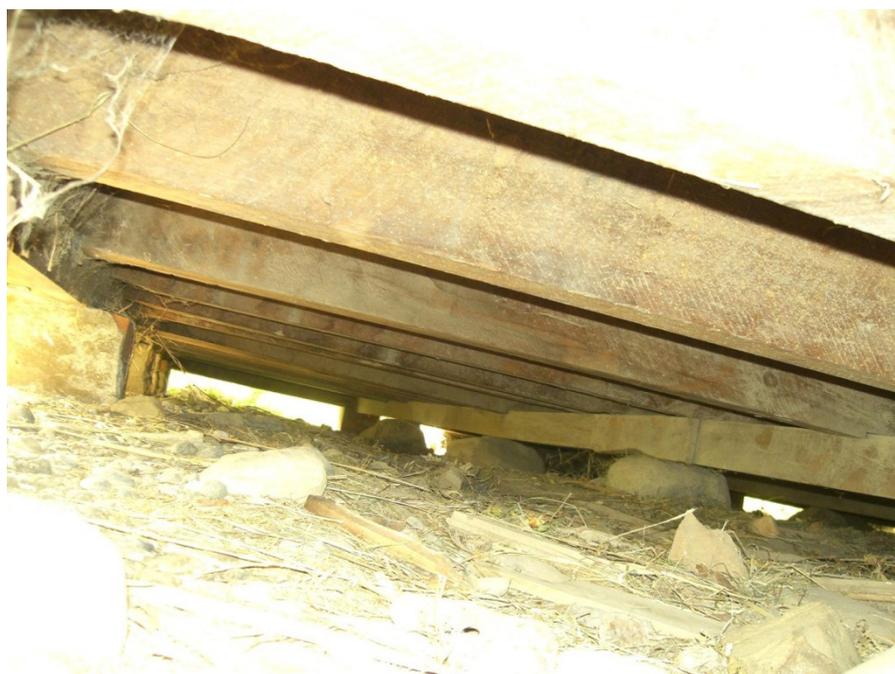
The existing foundations appear to have performed satisfactorily in the recent seismic events, even though the bearers are not connected to appropriate footings. Some deterioration of one corner masonry pile is evident, which may need to be plastered to avoid further deterioration. It is not obvious if the observed settlement around the pool has been caused by the earthquakes. No liquefaction has been observed on site. The stream is located 90m south east therefore it is considered to be low risk of lateral spreading. Due to

Photo 3: Foundation of the Community Hall.

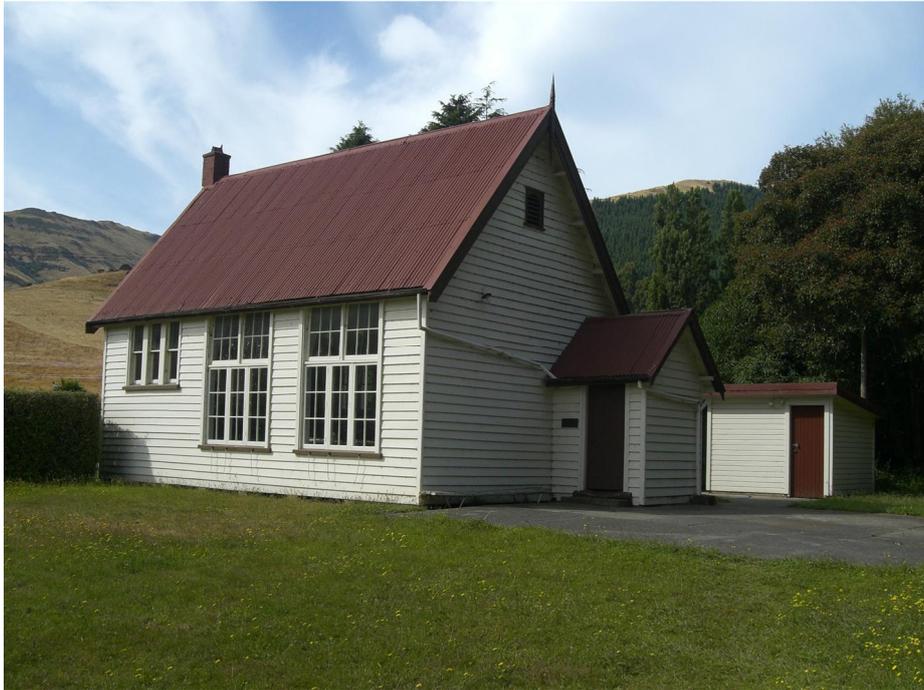
Photo 3: View of the building from the north

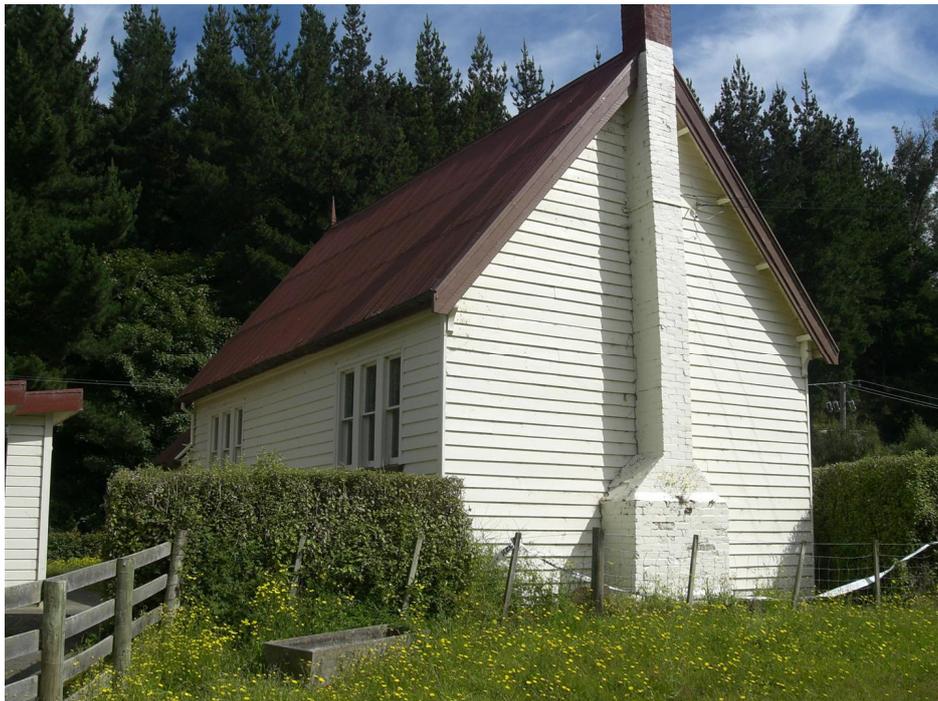
Photo 4: View of the building from the south

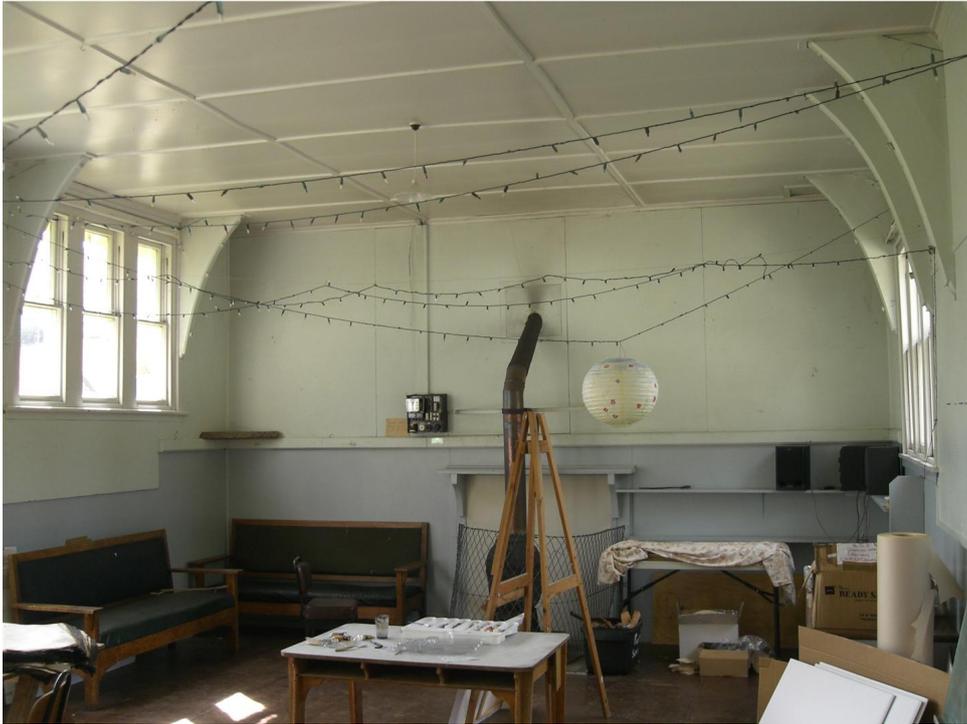
Photo 5: View of the main hall

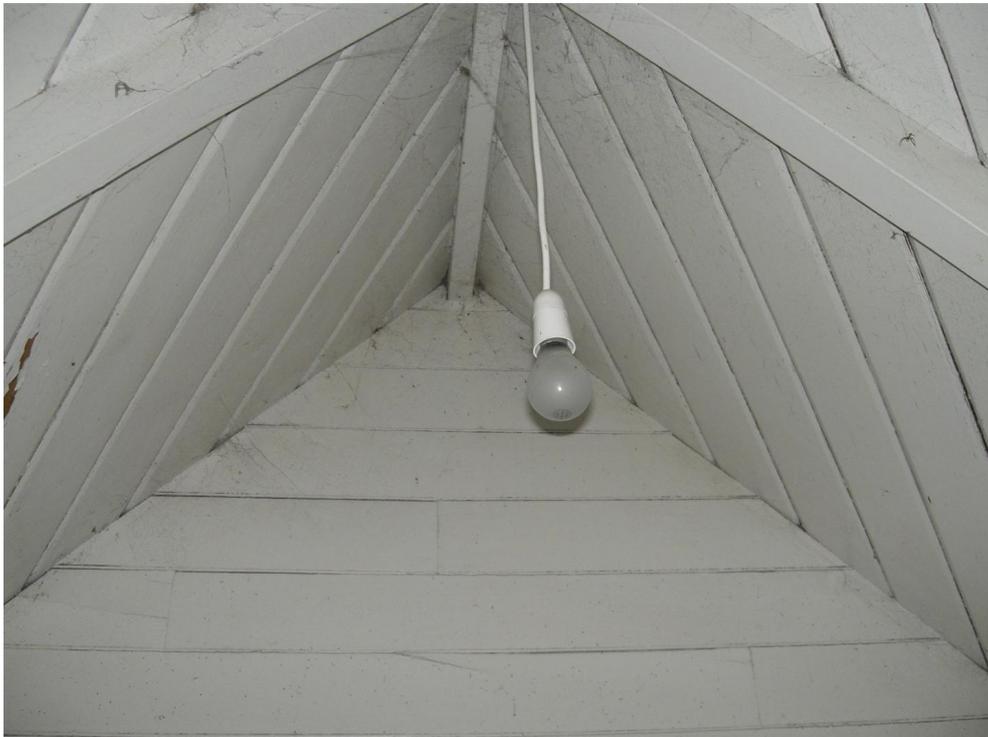
Photo 6: View of the tongue and groove ceiling and walls in the entrance area
