Poulton Courts Housing Complex PRO 0670

**Detailed Engineering Evaluation
Quantitative Assessment Report**

36 Poulton Avenue,

Date: February 2014
Reference: 6-QC391.00
Status: Final

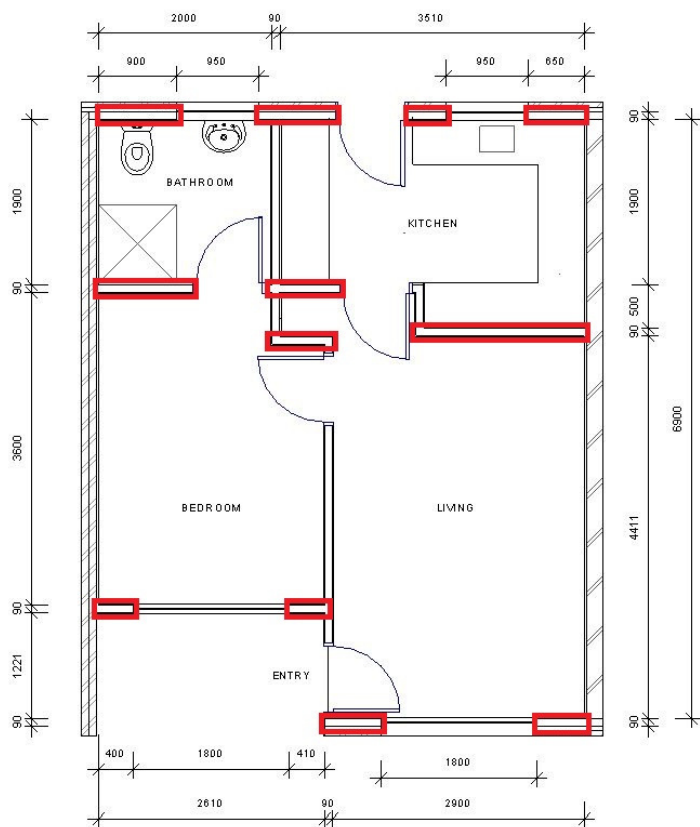
Figure 6: Walls used for bracing in the longitudinal direction.

The residential units have a capacity of 57% NBS as limited by the in-plane shear capacity of the timber-framed shear walls in the longitudinal direction. They are deemed to be a 'moderate risk' in a design seismic event according to NZSEE guidelines.

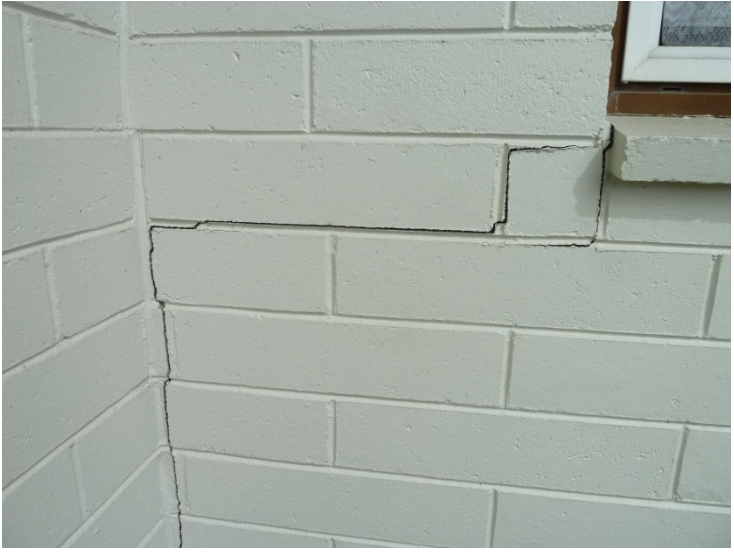
Stepped cracking in the brick veneer exterior cladding mortar joints was observed on some units (photos 7 and 8).

7.	Typical stepped cracking of brick veneer

- Structural systems be developed to increase the seismic capacity of the buildings to at least 67%NBS.
- Cosmetic repairs be undertaken as required.

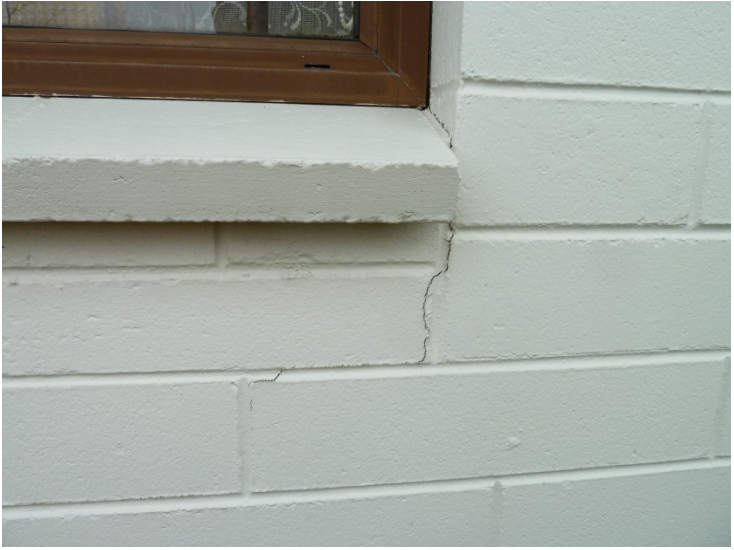
8.	Typical stepped cracking of brick veneer

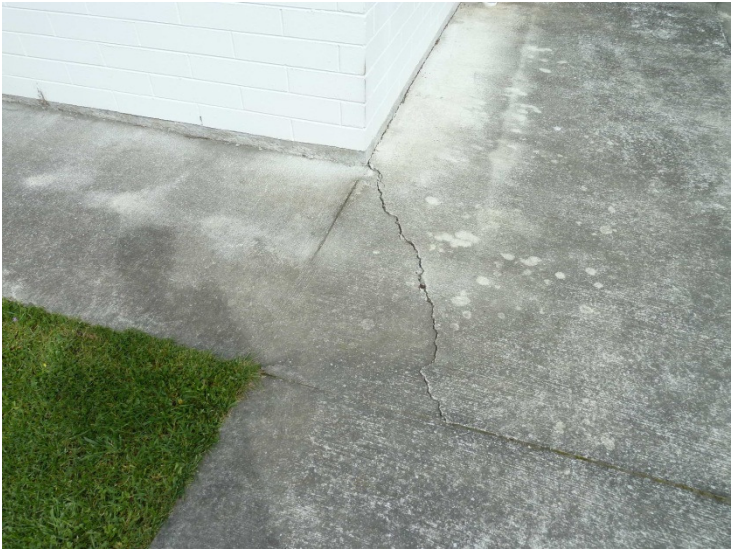
9.	Typical cracking of concrete footpath

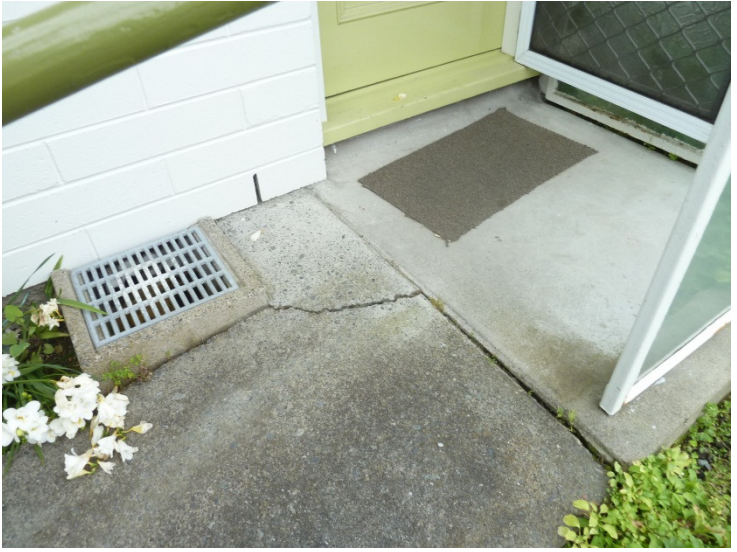
10.	Typical cracking of concrete footpath

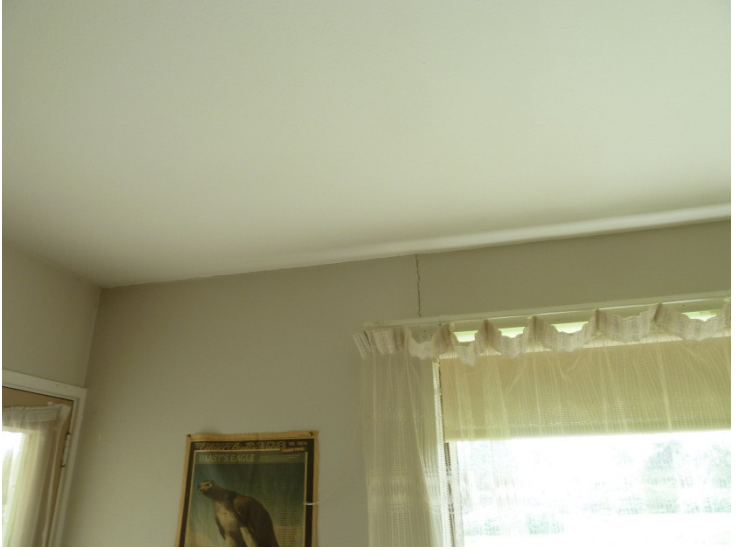
Minimal cracking of plasterboard ceiling diaphragms and wall linings was observed in the units (photos 11 and 12). This form of damage is common throughout the units.

11.	Typical cracking of wall lining
