Proctor Place
Quantitative Engineering Evaluation

Functional Location ID: PRO 0589

Address: 64 Proctor Street, Papanui

Revision: 2

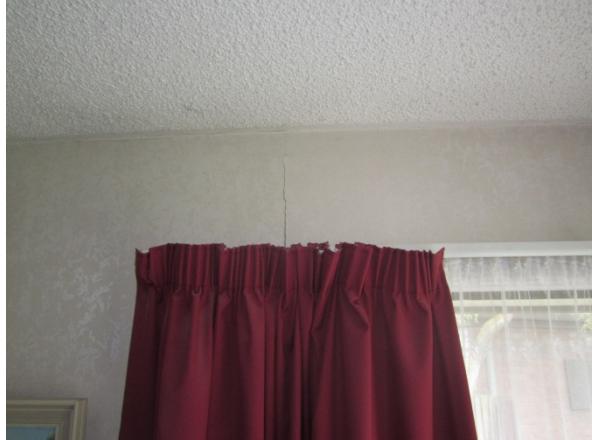
Building units	
Cracks in interior lining around window.

- Cracks in the perimeter concrete foundation should be repaired by epoxy injection.
- Cracks in the perimeter concrete slab on grade should be repaired by epoxy injection.
- Cracks in internal walls and ceiling fibrous plaster linings should be repaired similar to that used for Gib linings in accordance with "Gib guidelines for preparing Gib plasterboard linings in wind and earthquake damaged properties".
- In line with the previous report by OPUS (see Appendix F) we recommend a geotechnical report is obtained for the building, the ground around the building be built up again and possible voids under floor to be filled. The Geotechnical engineer should comment on the procedure and different options for filling the voids.

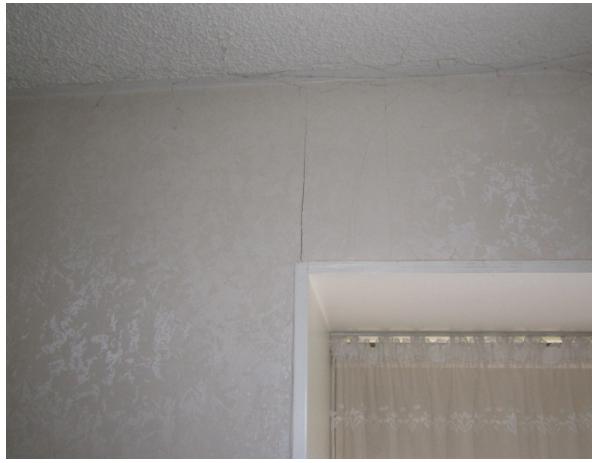
Cracks in interior lining around window.

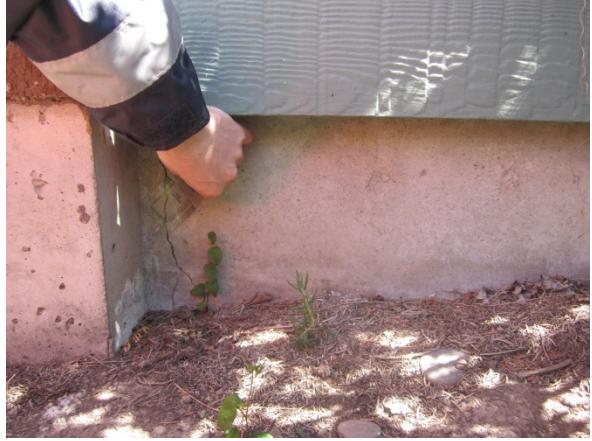
Cracks in exterior concrete foundation.

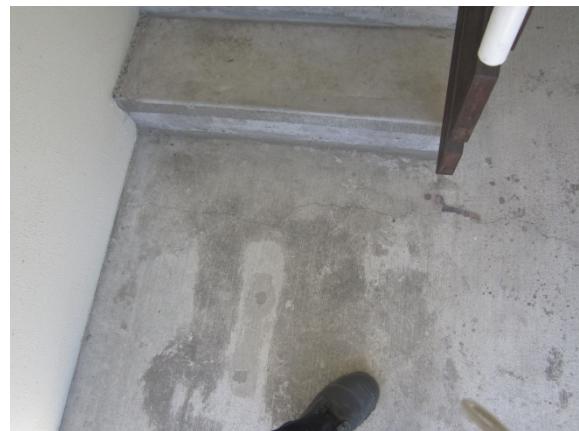
Cracks in concrete slab-on-grade.

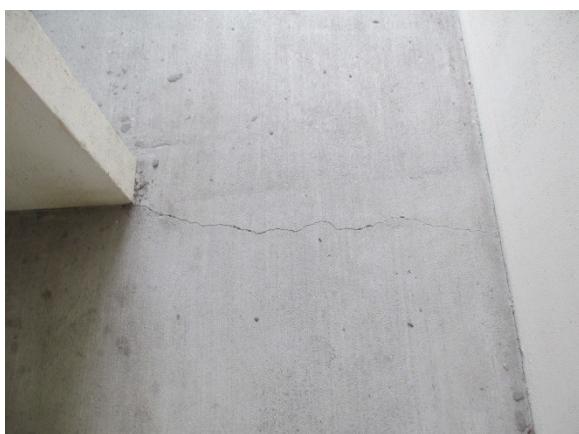
Cracks in concrete slab in the ground floor.

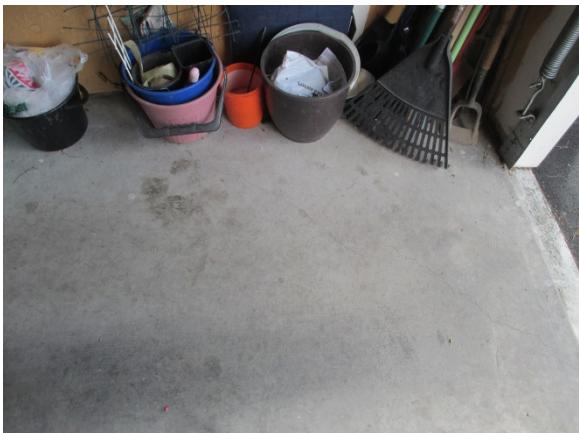
Cracks in concrete slab in the garage.

- Cracks in the concrete floor should be repaired by epoxy injection.

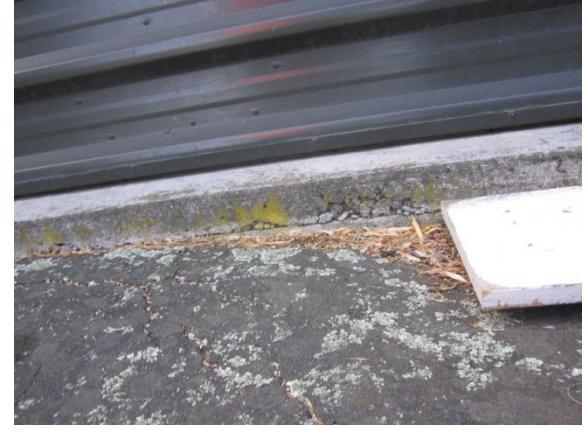
- Minor cracks in the concrete floor.
- The pavement in front of the garage has settled approximately 50 mm creating a step when entering the garage.

View of pavement which has sustained some differential settlements.

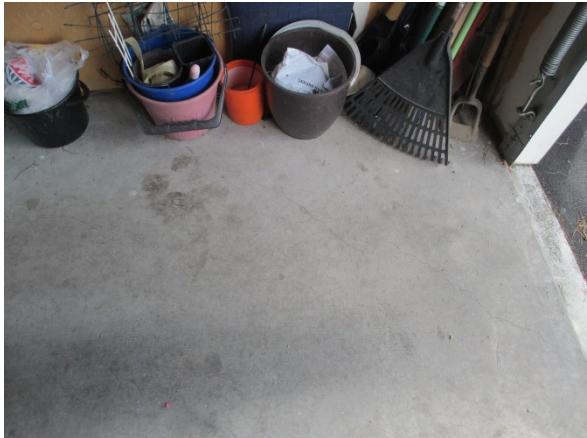
Cracks in the concrete floor of the garages.

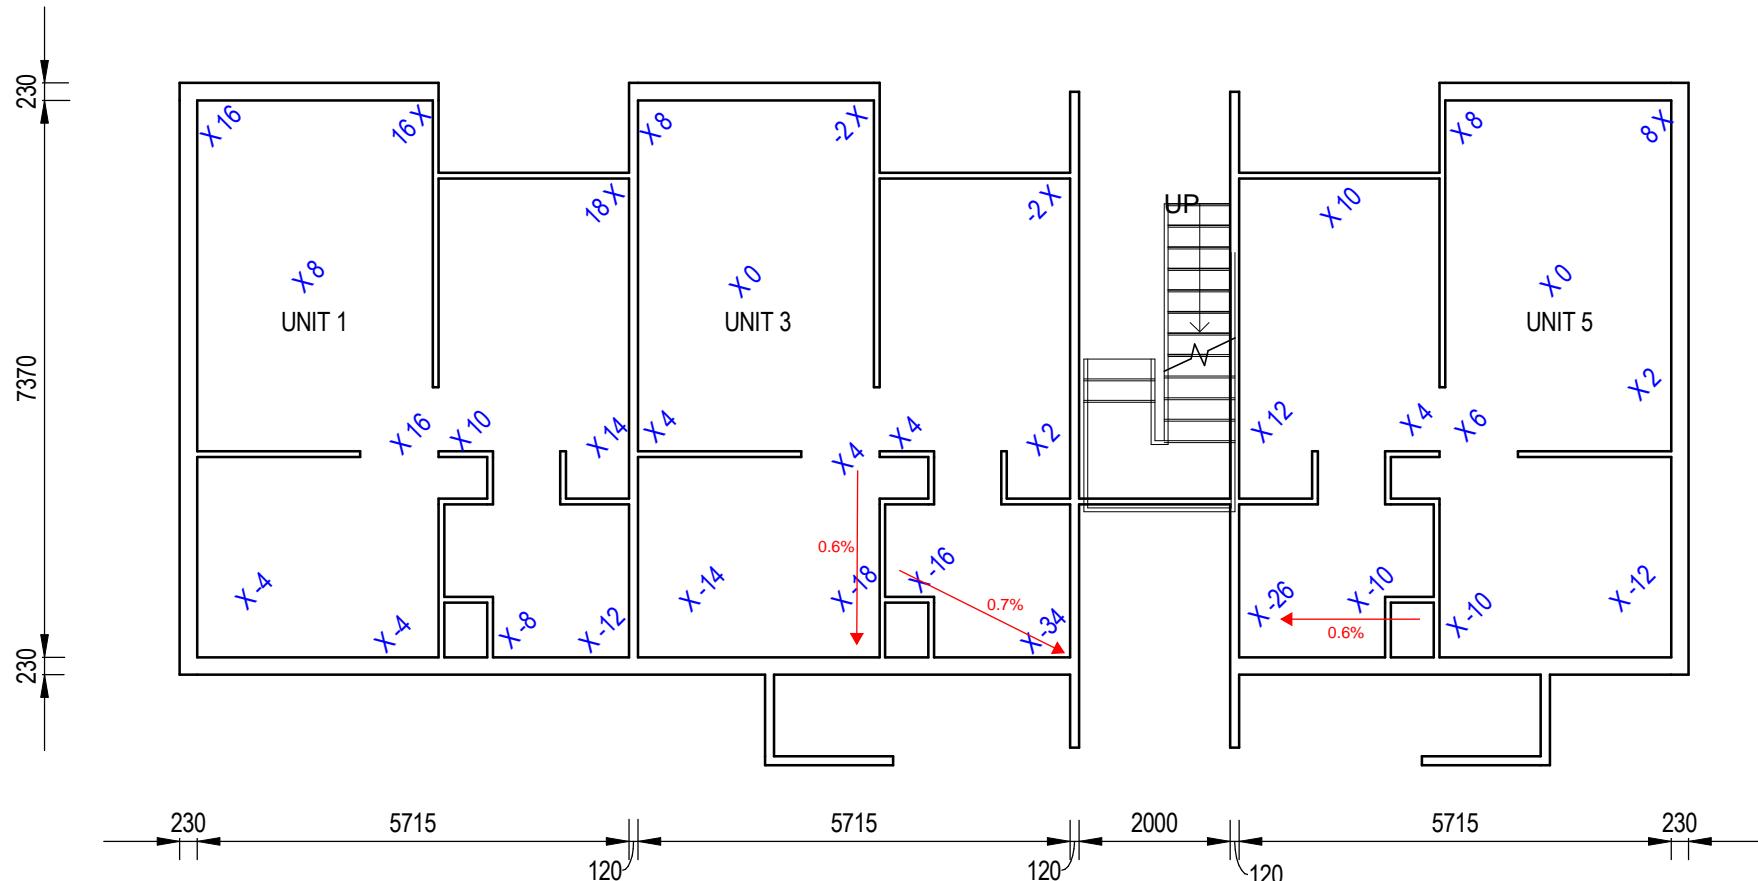
The floor levels for the Proctor Place are considered to be acceptable, the tolerance were exceeded in some areas where it was due to either floor coverings or where a floor was intentionally sloping towards a drain.

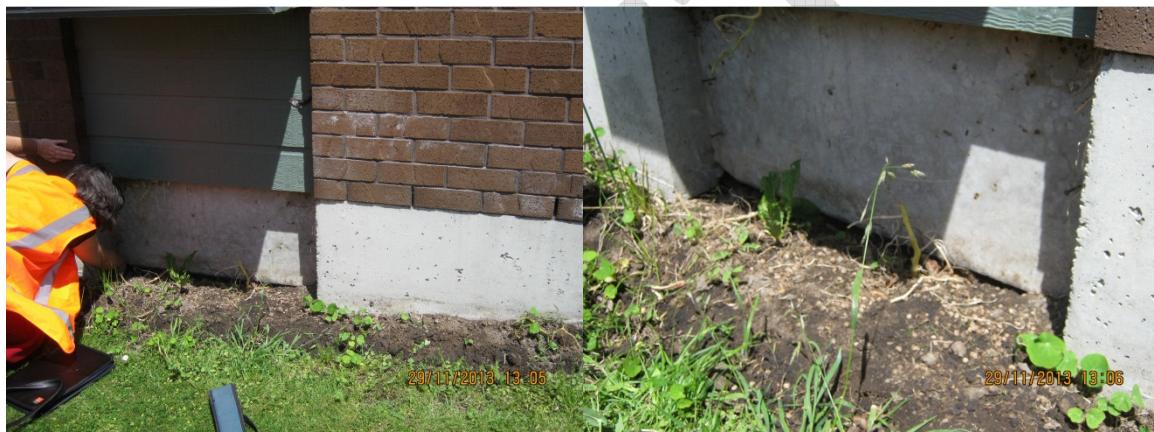
1. The ground was found to have lowered by approximately 100mm on the western end of the complex and up to 200mm on the eastern end. Voids were located under the floor which were large enough to fit an arm under, refer to the photo below.

It is considered that the building in its current state has a significant loss of passive soil resistance which should be reinstated.

We recommend that an investigation be carried out to fully document these findings but for the purposes of determining a likely repair cost then the following should be priced:-

1. The foundation on the east side and half way along the north and south sides have the footing extended as shown on the attached sketch 1.
