R&R Sport

BU 2677-005 EQ2

Detailed Engineering Evaluation

**645 - 647 Colombo Street, Christchurch
Christchurch City Council**

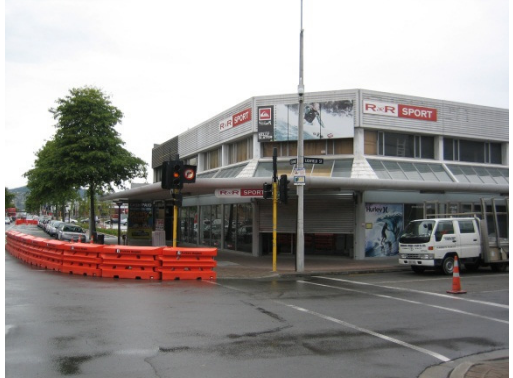
Manchester Street Car Park Building		
No.	Item description	Photo
1.	View of the northeast corner at the intersection of Colombo and Lichfield

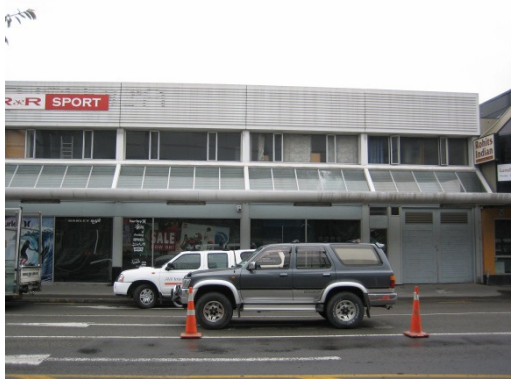
A photograph showing the northeast corner of the intersection of Colombo and Lichfield streets. The R&R Sport building is visible on the corner, with orange traffic barriers and a white van in the foreground.
2.	North face

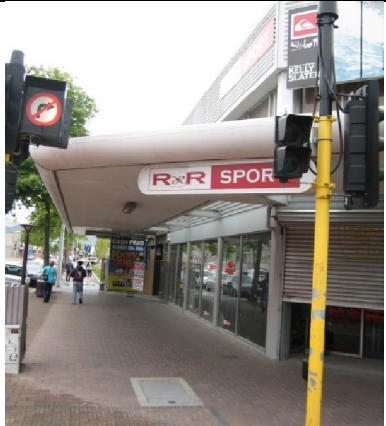
A photograph showing the north face of the R&R Sport building. The building has a modern design with large windows and a flat roof. A silver SUV is parked in front of the building, and orange traffic cones are visible on the street.
3.	Canopy on east face

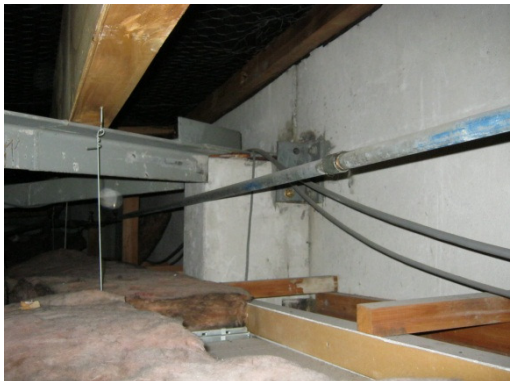
10.	Boxed plywood roof purlin

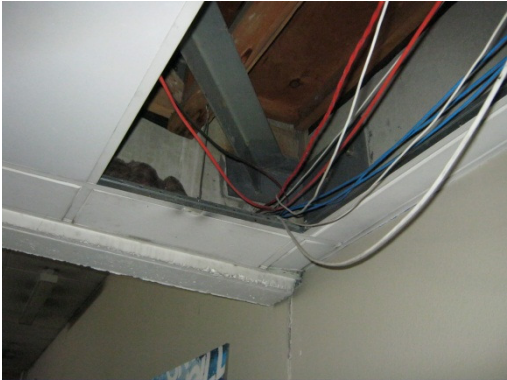
11.	Roof bracing connection to precast column

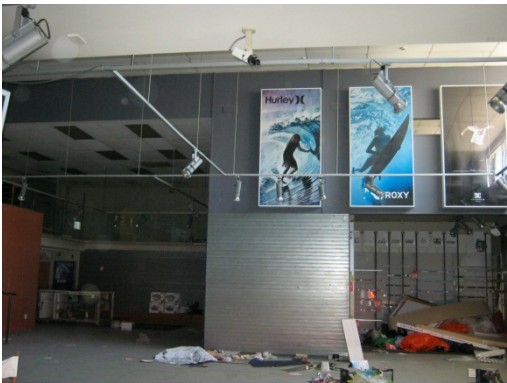
13.	Cracking at Panel P30 and P14 interface

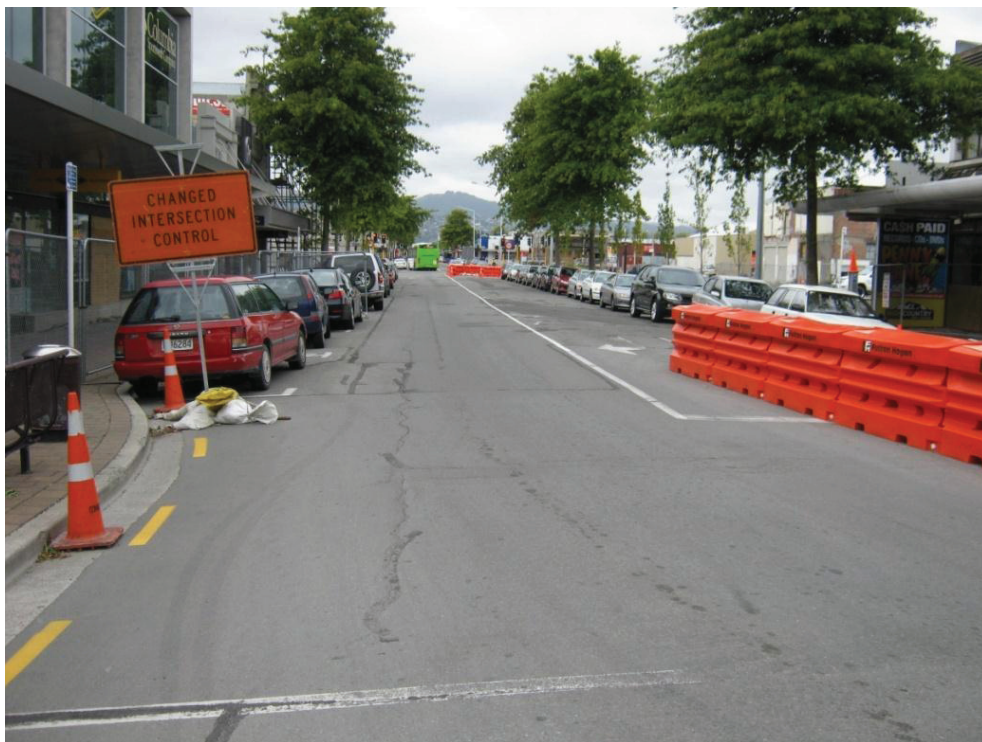
- Minor cracking of the pavement was observed on both Lichfield and Colombo Street. The predominant orientation of cracking was north – south (Photograph 2).

Photograph 2 - View south down Colombo from intersection with Lichfield; pavement cracking (24 January 2012).

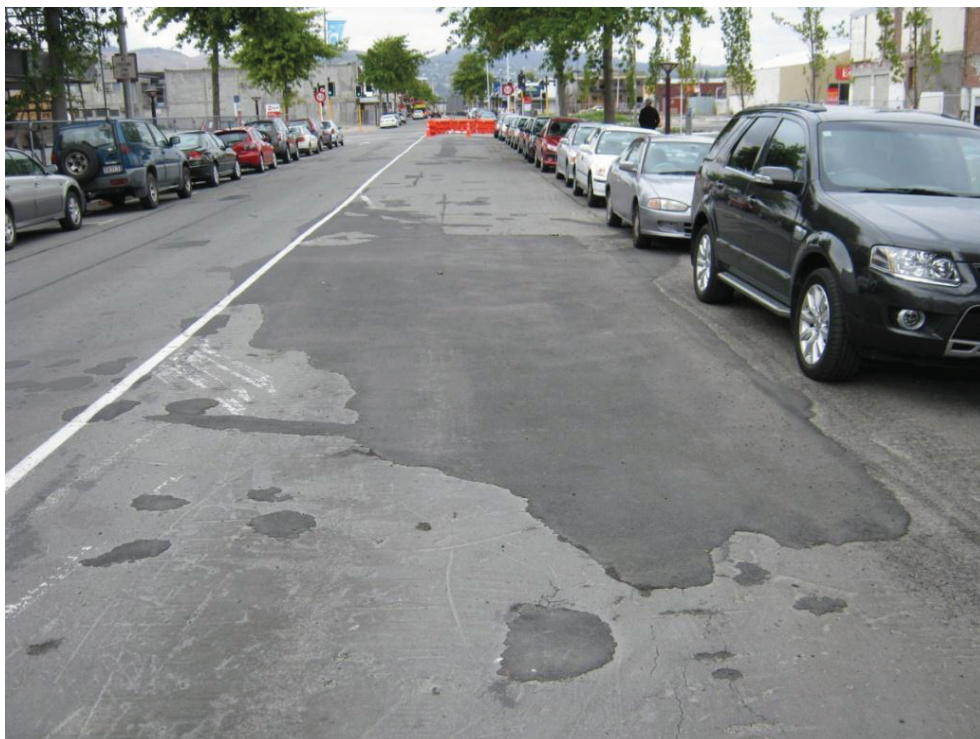
Photograph 3 - View south down Colombo from outside Penny Lane; pavement repair (24 January 2012).

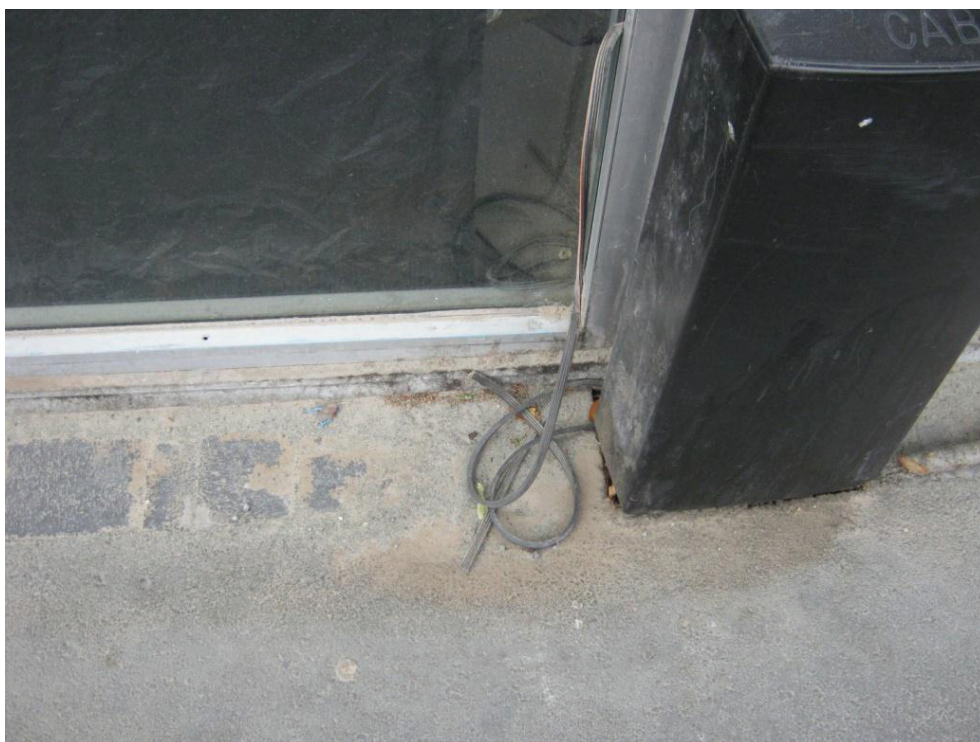
Photograph 4 – Minor sand ejection around service duct; north side of R and R building (24 January 2012).

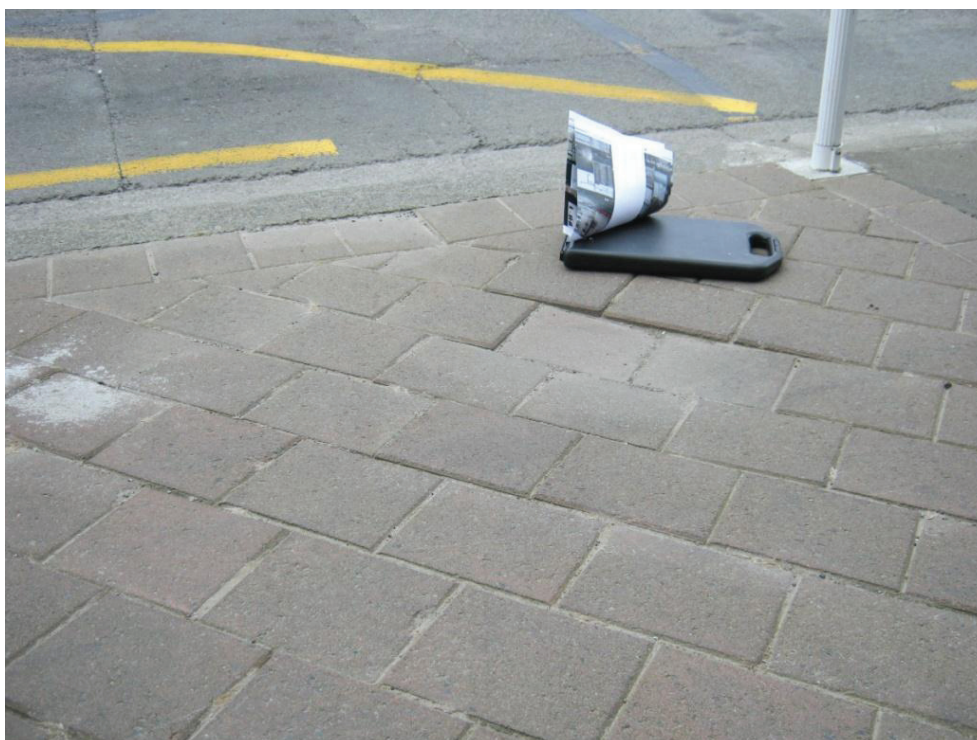
Photograph 5 – Minor settlement in footpath flagstones on the North side of Lichfield Street across from Rhotis restaurant (24 January 2012).

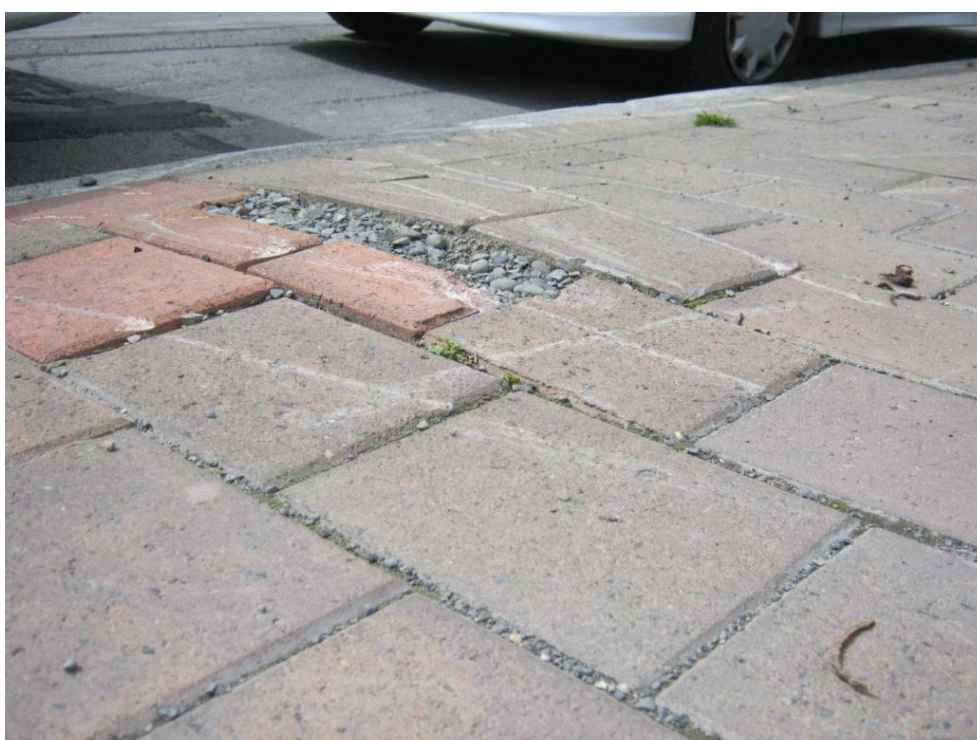
Photograph 6 – Minor heave in footpath flagstones on the west side of Colombo Street (24 January 2012).

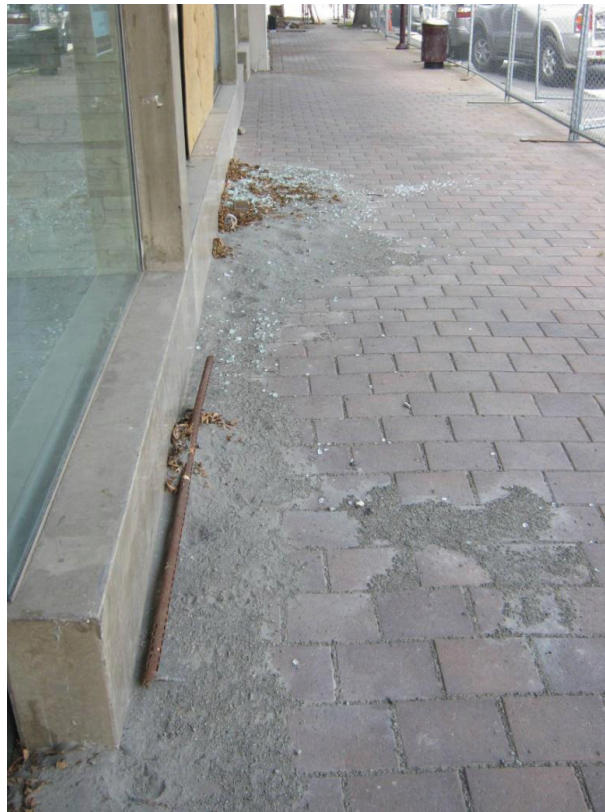
Photograph 7 – Piling of sand ejected by minor liquefaction on the east side of Colombo Street across from R&R (24 January 2012).
