**Rawhiti Domain (East) Toilets**  
**PRK 2004 BLDG 003 EQ2**  
Detailed Engineering Evaluation  
Qualitative Report  
Version FINAL

136 Shaw Avenue, New Brighton,  
Christchurch

Christchurch City Council

**Date**  
7<sup>th</sup> September 2012

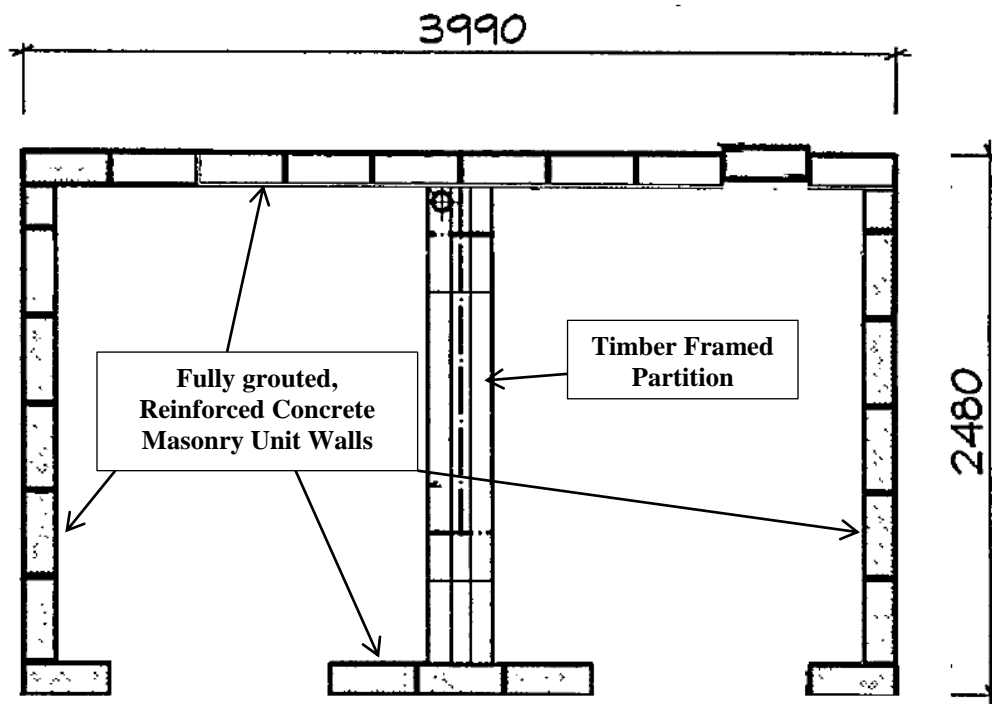
**Figure 2 Plan Sketch Showing Key Structural Elements**

In both the longitudinal and transverse directions, primary lateral load resistance is provided by the fully grouted reinforced concrete masonry units. Secondary lateral load resistance is provided within the roof structure by the timber sarking, rafters and purlins.

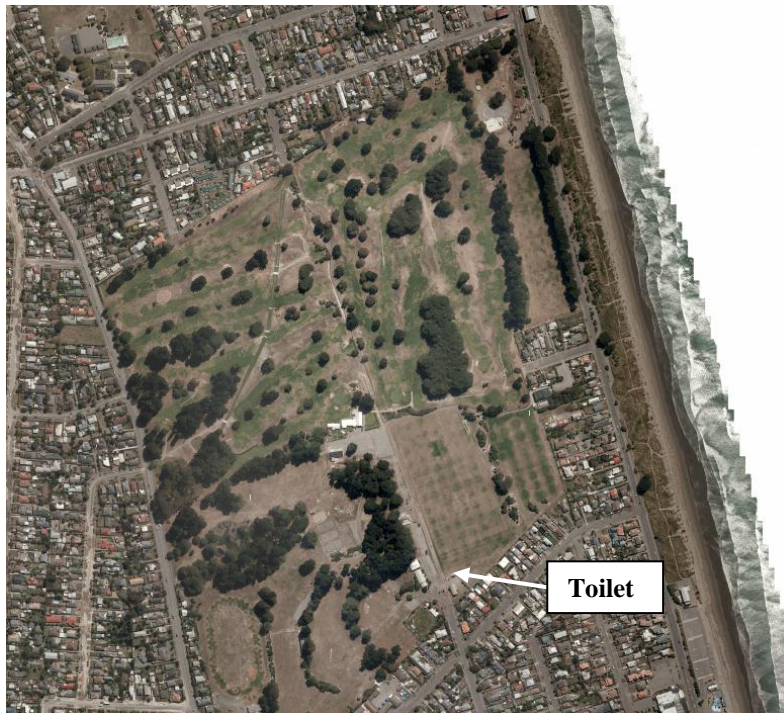
**Figure 3 Post February 2011 Earthquake Aerial Photography <sup>2</sup>**

Aerial photography taken following the 22 February 2011 earthquake shows no signs of liquefaction outside the building footprint or adjacent to the site, as shown in Figure 3.

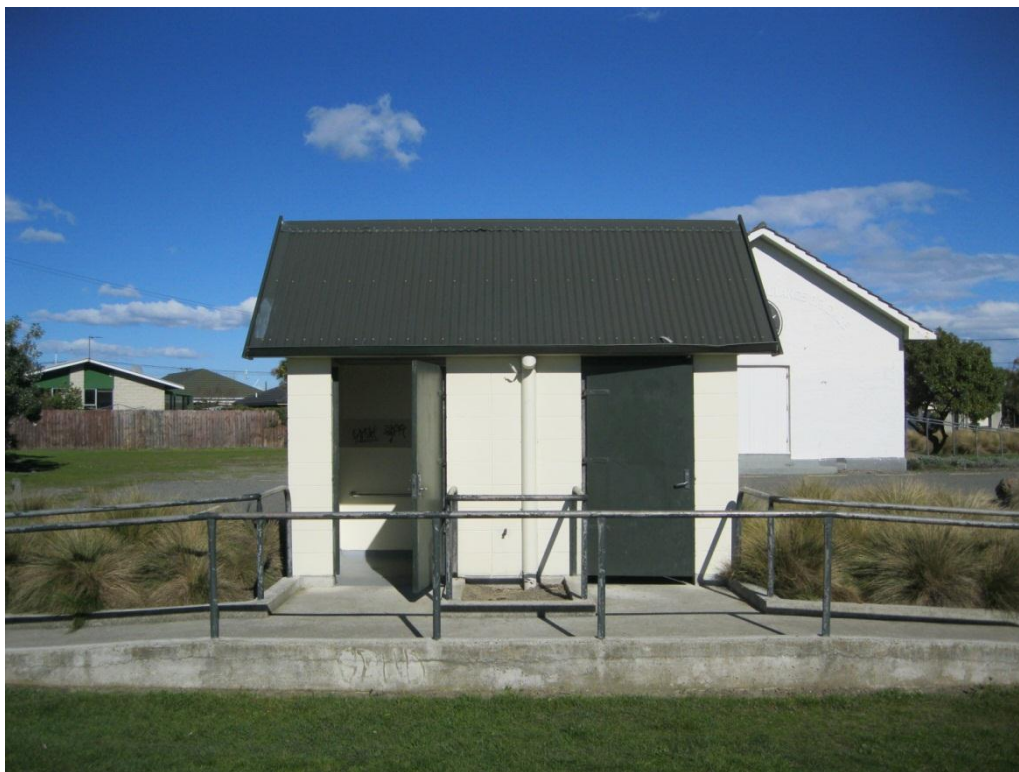
**Photograph 1 North elevation.**

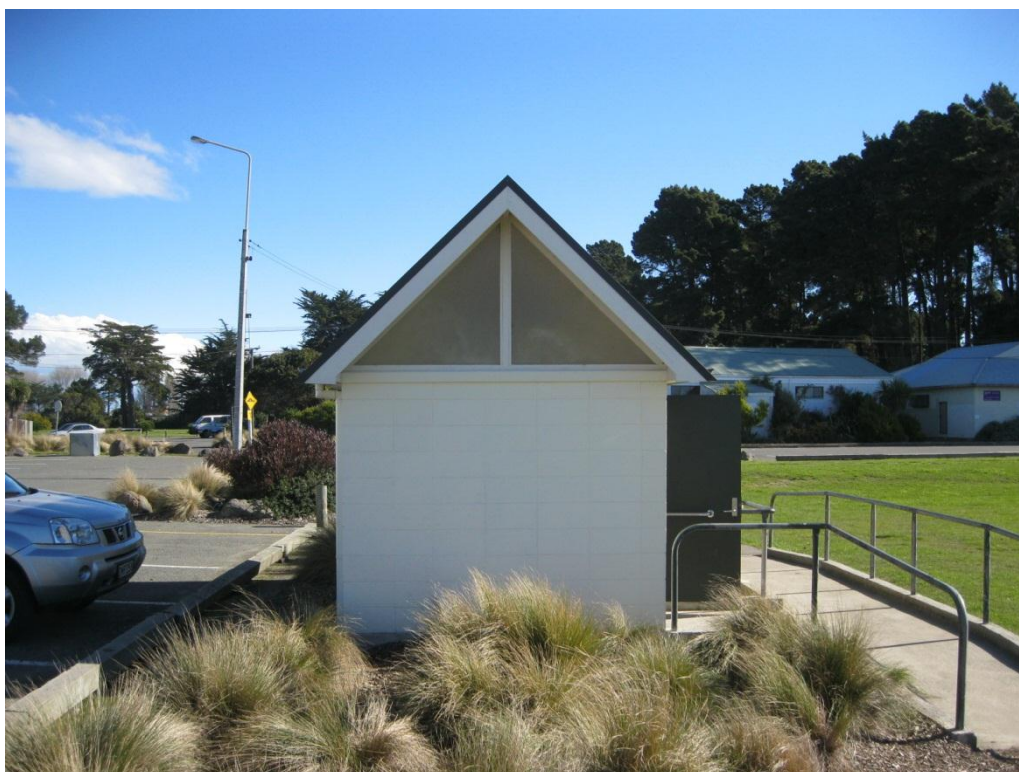
**Photograph 2 View of the toilet from the East.**

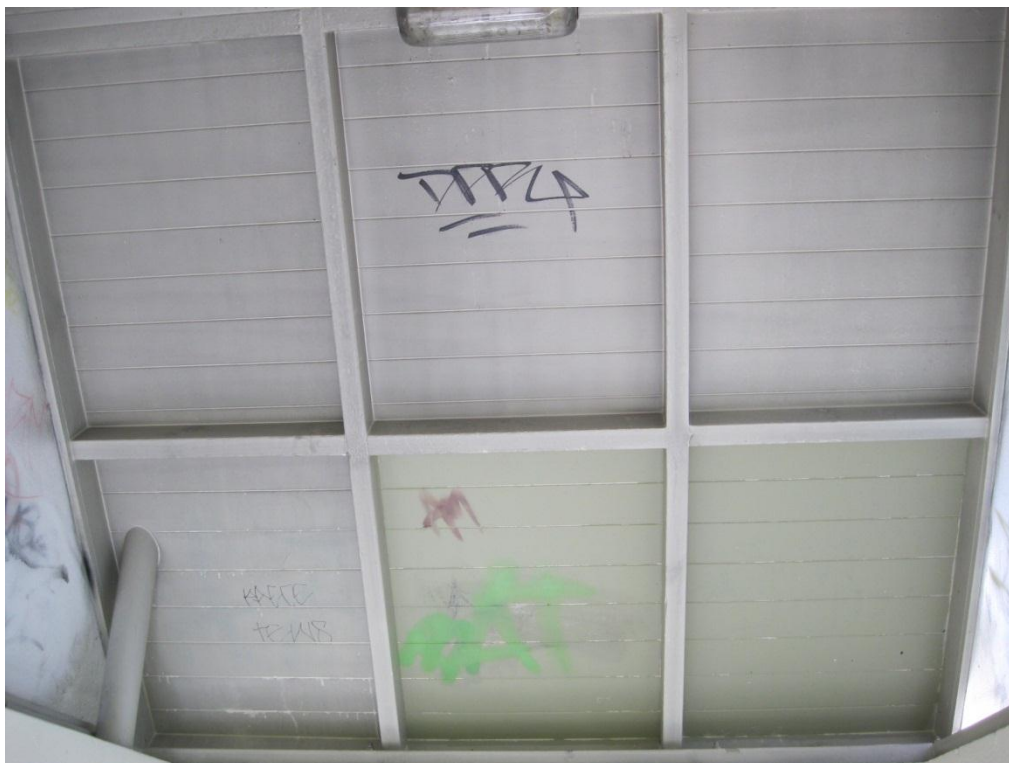
**Photograph 3 Roof structure showing timber sarking, rafters and purlins.**

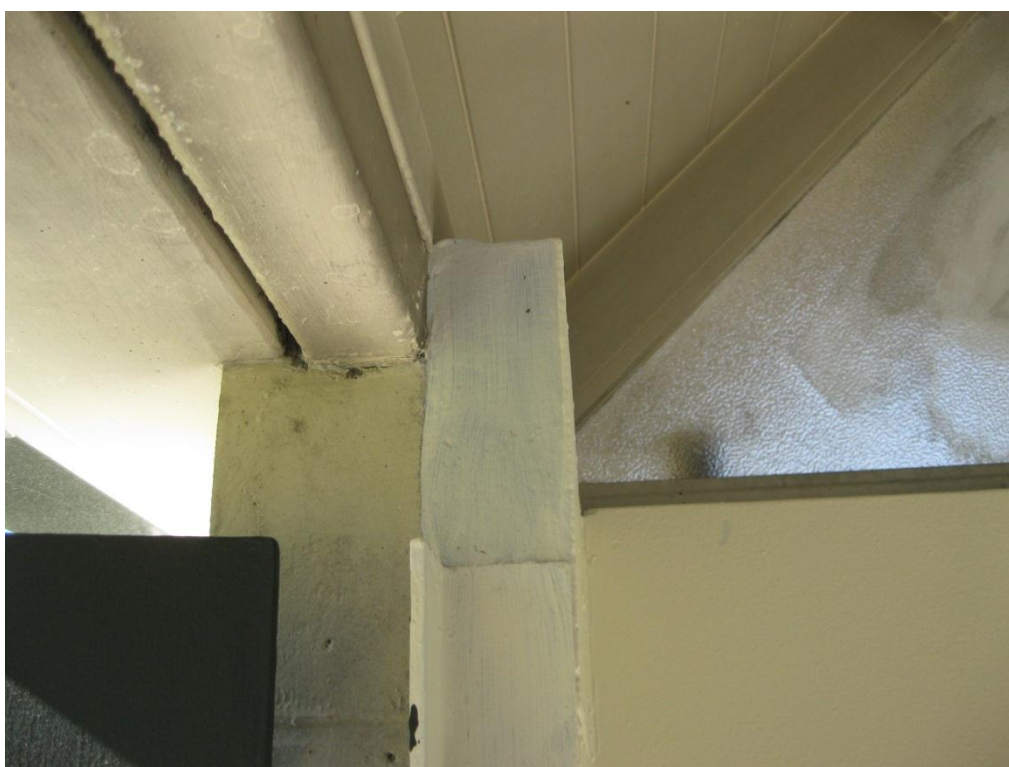
**Photograph 4 Rectangular hollow section lintel above door, embedded into the concrete masonry unit wall.**

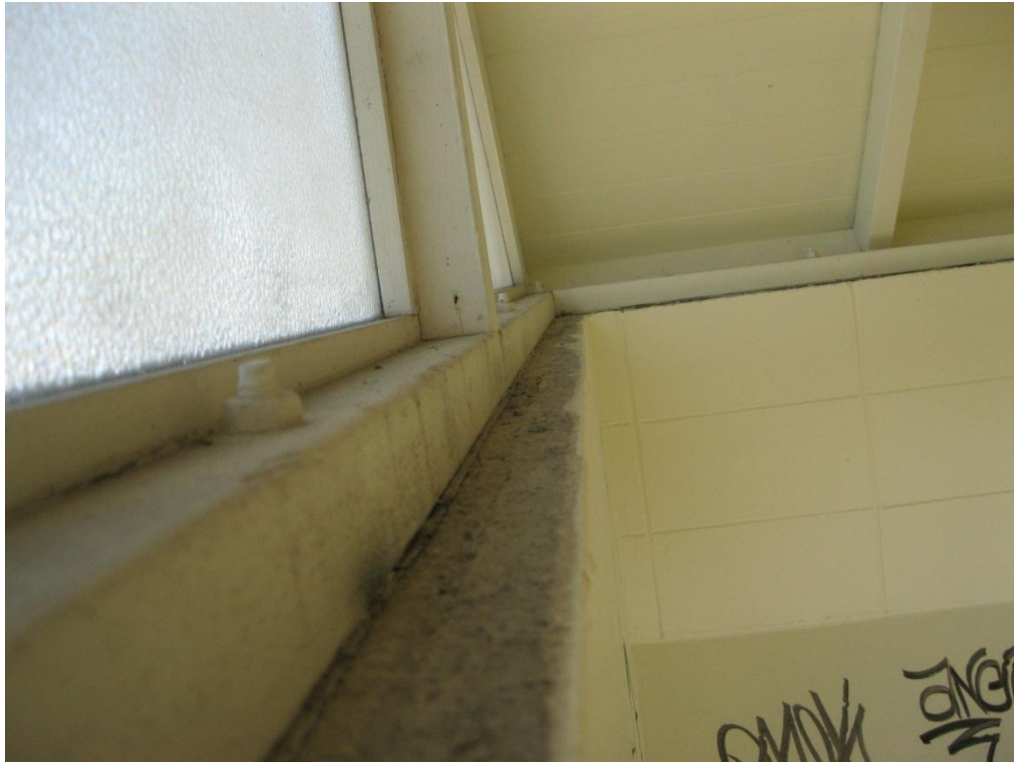
**Photograph 5 Timber wall plate fixed to fully grouted concrete masonry wall with 12mm diameter bolts.**
