Rawhiti Domain Tennis Club  
PRK 2004 BLDG 020

Detailed Engineering Evaluation  
Quantitative Report  
Version FINAL

35-37 Bowhill Road, New Brighton

**Date**  
28<sup>th</sup> May 2013

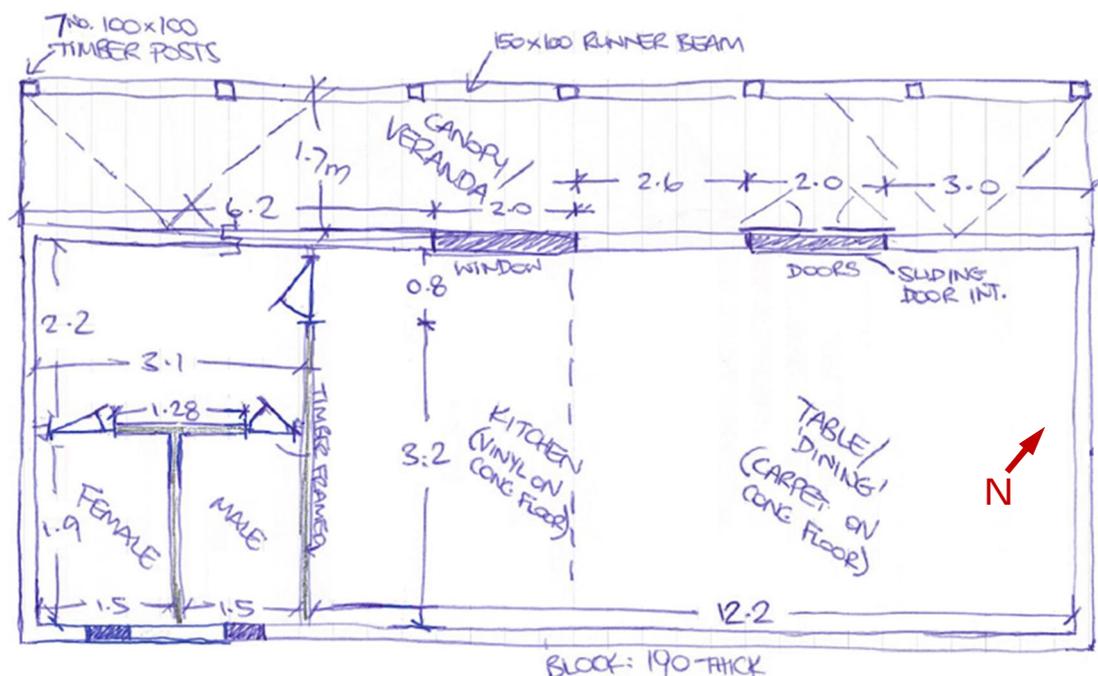
**Figure 2: Plan Sketch Showing Key Structural Elements**

Gravity loads are resisted by the reinforced blockwork walls around the building perimeter. The walls are supported on the reinforced concrete perimeter foundation.

Trusses span across the building, which transfer lateral loads from the roof acting along the building to the side walls. These walls, acting as in-plane shear walls, carry the loads to the foundations and into the ground. As the ceiling spans only 4.1 m across the building, the plasterboard ceiling lining, along with the timber roof trusses, is assumed to act as a ceiling diaphragm. Out-of-plane action on the end walls is assumed to be simply supported between the two side walls, which resist these loads as shear walls.

Roof loads acting across the building are transferred through the trusses into the top of the side walls. As the ceiling spans over 15 m in this direction, the ceiling has been assumed to not act as a diaphragm. Hence, lateral loads from the roof act at the top of the reinforced blockwork walls. These walls act out-of-plane in cantilever resisting the loads by flexure, transferring them to the foundations, through the starter bars at the connection between the walls and footings.

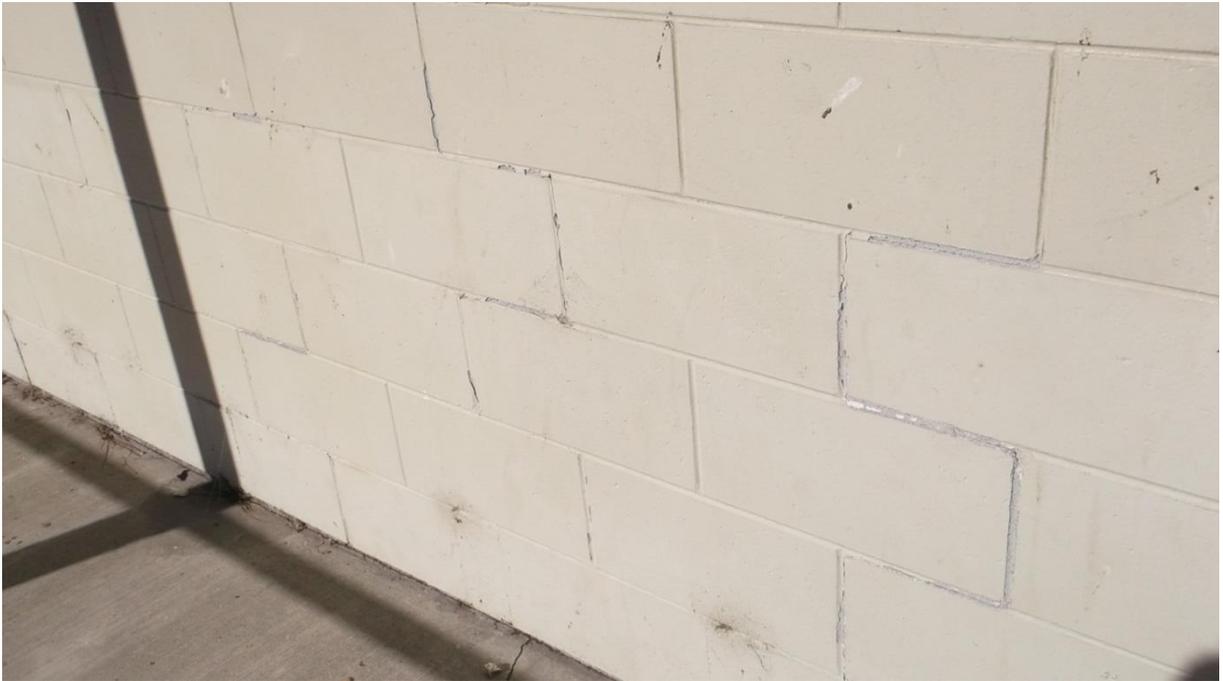
Cracking was noted to the external blockwork walls in several locations around the building; see Photographs 5 and 6. These cracks are not considered to be significant.

**Photograph 5: Typical cracking in blockwork walls between concrete blocks**

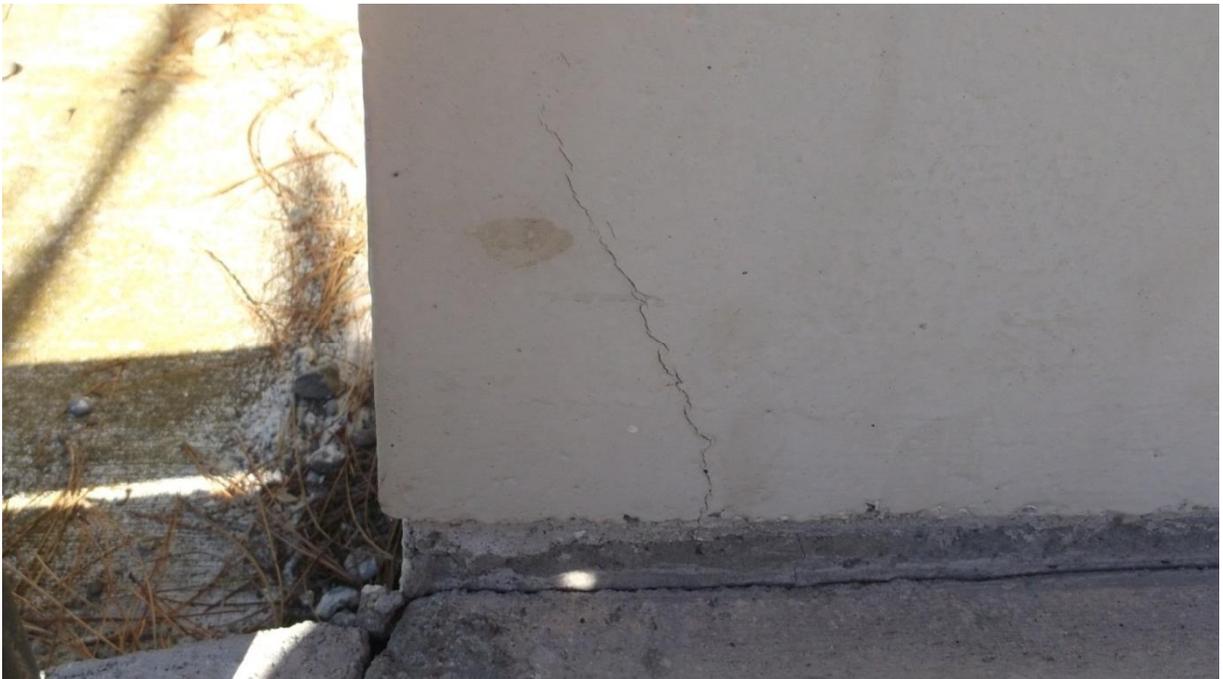
**Photograph 6: Close up of crack through bottom concrete block**

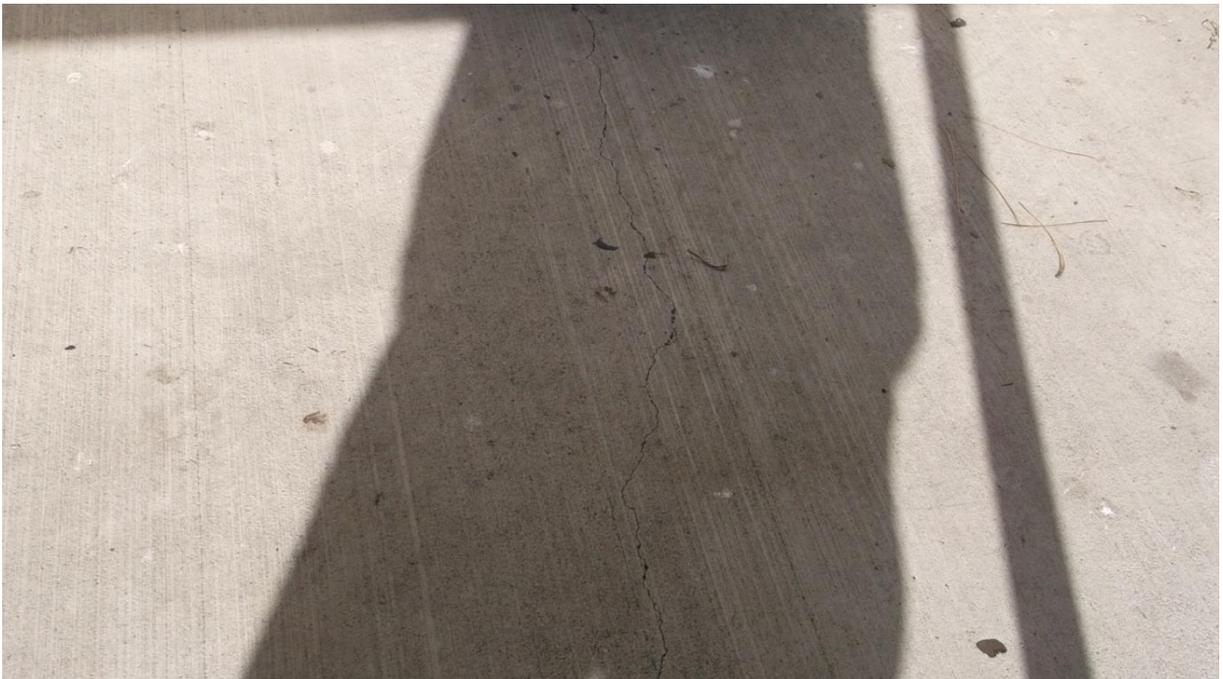
Cracking was also observed in the concrete pad under the veranda canopy; see Photograph 8. These cracks are not considered to be significant.

**Photograph 8: Close up of crack veranda concrete slab**
