Christchurch City Council

Ray Blank Park Pavilion/Toilet

PRK 0251 BLDG 001 EQ2

Detailed Engineering Evaluation

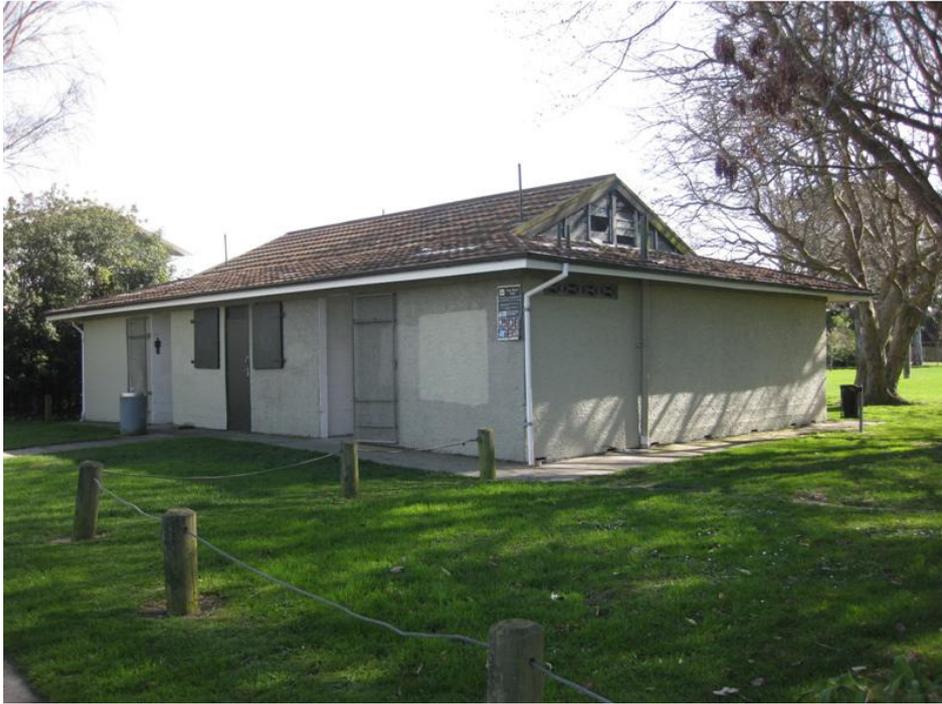
Building frontage

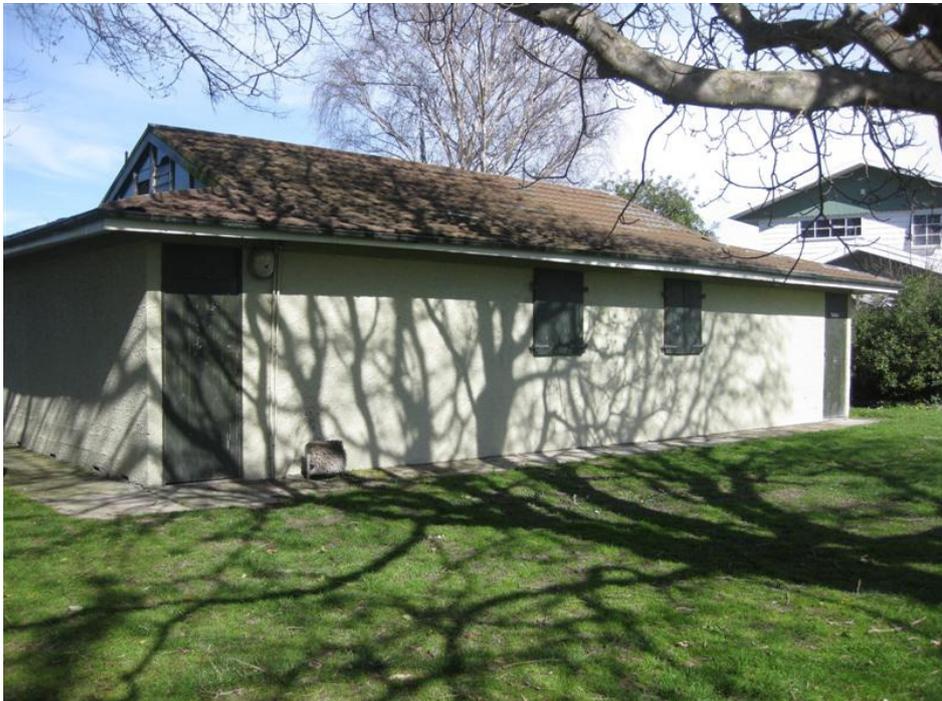
Building rear

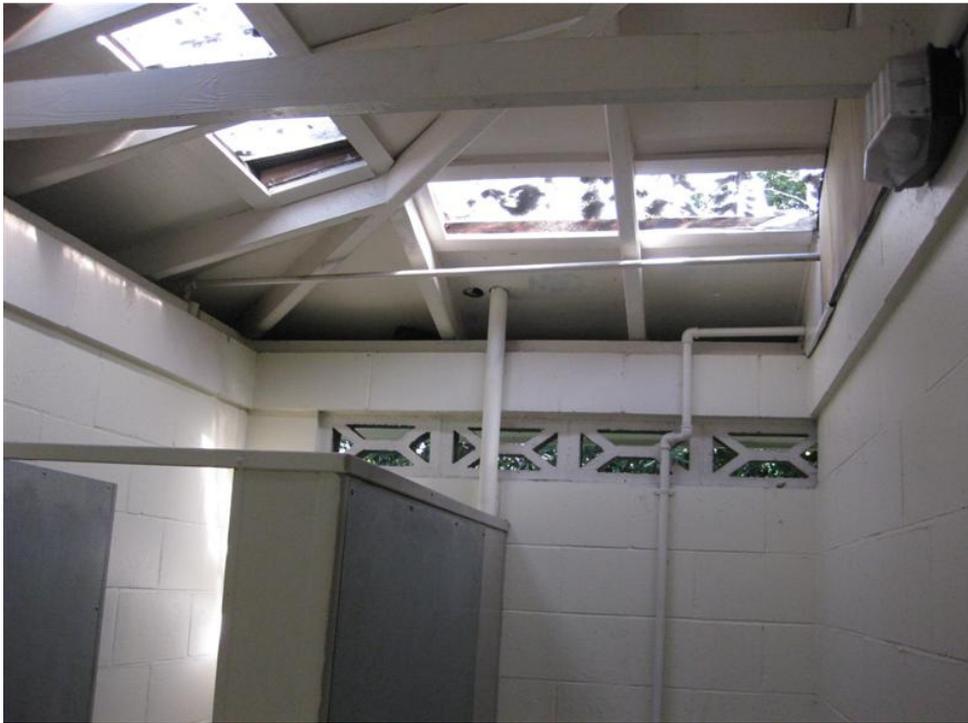
Toilet interior

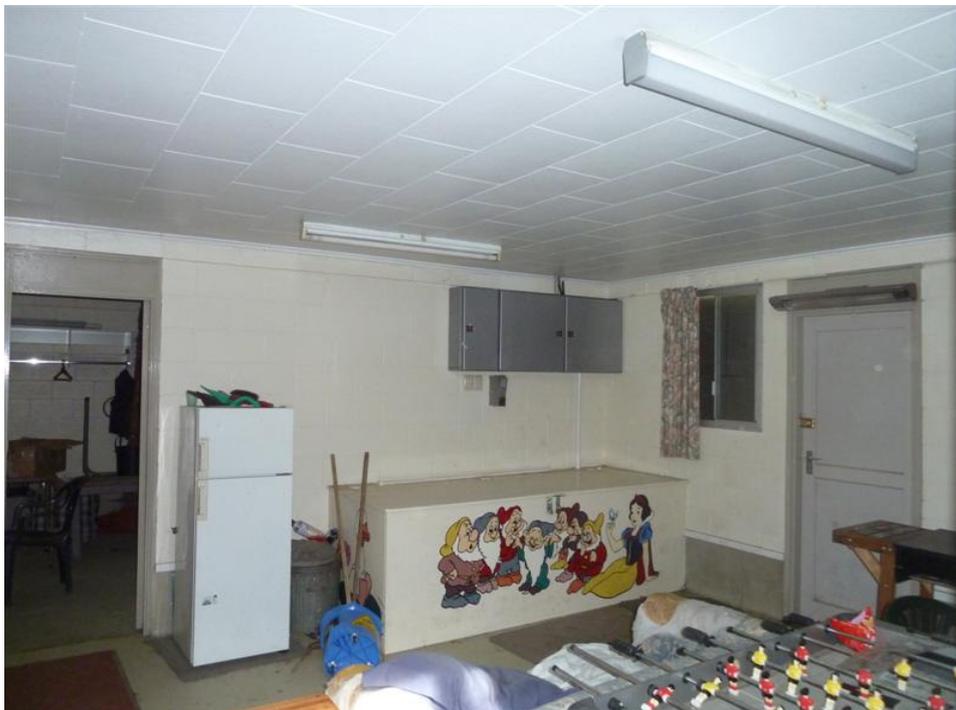
Social room

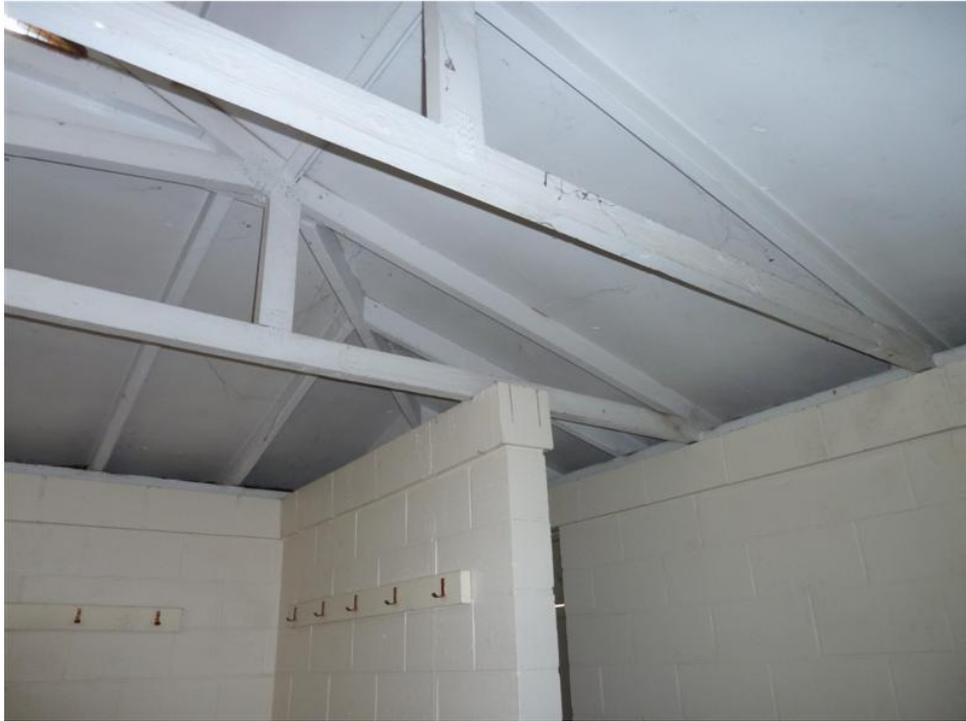
Changing room entry

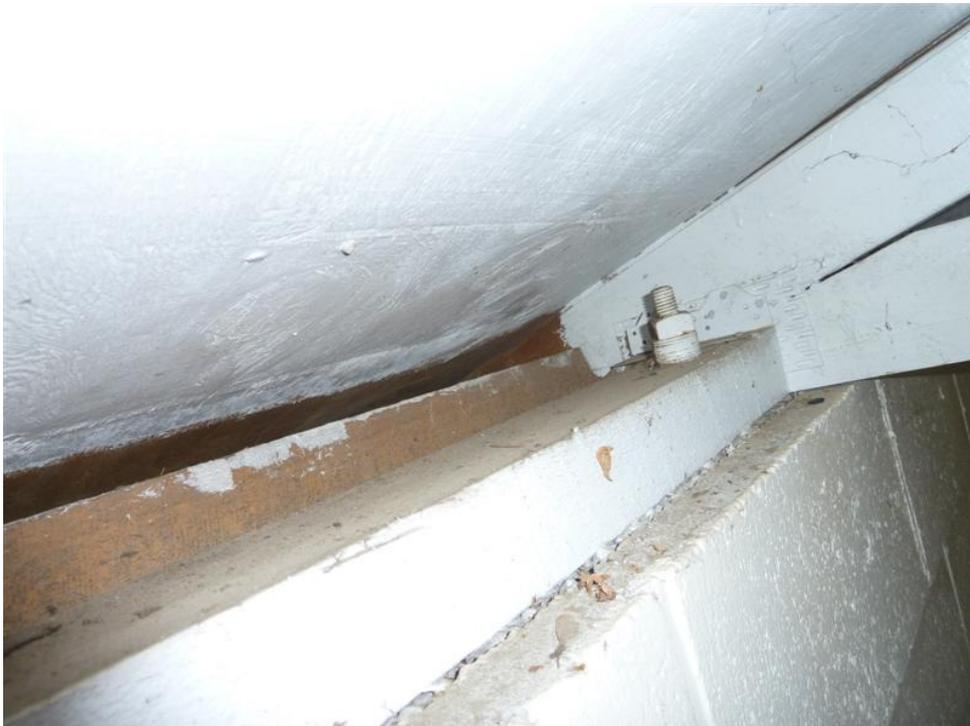
Truss, top plate connection to masonry bond beam

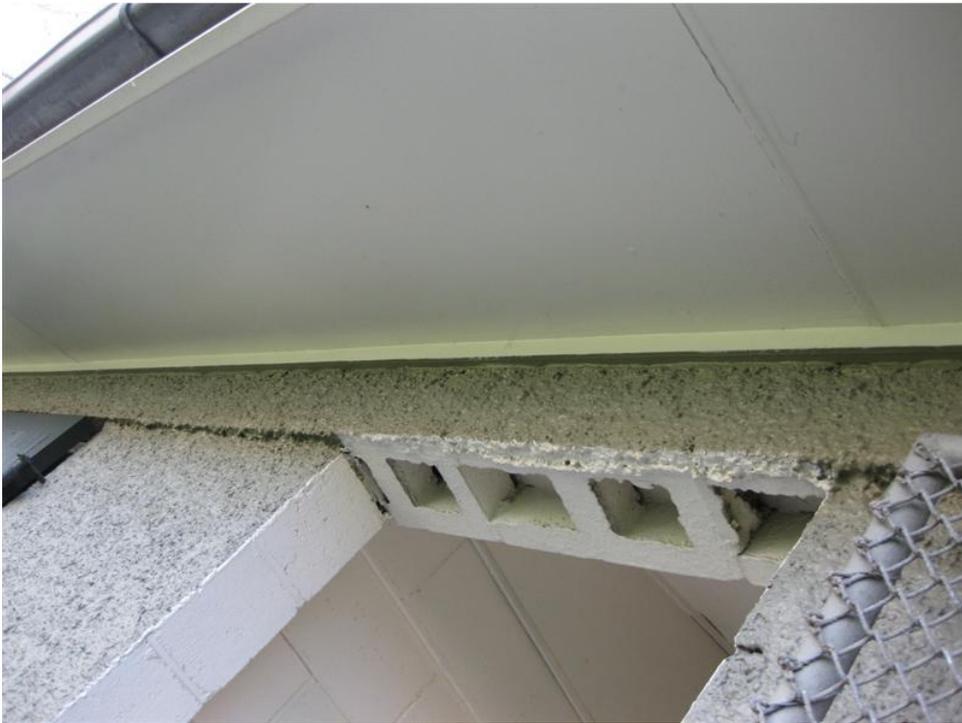
- 1) The masonry ungrouted cells at the toilets entrance lintels. Masonry shell concrete is typically low strength, and could dislodge and fall in a seismic event.
- 2) Minor impact type damage to the masonry walls bottom course at several locations was observed during the building inspection. The damage appears to be located at masonry drainage cut outs. The damage does not appear to be earthquake related, but this is not confirmed.
- 3) A number of roof gable end glazing panes are broken at both ends of the building

Toilet entry lintel blocks

- 1) That a support structure be provided below the masonry ungrouted cells at the toilets entrance lintels.
- 2) That the damage observed on the building exterior to the bottom masonry course at several locations, be repaired.
- 3) That the damaged roof gable end glazing panes be repaired or replaced.

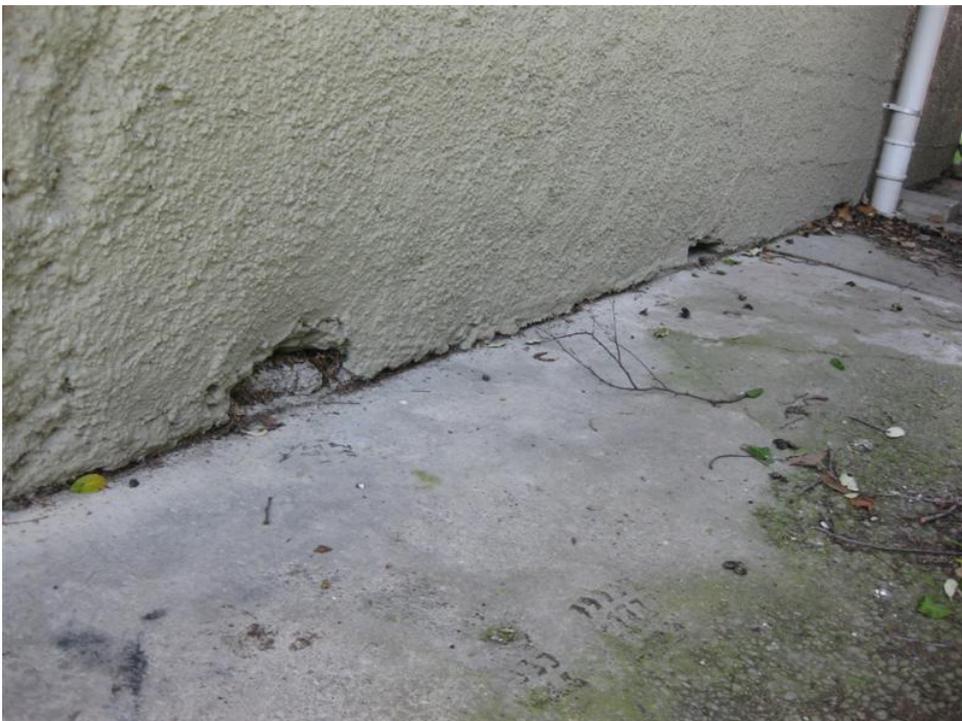
Exterior wall damage
