# **Redwood Plunket PRK 2179 BLDG 003B**

**Detailed Engineering Evaluation**

**Quantitative Assessment Report**

**337 Main North Rd, Redwood**

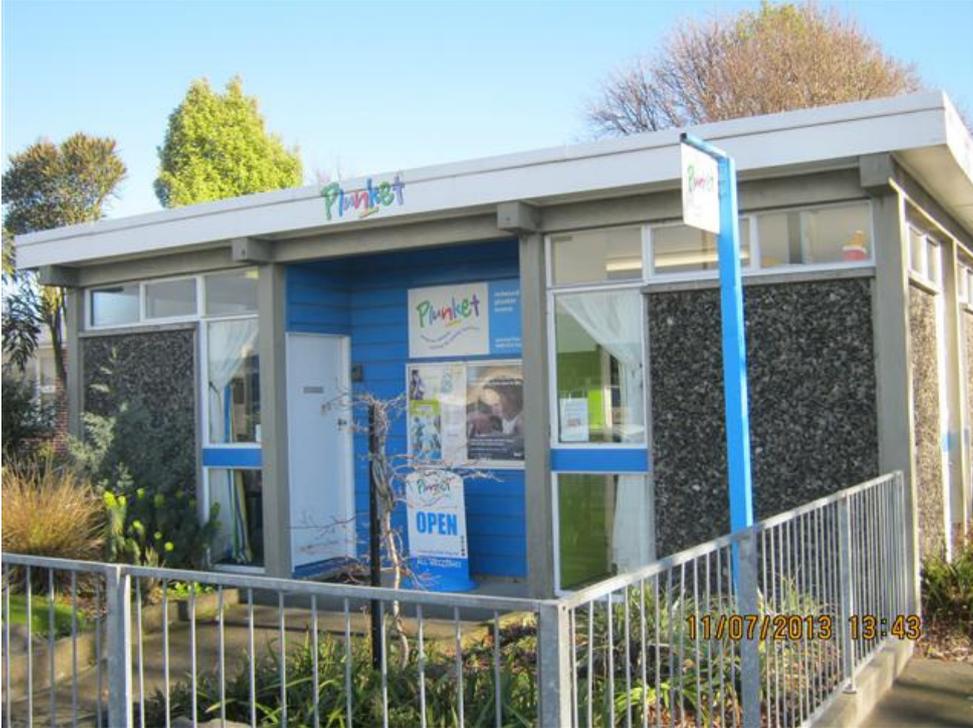
| No. | Description | Photo |
|---|--|--|
| 1. | View of front entrance wall from Main North Road | |

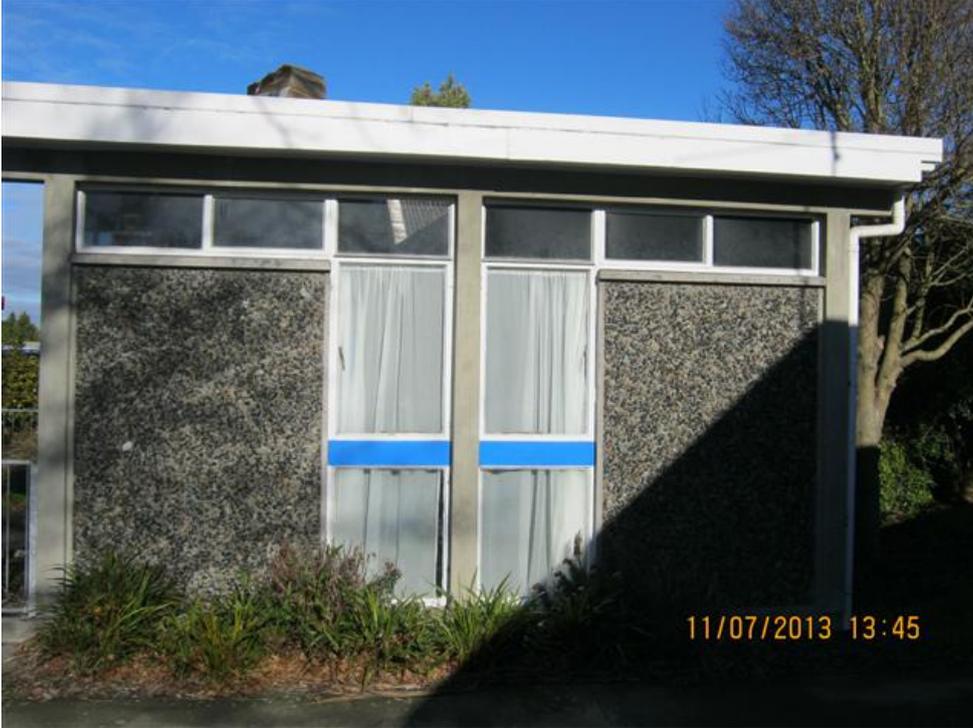
| No. | Description | Photo |
|---|--|--|
| 2. | View of wall on northern side | |

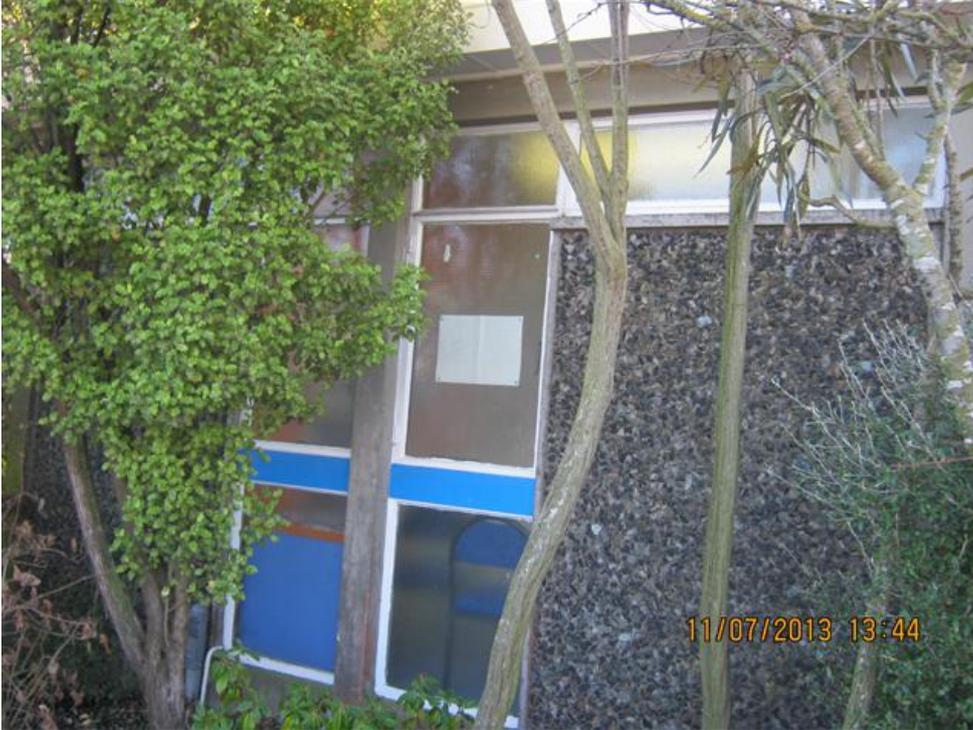
| No. | Description | Photo |
|---|---|--|
| 3. | View of wall panels on southern side | <p>A photograph showing a section of a building's exterior wall. On the left, there is a window with a white frame and blue horizontal trim. To the right of the window is a wall with a dark, textured, possibly stone or aggregate finish. A tree trunk is visible in the foreground, partially obscuring the wall. A timestamp in the bottom right corner reads "11/07/2013 13:44".</p> |

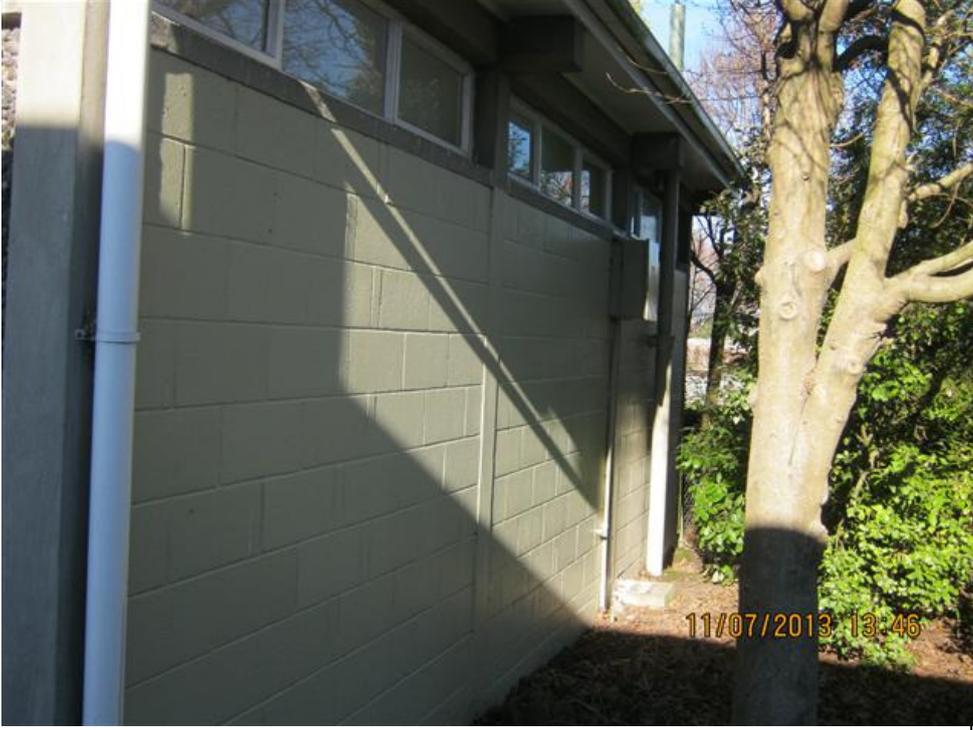
| No. | Description | Photo |
|---|---|--|
| 4. | View of block wall on western side | <p>A photograph of a light-colored block wall, likely made of concrete or masonry. A white downspout runs vertically along the left side of the wall. A tree trunk is visible on the right side of the frame. The wall is partially in shadow. A timestamp in the bottom right corner reads "11/07/2013 13:46".</p> |

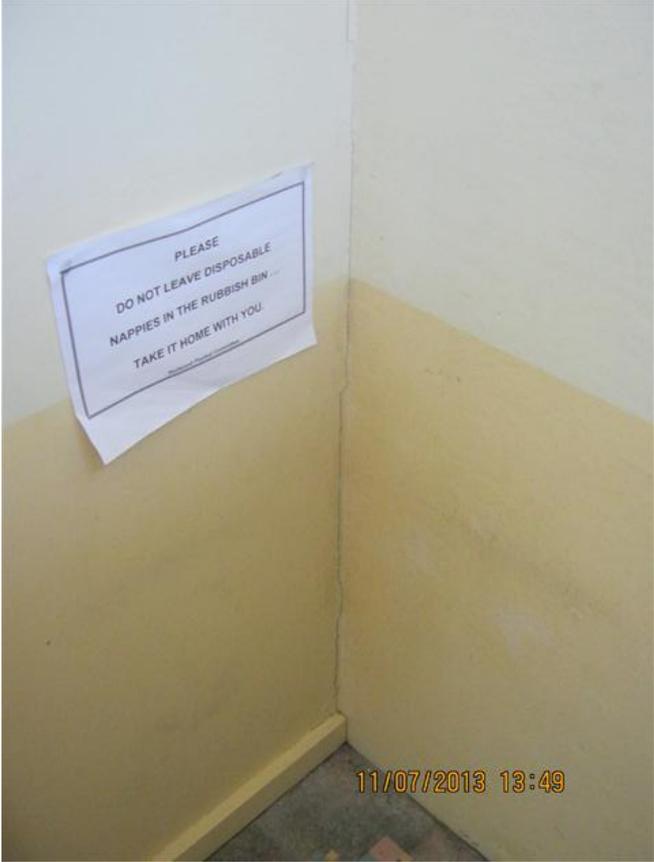
| No. | Description | Photo |
|---|---|---|
| 5. | Crack in wall corner | |

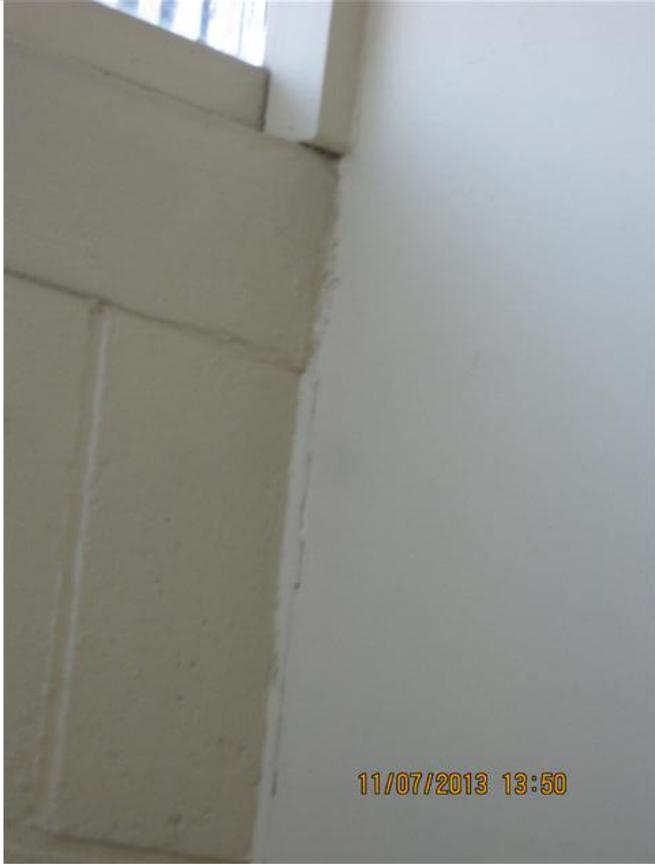
| No. | Description | Photo |
|---|---|--|
| 6. | Crack in wall corner | |

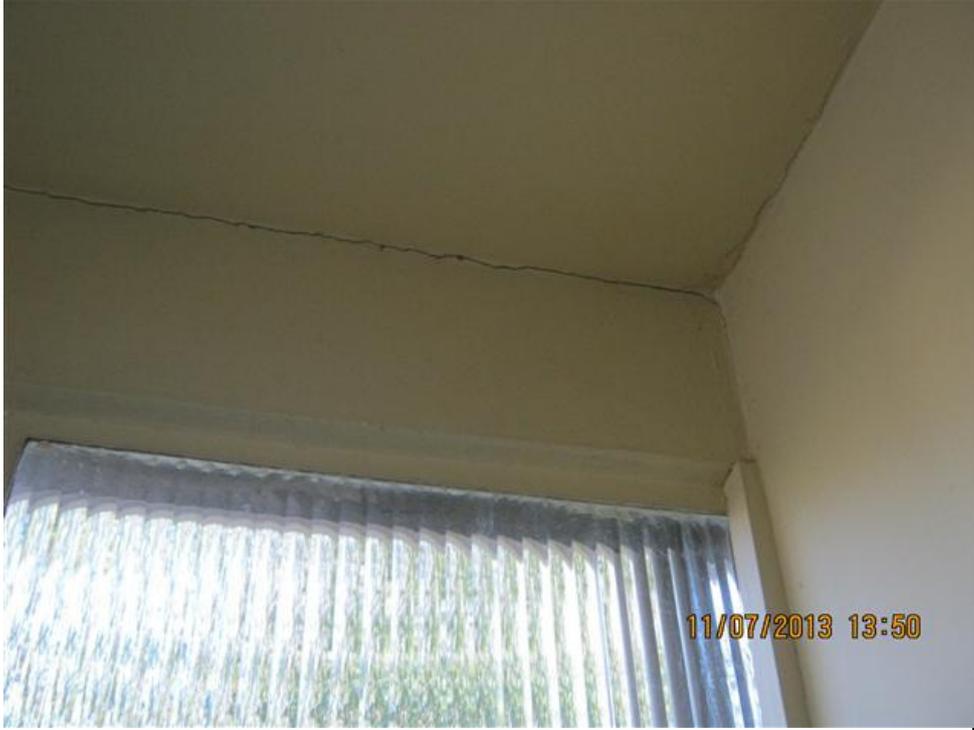
| No. | Description | Photo |
|---|---|--|
| 7. | Crack around ceiling wall interface | |

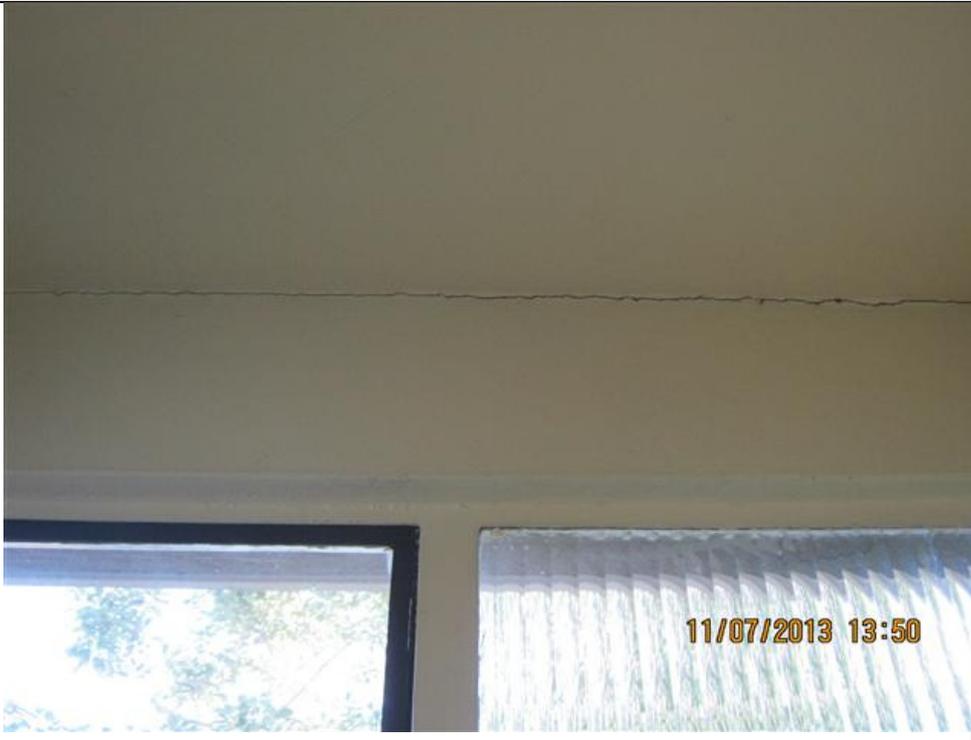
| No. | Description | Photo |
|---|---|---|
| 8. | Crack around ceiling wall interface | A photograph showing a horizontal crack in the ceiling, approximately 1-2 cm wide, extending across the width of the room. The crack is located just above a window frame. The ceiling is a light beige color. A timestamp "11/07/2013 13:50" is visible in the bottom right corner of the photo. |

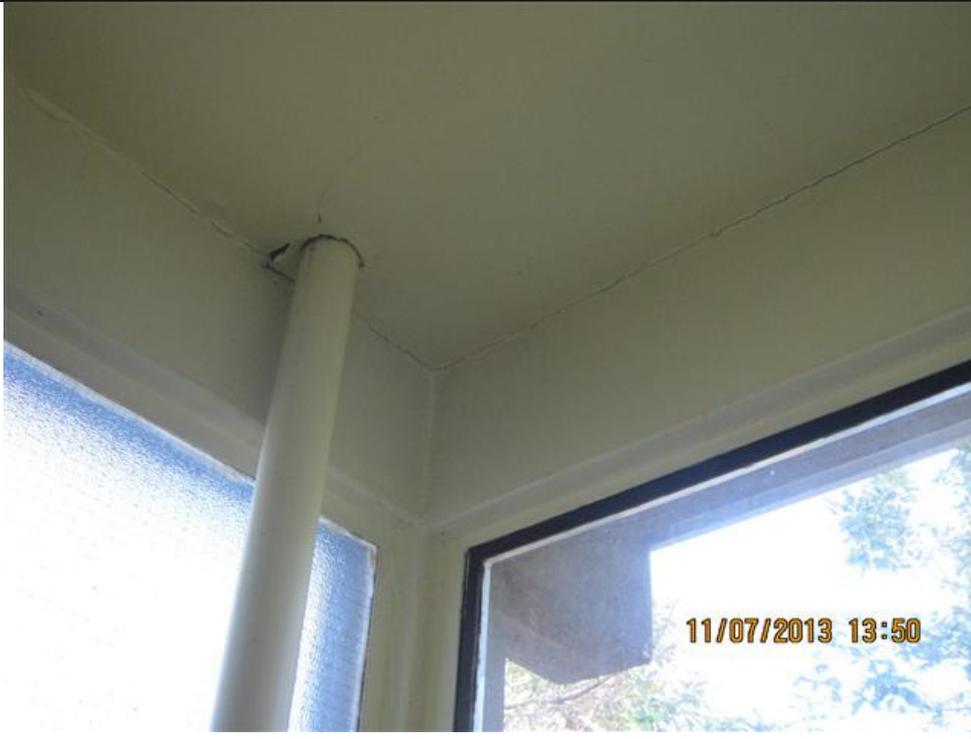
| No. | Description | Photo |
|---|---|---|
| 9. | Crack in ceiling wall interface | A photograph showing a crack in the ceiling at the corner where a wall meets the ceiling. A white cylindrical pillar is visible in the foreground. The crack follows the edge of the ceiling. A timestamp "11/07/2013 13:50" is visible in the bottom right corner of the photo. |

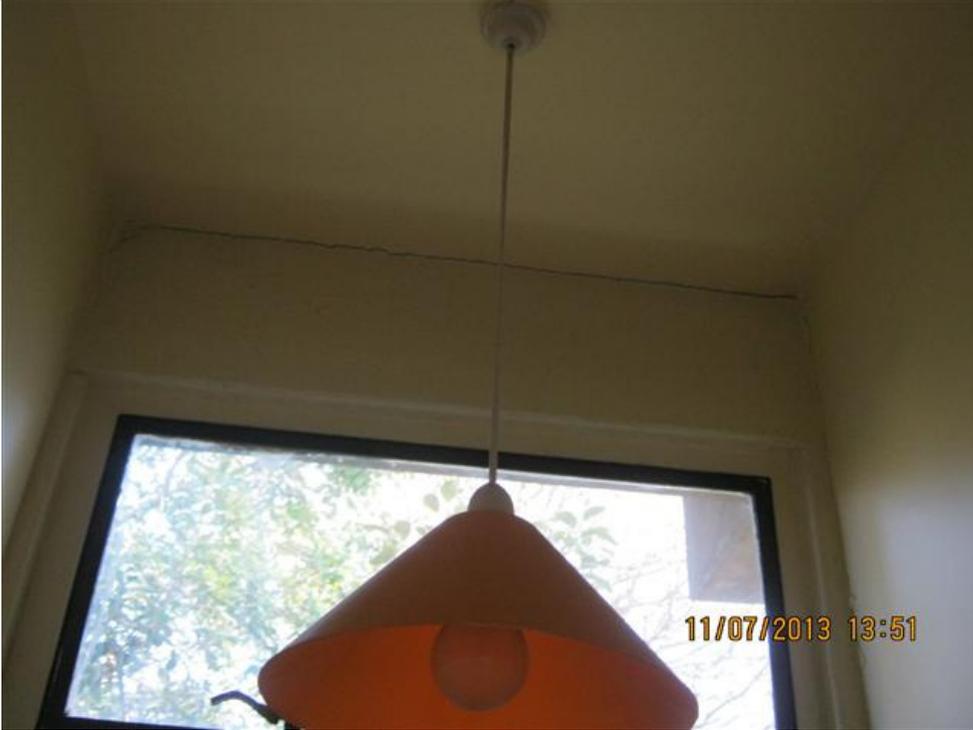
| No. | Description | Photo |
|---|---|--|
| 10. | Crack in ceiling wall interface | |

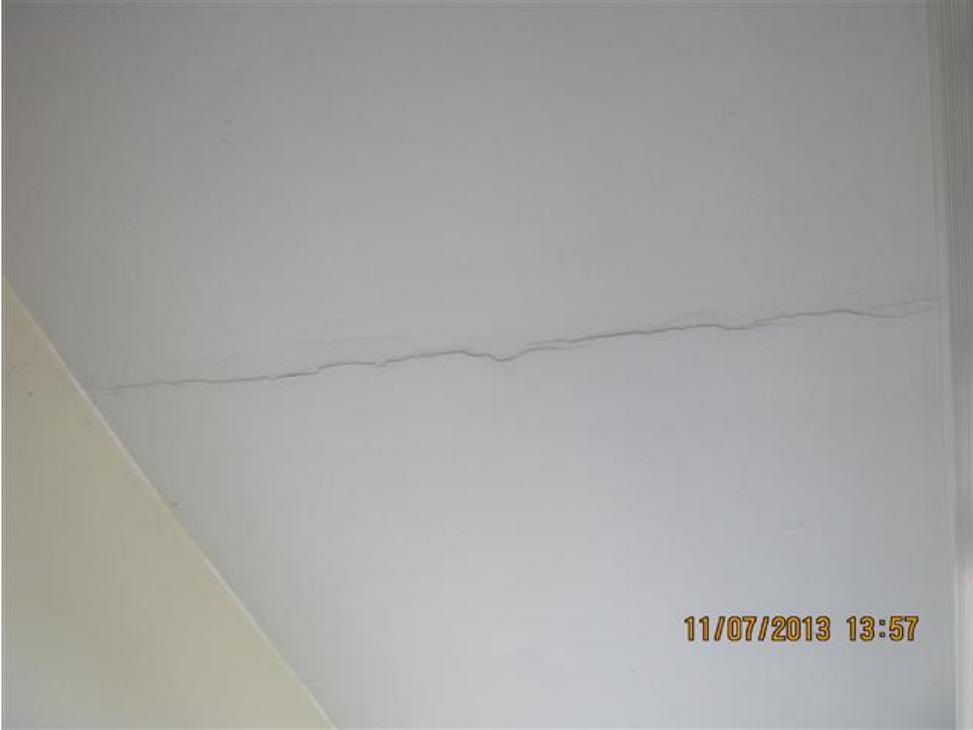
| No. | Description | Photo |
|---|---|--|
| 11. | Crack in ceiling | |

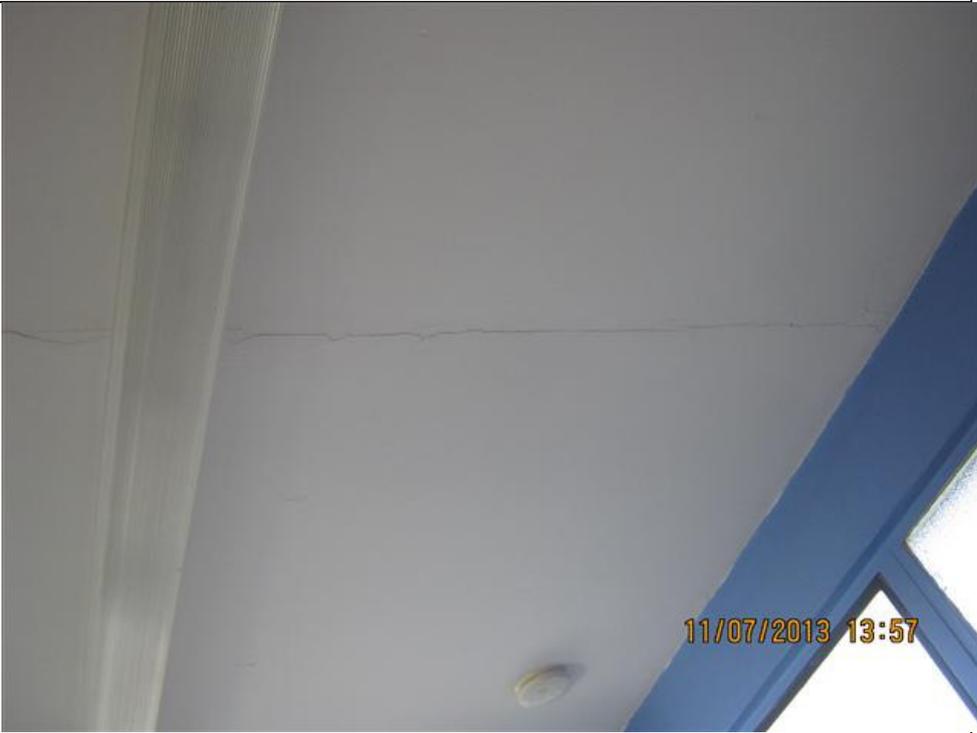
| No. | Description | Photo |
|---|---|--|
| 12. | Crack in ceiling | |

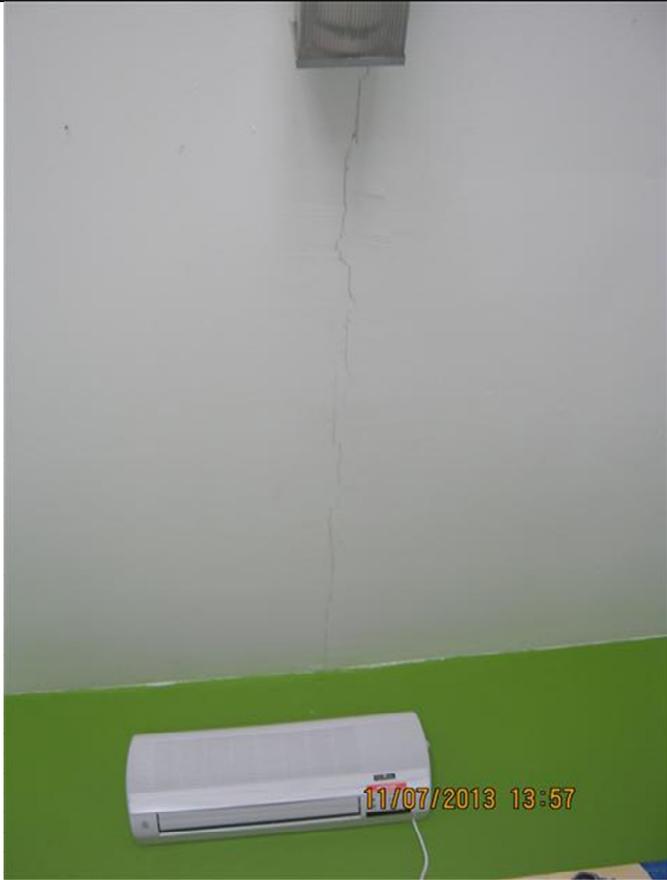
| No. | Description | Photo |
|---|---|--|
| 13. | Crack in ceiling | |

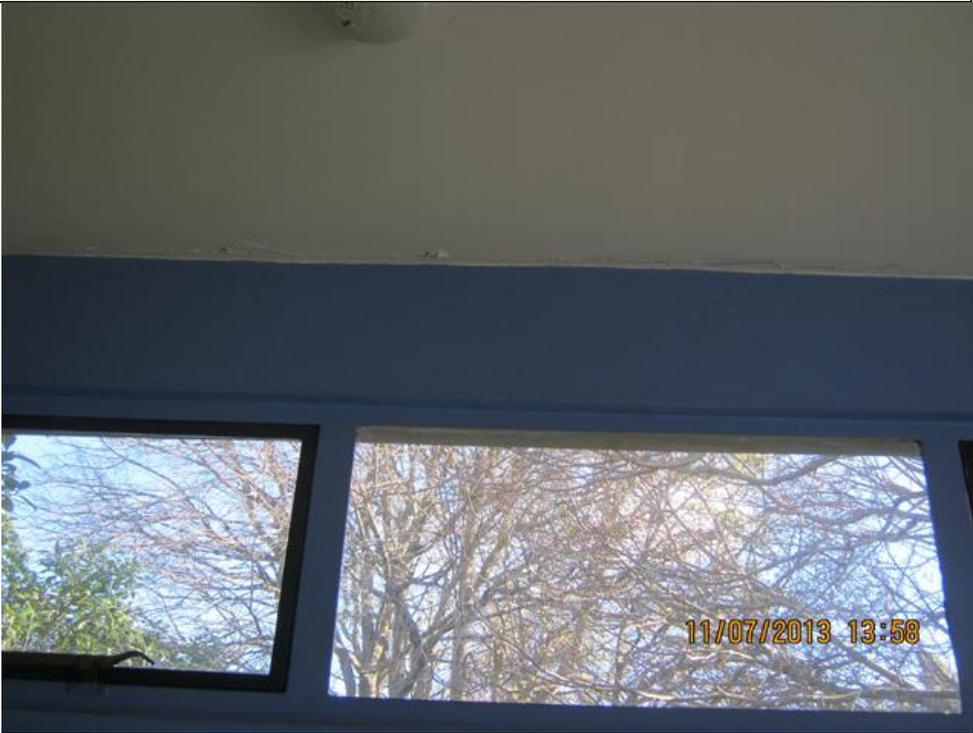
| No. | Description | Photo |
|---|---|--|
| 14. | Crack along ceiling wall interface | A photograph showing a crack along the ceiling wall interface. The crack is visible on the white ceiling, extending horizontally. Below the ceiling is a dark blue wall with a window. The window shows a view of trees and a blue sky. A timestamp "11/07/2013 13:58" is visible in the bottom right corner of the photo. |

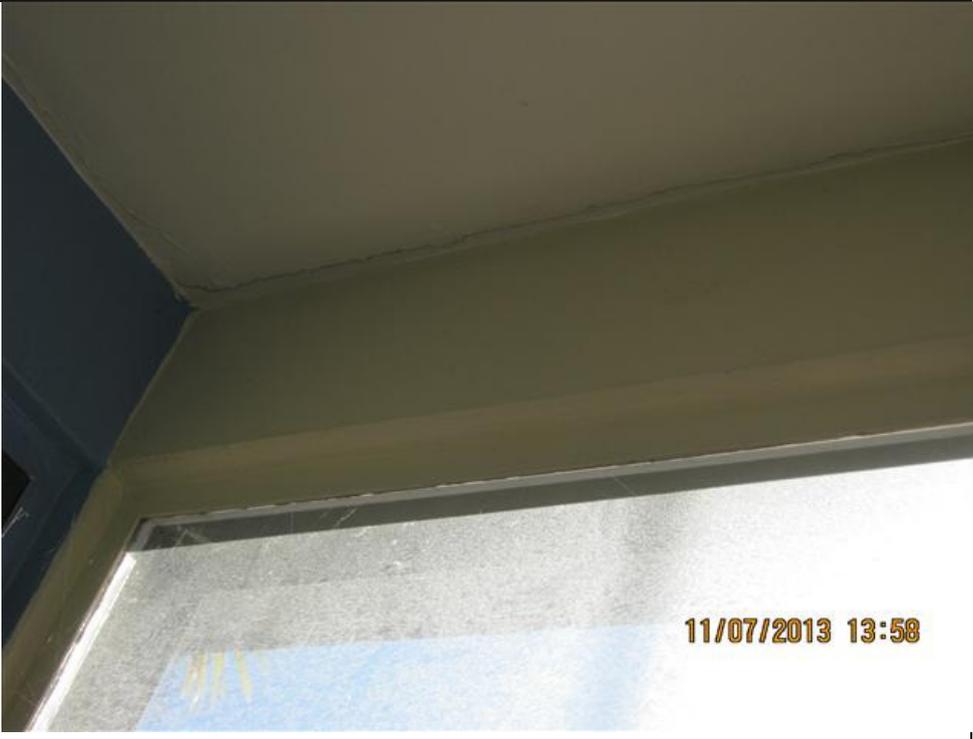
| No. | Description | Photo |
|---|---|--|
| 15. | Crack in corner of ceiling and wall | A photograph showing a crack in the corner of the ceiling and wall. The crack is visible in the corner where the white ceiling meets the dark blue wall. Below the ceiling is a window with a view of trees and a blue sky. A timestamp "11/07/2013 13:58" is visible in the bottom right corner of the photo. |

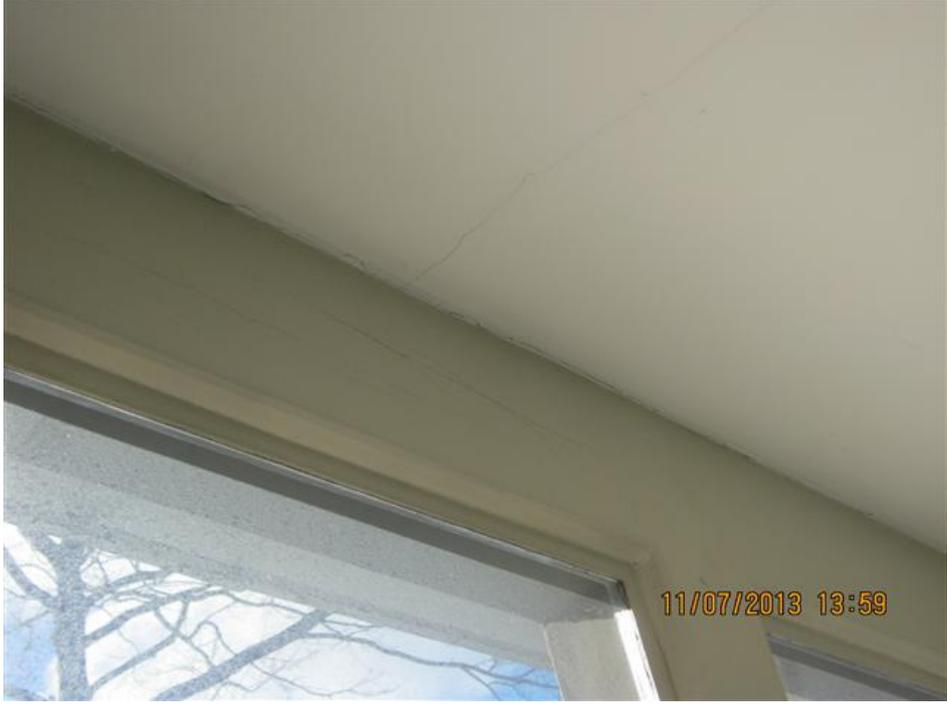
| No. | Description | Photo |
|---|---|--|
| 16. | Crack in ceiling | |

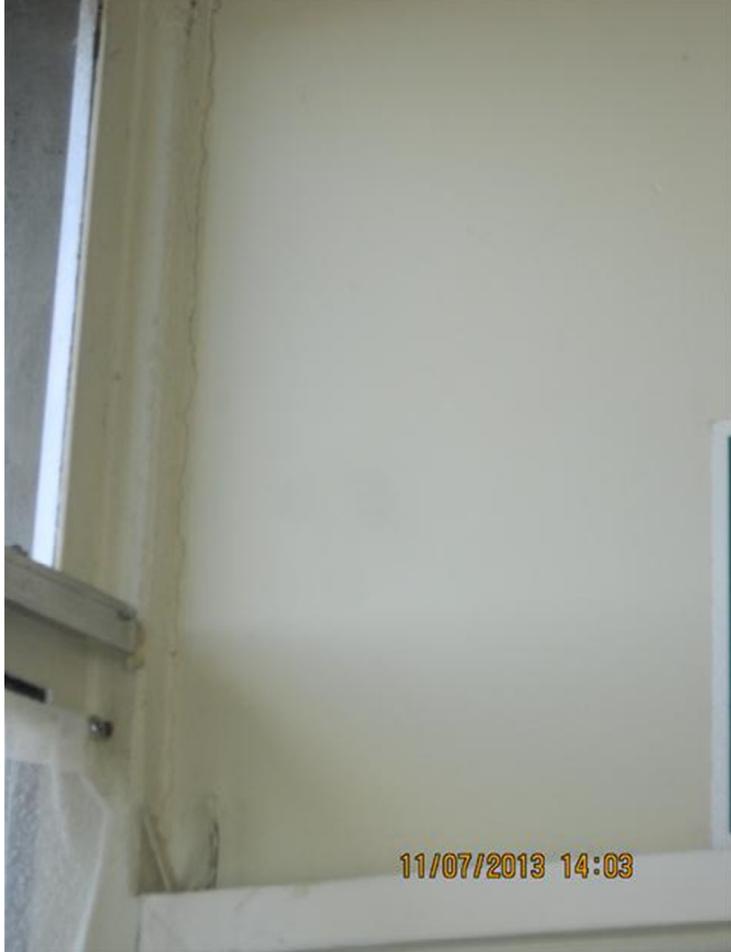
| No. | Description | Photo |
|---|---|--|
| 17. | Crack in corner of wall frame | |

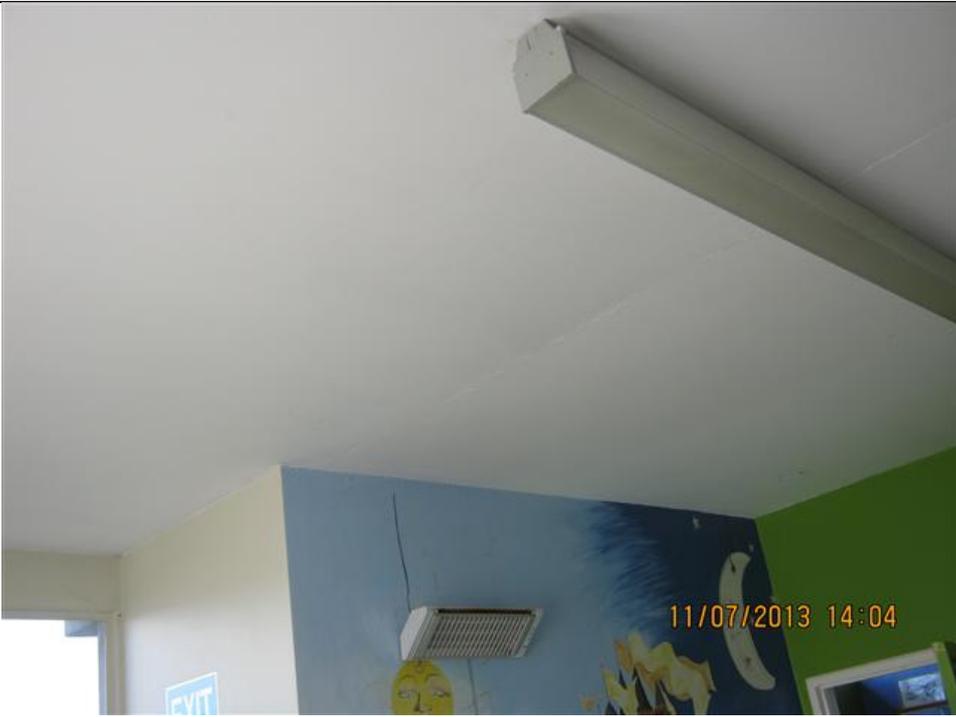
| No. | Description | Photo |
|---|--|--|
| 18. | Crack in ceiling lining | |

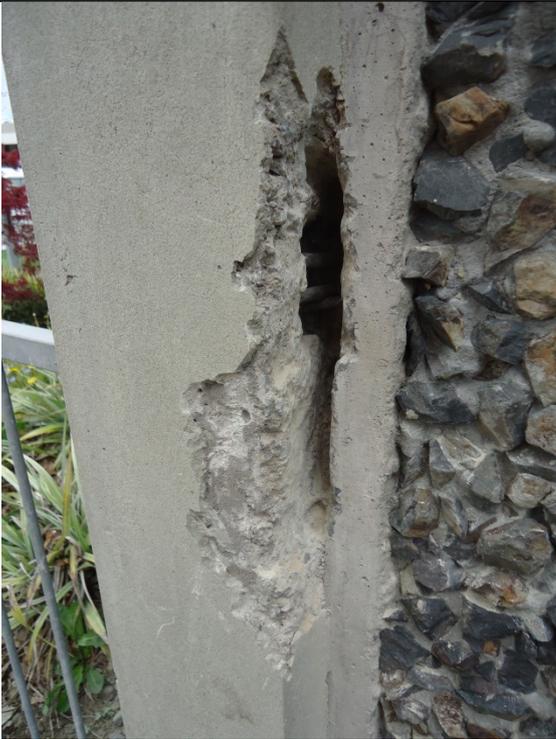
The intrusive investigation also revealed that there is no reinforcement in the concrete block wall, no adequate connection to the foundation and no connection to the concrete columns (see Figures in Appendix 1). Minimal reinforcement between the precast concrete panels and concrete columns was discovered and cannot be relied upon to resist the out-of-plane inertia of the panels or transfer adequate shear to provide in-plane lateral support for the concrete columns (see Figures in Appendix 1).

| No. | Description | Photo |
|---|--|--|
| 19. | Joint between concrete column and precast concrete panel after intrusive investigation | |

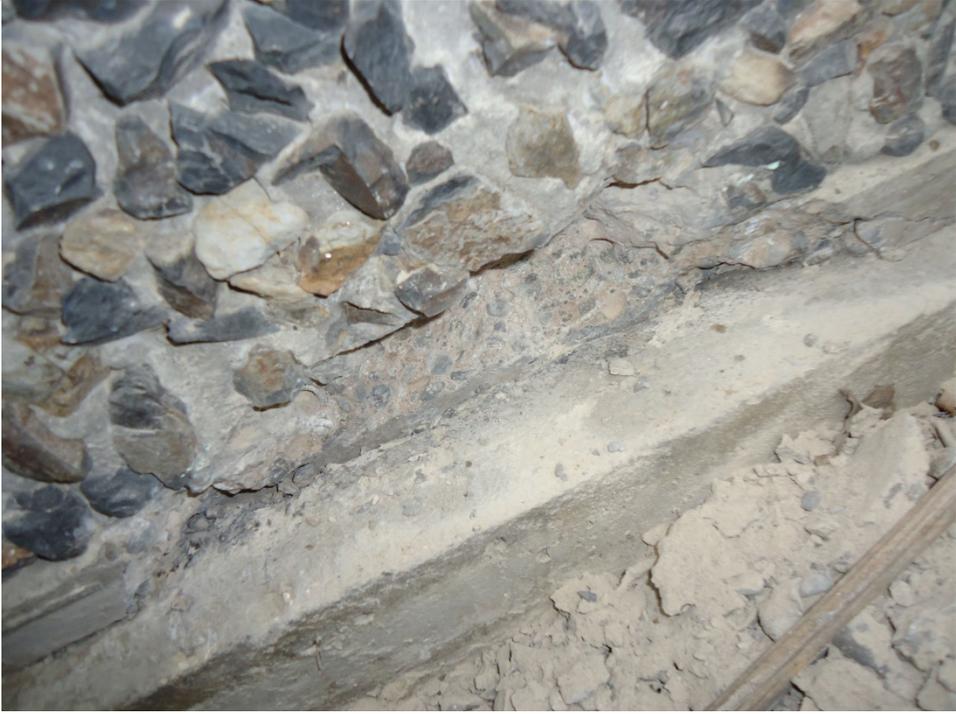
| No. | Description | Photo |
|---|---|--|
| 20. | Joint between concrete footing and precast concrete panel after intrusive investigation | |

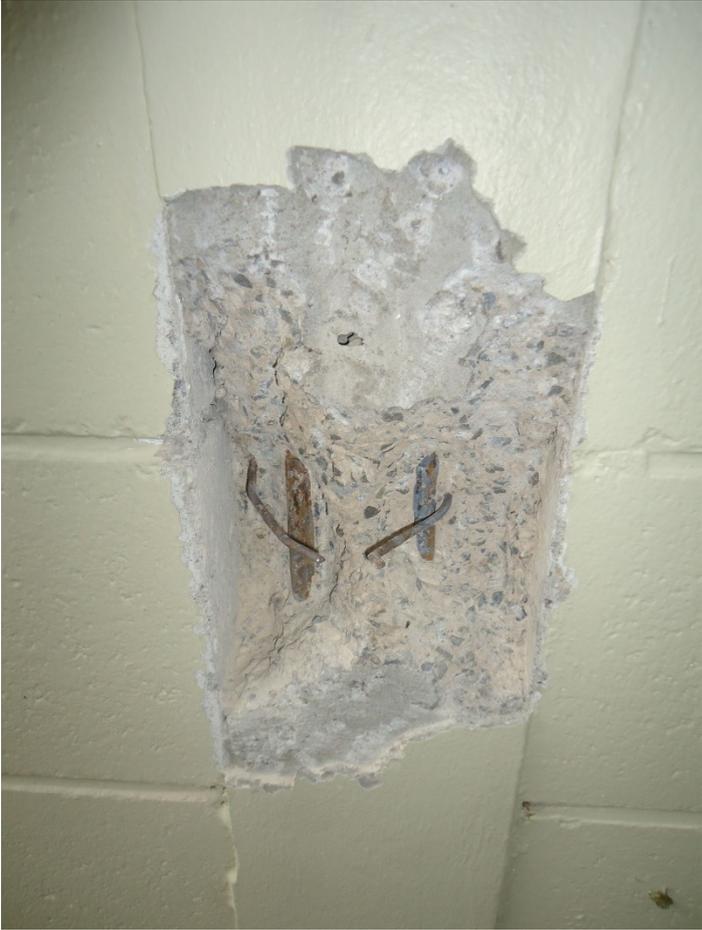
| No. | Description | Photo |
|---|---|--|
| 21. | Concrete column after intrusive investigation | |

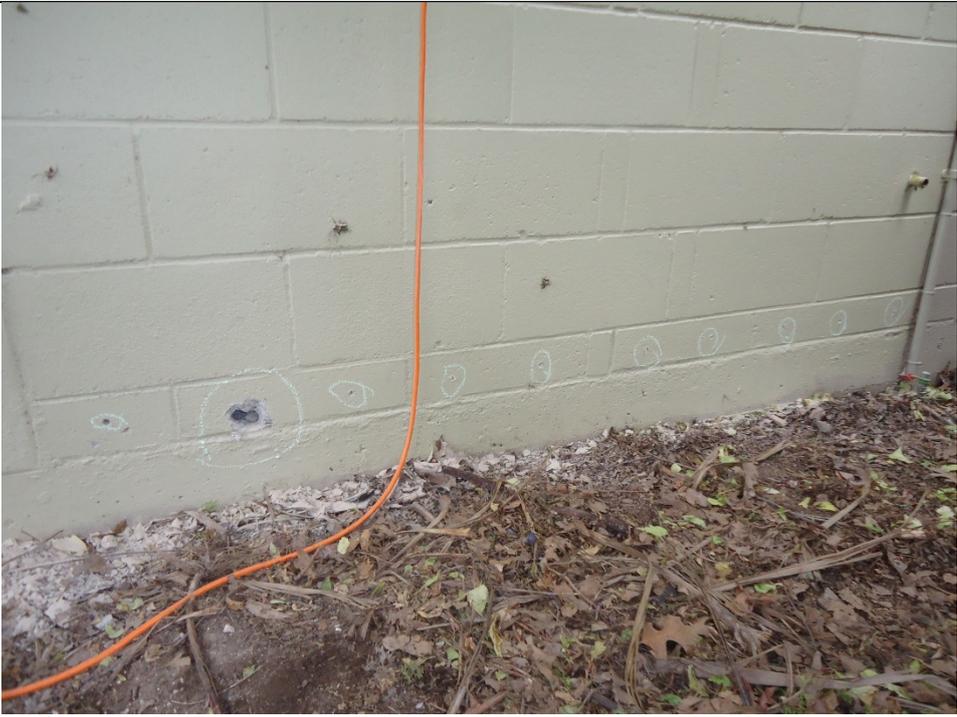
The building’s estimated seismic capacity is 20%NBS as limited by the out-of-plane capacity of the 90 series block infill wall. An intrusive investigation undertaken on 14 October 2013, found that the 90 series concrete blockwork on the western face is ungrouted, and there is inadequate fixing between the blockwork and the building’s columns (see Figures in Appendix 1). The intrusive investigations also found that there is inadequate connection of the reinforced concrete wall panels to the columns for the wall panels to be considered as effective elements of the seismic load path or as adequate out-of-plane restraint for the wall panels (see Figures in Appendix 1).

| No. | Description | Photo |
|---|--|--|
| 22. | Intrusive investigation of concrete block wall | A photograph showing an exterior concrete block wall. A hole is visible in the wall, circled in white chalk. Several other white chalk circles are drawn along the base of the wall. An orange cable runs vertically down the wall and curves across the ground in the foreground. The ground is covered with dry leaves and debris. |

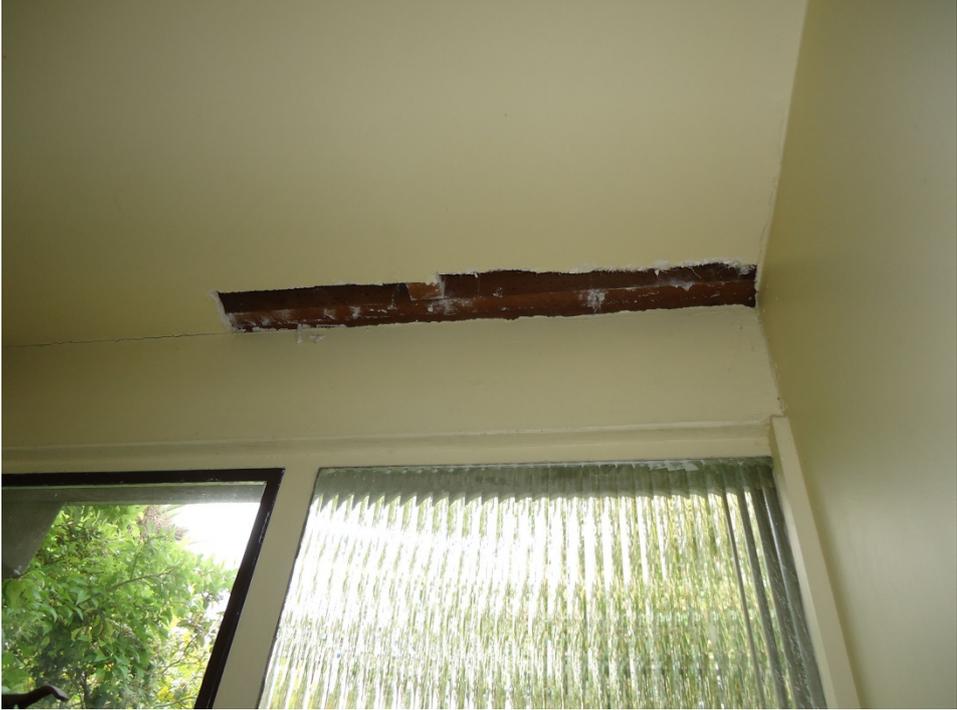
Seismic load distribution has been based on considering the ceiling acting as an adequate horizontal diaphragm being able to transfer the seismic induced actions to the side walls. However, we observed significant cracking around the perimeter of the ceiling diaphragm and the intrusive investigation revealed minimal connections between the diaphragm and concrete perimeter beams. Therefore, these connections should be addressed during the strengthening investigation.

| No. | Description | Photo |
|---|--|--|
| 23. | Intrusive investigation of ceiling diaphragm | A photograph showing the interior of a room. A section of the ceiling has been removed, revealing a dark, jagged opening in the ceiling diaphragm. Below the opening is a window with light-colored curtains. The walls are a light beige color. |

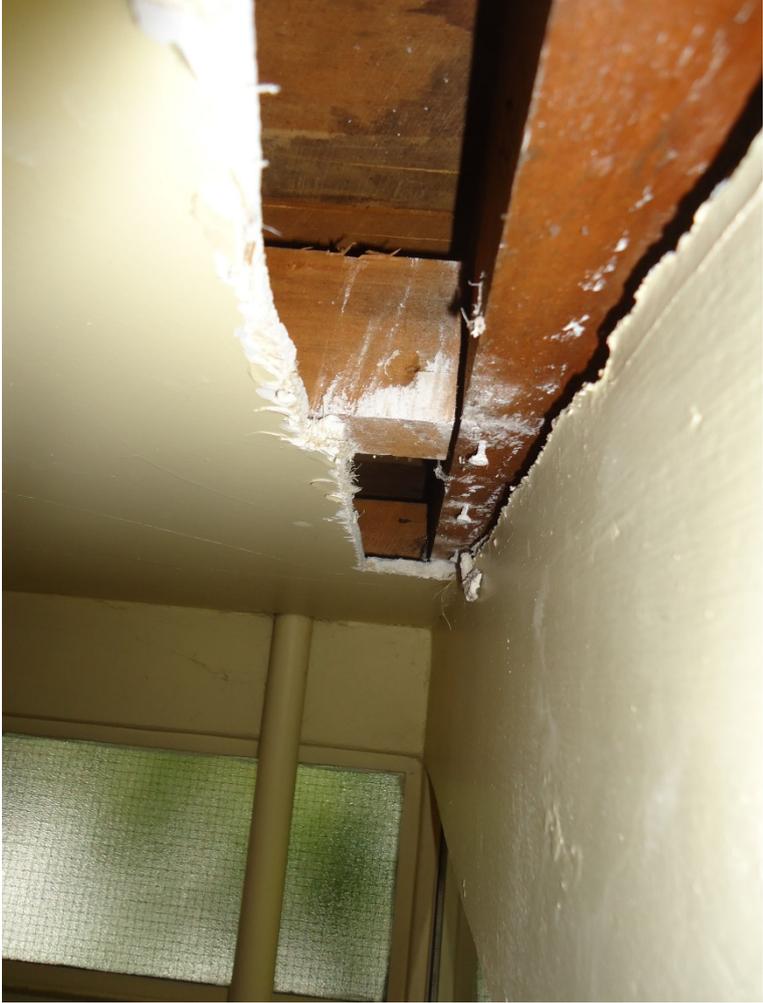
| No. | Description | Photo |
|---|--|---|
| 24. | Intrusive investigation of ceiling diaphragm | |
