Project: Richmond Community Centre

Qualitative Engineering Evaluation

Prepared for: Christchurch City Council

Date: 28 June 2013

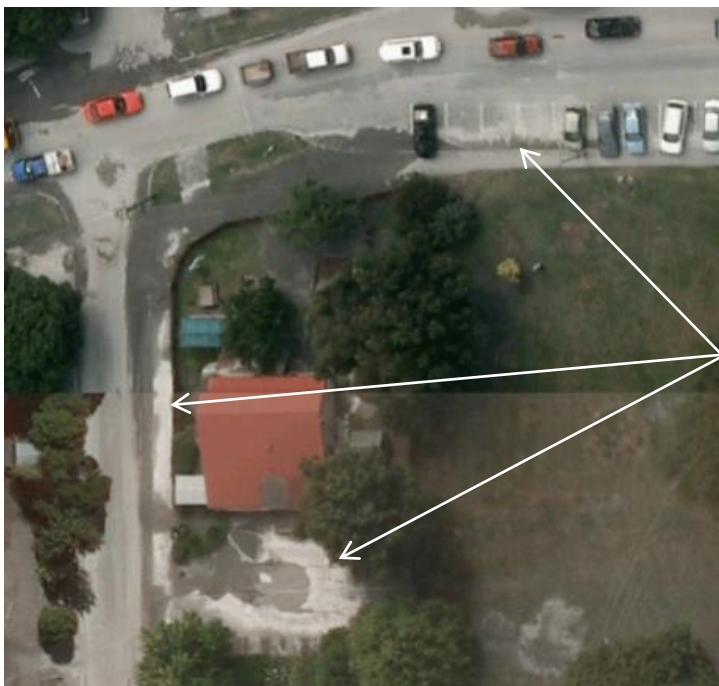
Evidence of significant local liquefaction

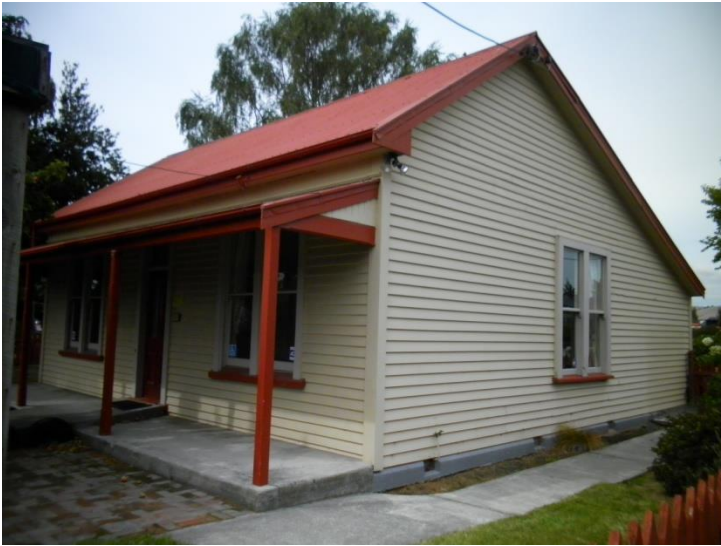
Building north elevation

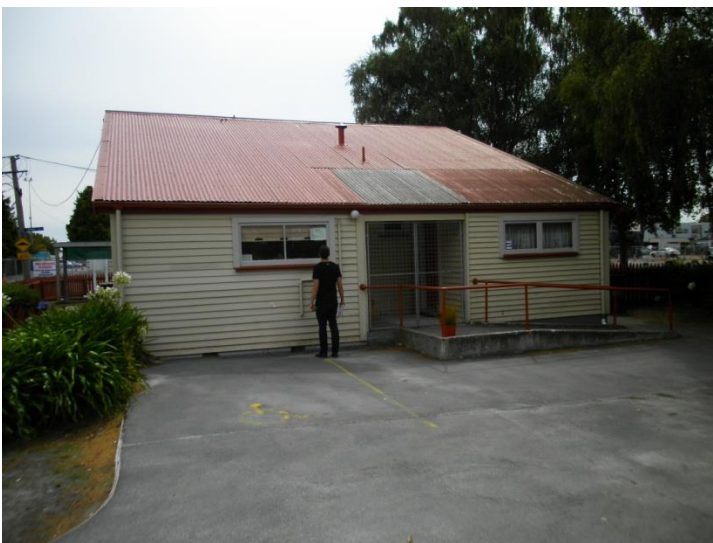
Building south elevation

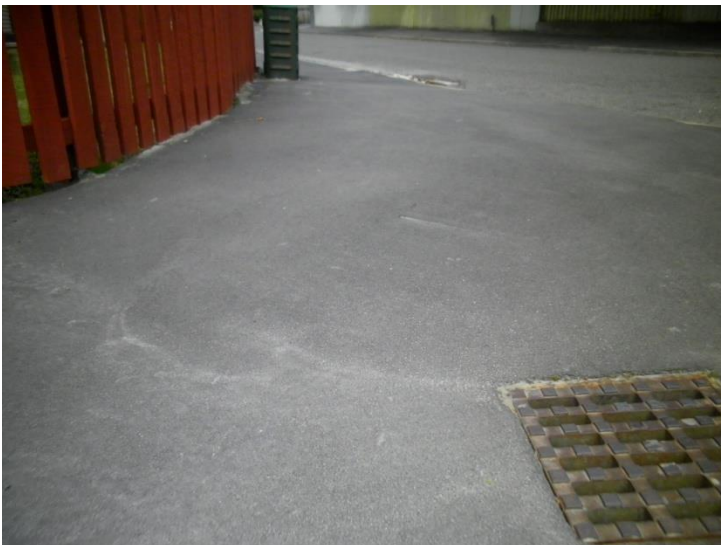
Sizable liquefaction boil below asphalt

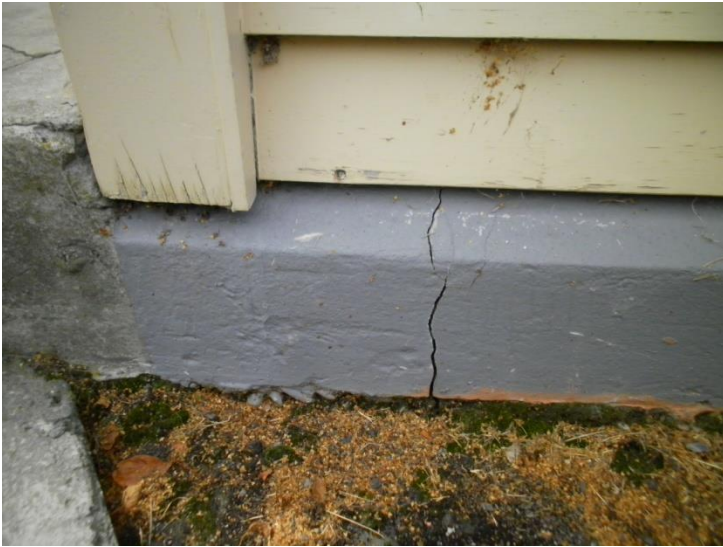
Perimeter foundation damage is likely due to a combination of differential settlement due to liquefaction and shear and flexural seismic loads transferred into it from walls and the floor. Although the Richmond Community Centre has suffered damage, at present it is considered that the damage has not reduced residual seismic capacity sufficiently to warrant building closure.

Crack in concrete perimeter foundation

It is recommended that the building be re-levelled with new piles and an enhanced perimeter footing installed, where required, in accordance with section 4.2 of DBH “Revised guidance on repairing and rebuilding houses affected by the Canterbury earthquake sequence” (November 2011). **It is recommended that a geotechnical investigation is carried out** to confirm the suitability of this repair approach.

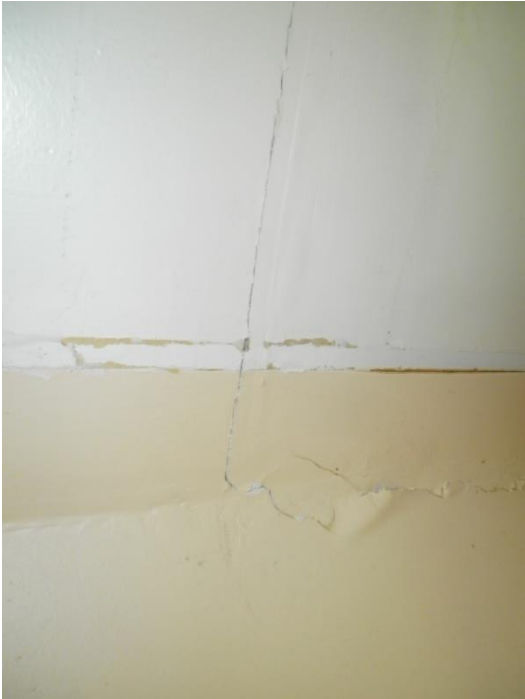
Lining damage at ceiling wall intersection

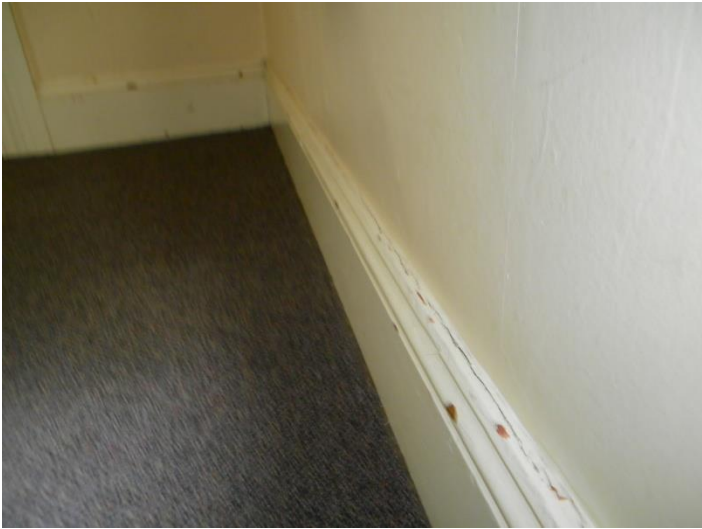
Lining damage at floor level

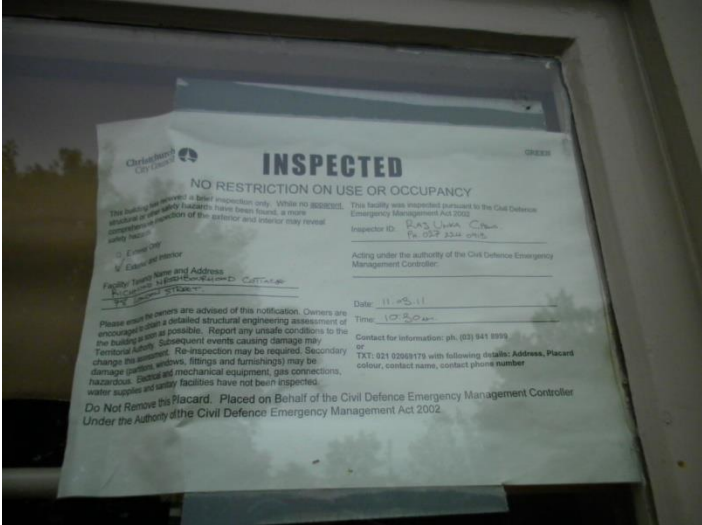
Green inspection sticker.
