CHRISTCHURCH CITY COUNCIL
PRK_0895_BLDG_007 EQ2
Ruru Lawn Cemetery – Toilets
Raymond Road, Bromley

QUALITATIVE ASSESSMENT REPORT

FINAL

- Rev B
- 02 May 2013

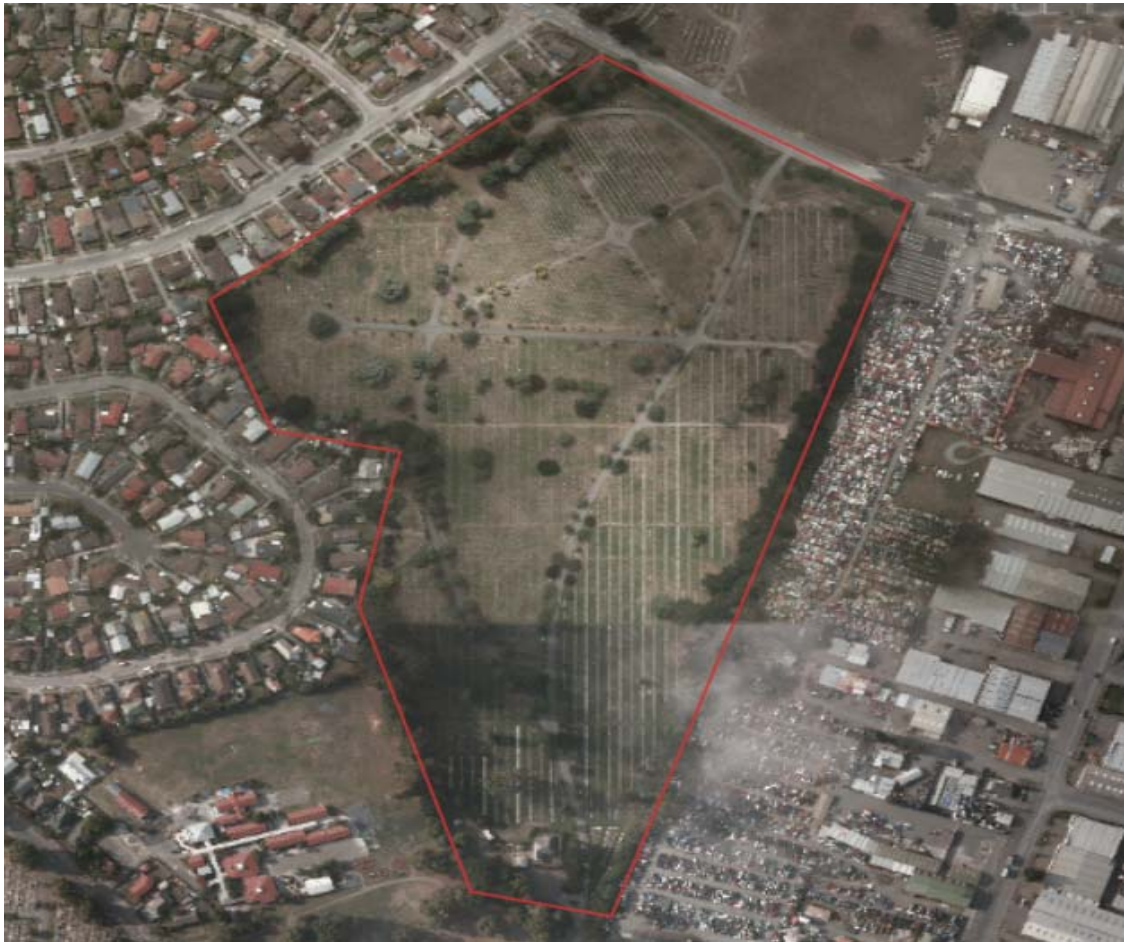
■ **Figure 6 – Aerial photography from 24 Feb 2011 (<http://viewers.geospatial.govt.nz/>)**

Significant amount of liquefied material can be seen on Ruru road, running down the northern section of the site, from the aerial photographs. Additionally, localised liquefaction and evidence of sand boils could be seen on adjacent properties.

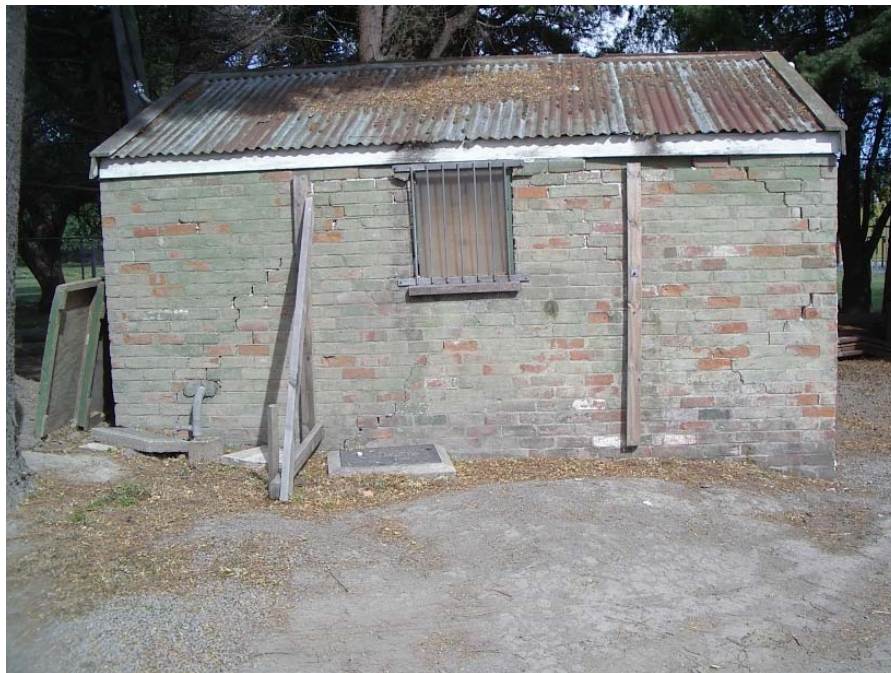
The toolshed was the only building on the site with any noticeable structural damage. The main damage observed was the cracking of the bricks.

■ **Figure 8 Visible damage to the tool shed**

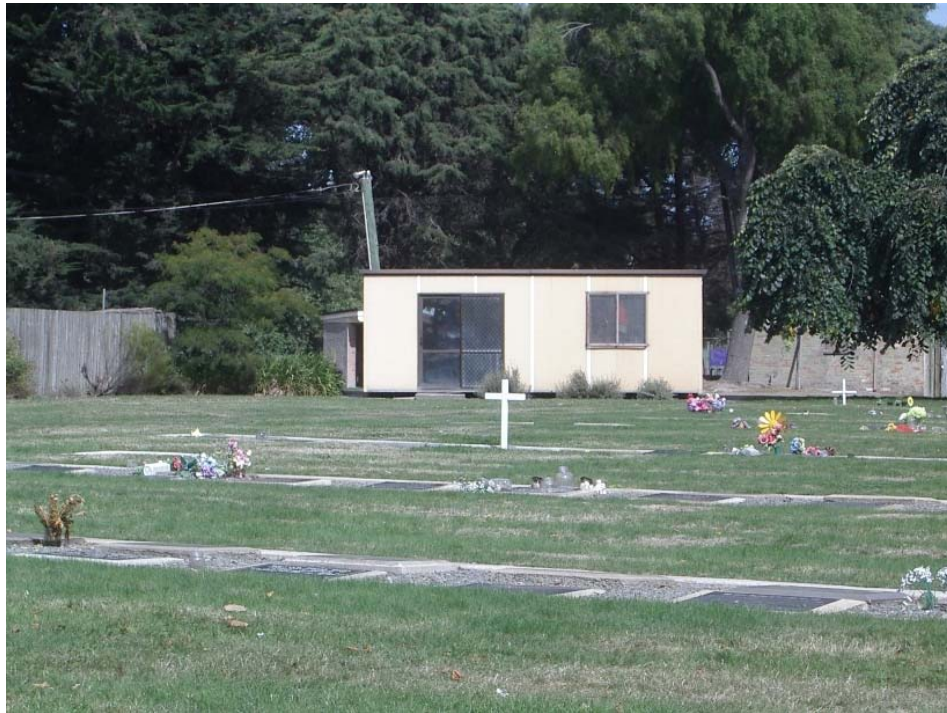
There was no significant sign of land damage or evidence that liquefaction had occurred on site. There were two toilets on site; one was a concrete block structure with the other being a brick structure. Both had metal roofing. The pump house was a timber structure with a felt roof, and the toolshed was constructed using bricks and a metal roof. The office was a portacom.

■ **Figure 9 No visible damage to land or the building**

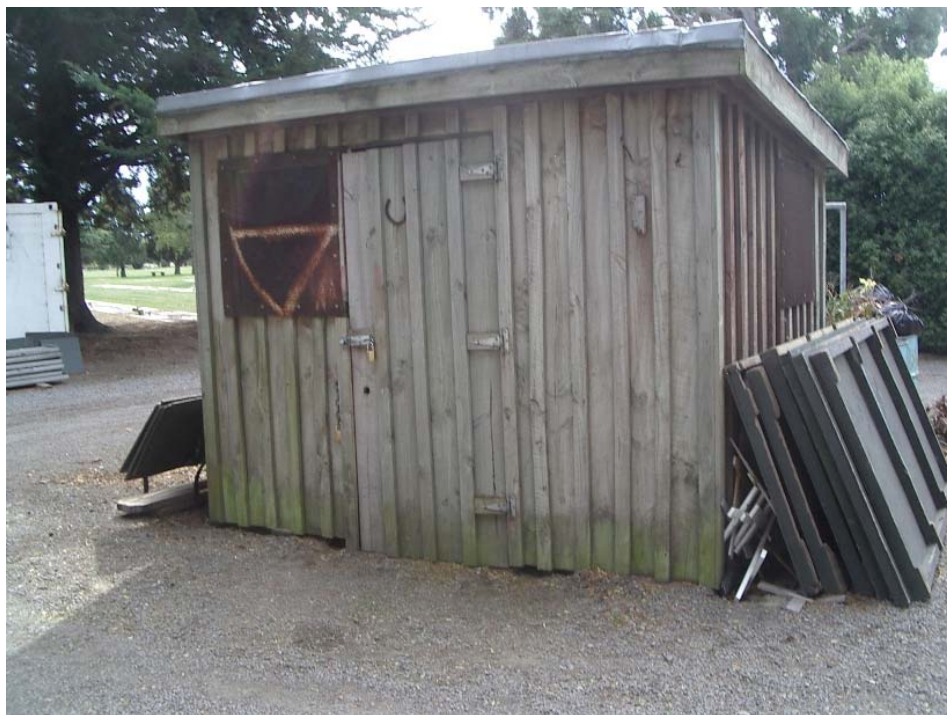
■ **Figure 10 No visible damage to the pump house**
