CHRISTCHURCH CITY COUNCIL
PRK_0895_BLDG_002 EQ2
Ruru Lawn Cemetery – Pump Shed
Raymond Road, Bromley

QUALITATIVE ASSESSMENT REPORT
FINAL

- Rev C
- 19 September 2012

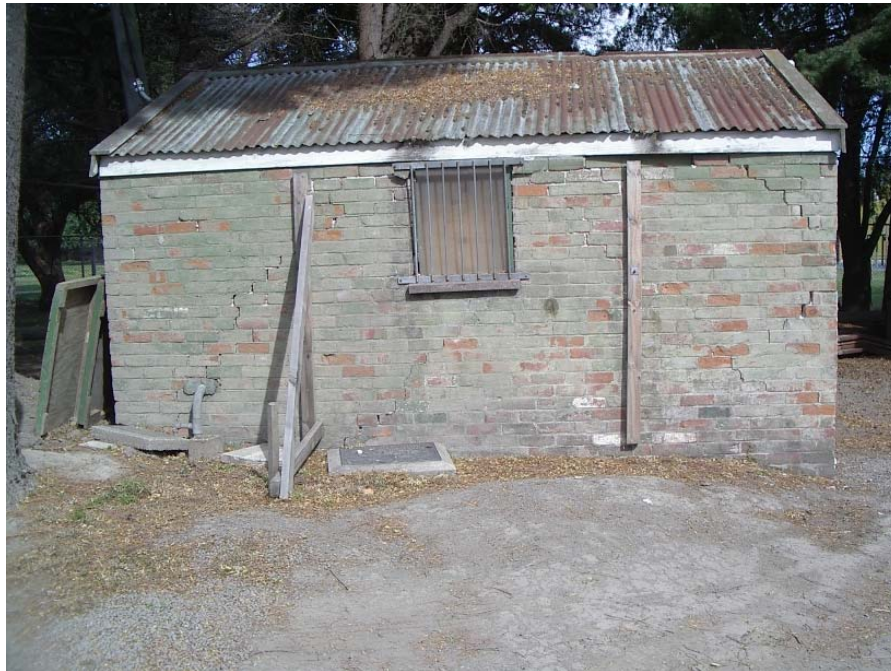
The toolshed was the only building on the site with any noticeable structural damage. The main damage observed was the cracking of the bricks.

■ **Figure 8 Visible damage to the tool shed**
