CHRISTCHURCH CITY COUNCIL
PRK_0895_BLDG_008 EQ2
Ruru Lawn Cemetery – Tool Shed & Lean-To
Raymond Road, Bromley

QUALITATIVE ASSESSMENT REPORT
FINAL

- Rev C
- 13 February 2013

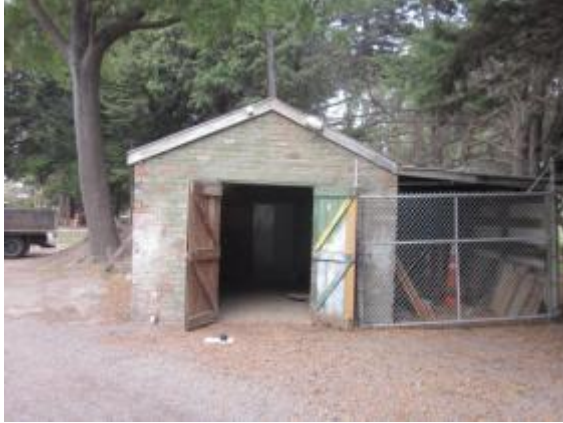
Photo 1: West Elevation of Building

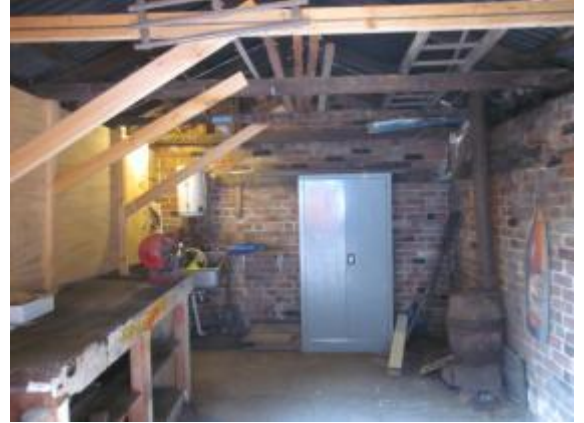
Photo 2: Internal View of Tool Shed - Temporary Proping Installed along North Face

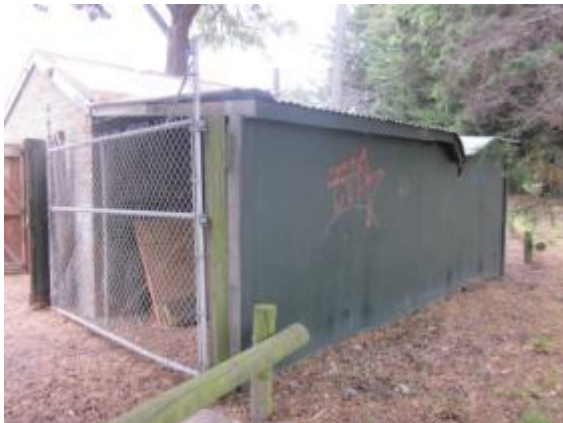
Photo 3: Lean-To Part of Building

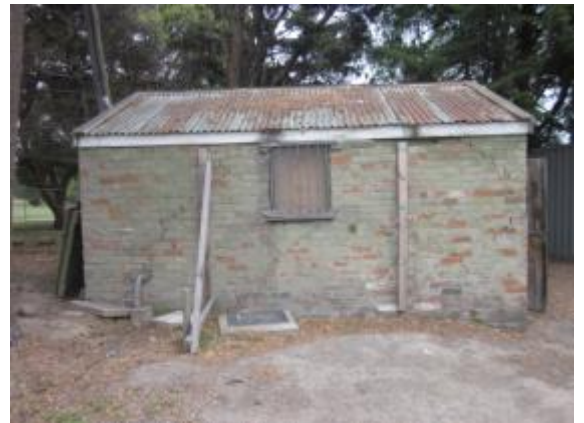
- Severe step cracking present along mortar joints. Bricks in NW corner have moved out of alignment. Temporary propping has been installed along the north wall to provide support to the damaged wall (PHOTO 4-8).

Photo 4: North Elevation of Building

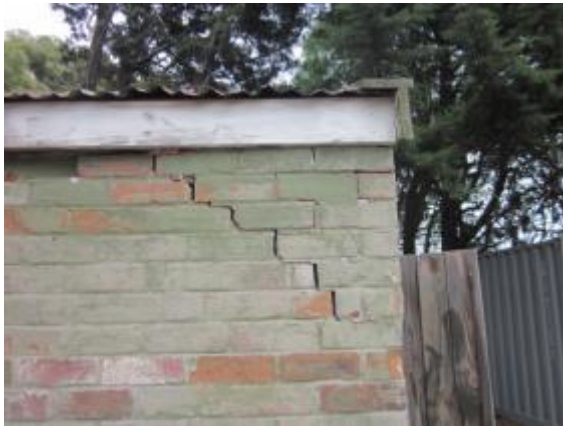
Photo 5: Major Cracking to Masonry in NW Corner

Due to the structural damage present and the size of the building it is not cost effective to carry out a quantitative assessment or strengthen the structure to current code requirements. We recommend that this structure is demolished and replaced with either a timber framed or reinforced concrete block building that meets current code requirements.

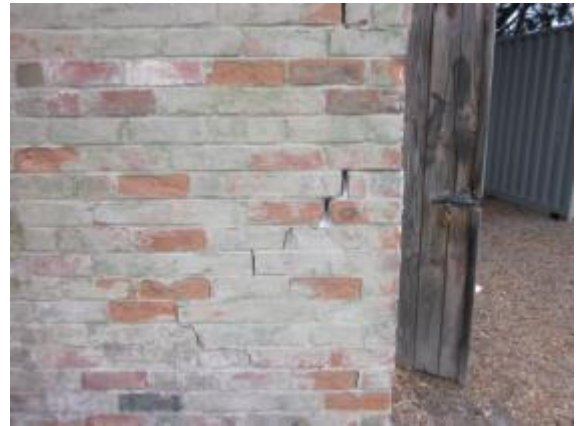
Photo 6: Major Cracking to Masonry in NW Corner

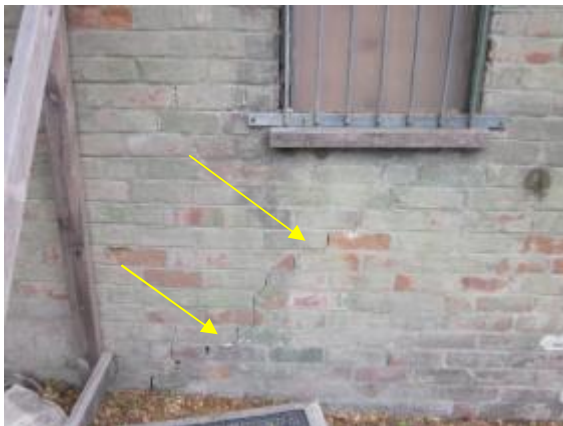
Photo 7: Step Cracking to Masonry on the North Face

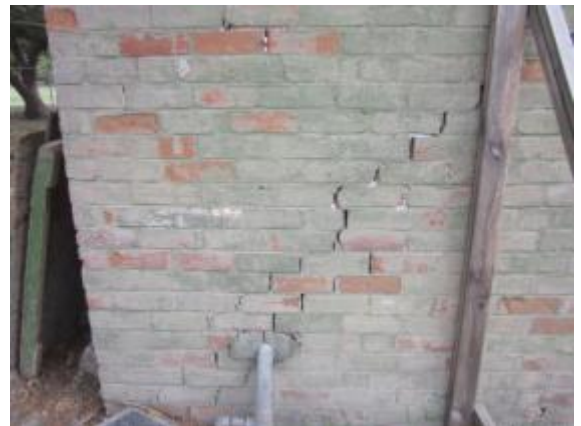
Photo 8: Major Cracking to Masonry in NE Corner

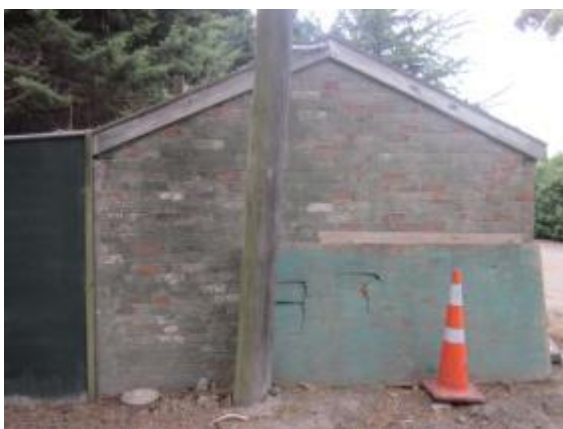
- Minor cracking to the mortar around the top brick in the south corner (PHOTO 9 & 10).

Photo 9: East Elevation

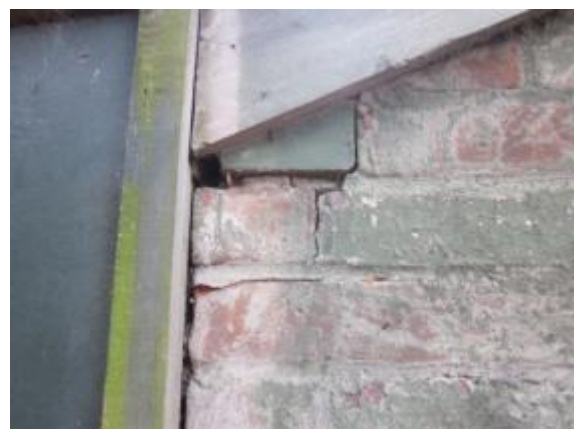
Photo 10: Minor Cracking around top Brick in the SE Corner

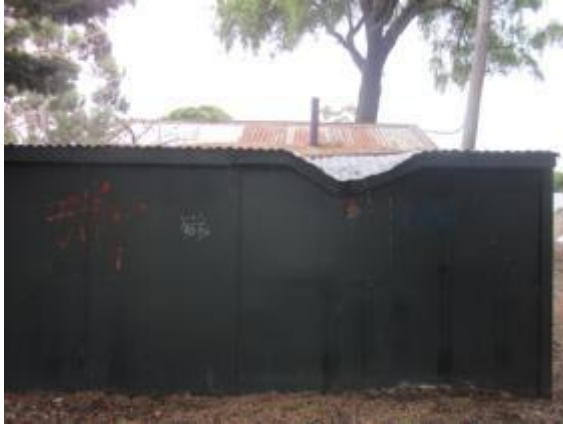
- Roof to the lean-to has been damaged mid-way along the south elevation. This damage appears to be existing and is not earthquake related (PHOTO 11).
- Step cracking present along masonry mortar joints.

Photo 11: Broken Lean-To Roof

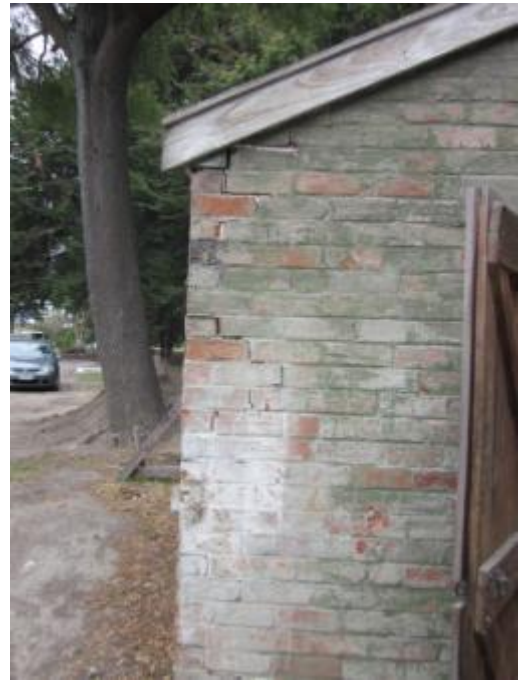
- Step cracking present along masonry mortar joints. Severe cracking present in the NW corner, bricks have moved out of alignment in this location (PHOTO 12 & 13).

Photo 12: Cracking to Masonry in NW Corner

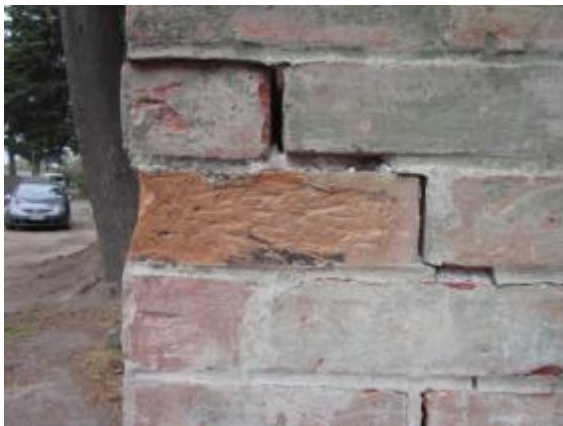
Photo 13: Close up of Photo 12
