CHRISTCHURCH CITY COUNCIL
PRK_1474_BLDG_001 EQ2
Scarborough Lifeboat Shed
2 Scarborough Beach

QUALITATIVE ASSESSMENT REPORT

- Rev B
- 25 January 2013

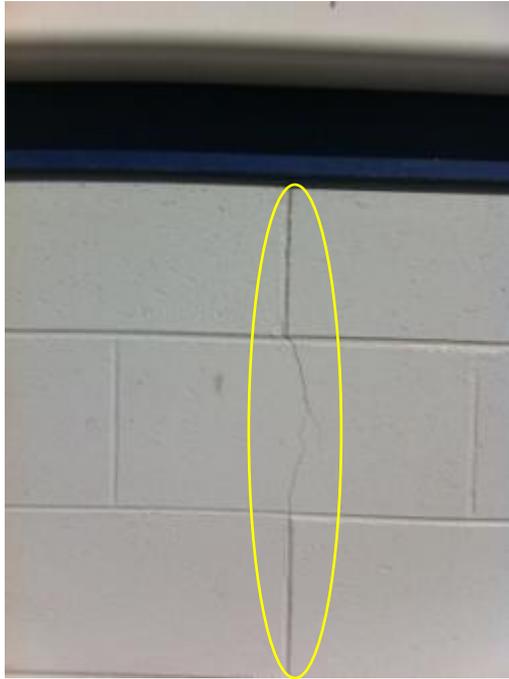
- 1) Vertical cracking present along the concrete block wall. These cracks span the full height of the wall and continue down through the concrete foundation. Cracks run through both the mortar joints and the face of the block. Cracking is reflected on both sides of the wall. Cracks range from 0.2mm - 1.0mm wide (PHOTO 5, 6, 7, 8, 9, 10 & 11).

Photo 5: Vertical Cracking to North Wall Blocks

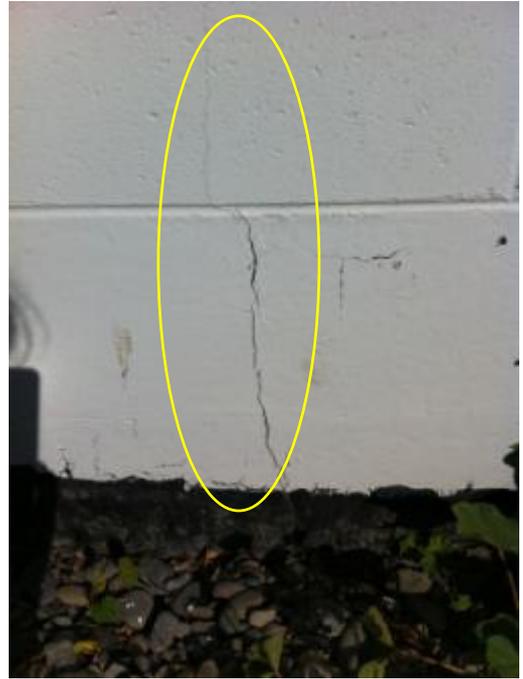
Photo 6: Cracking Continuing through Concrete Foundation

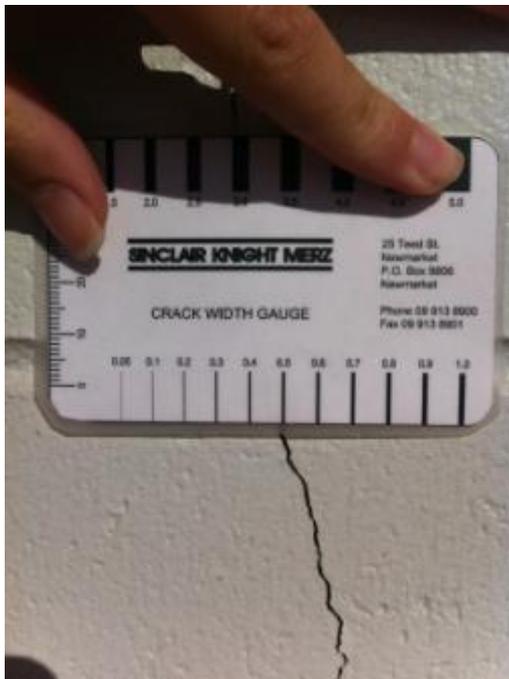
Photo 7: Close up of North Wall Crack

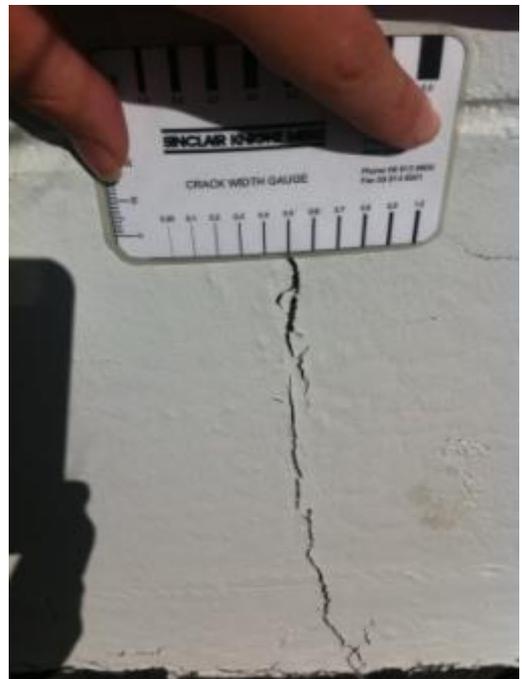
Photo 8: Close up of Foundation Crack

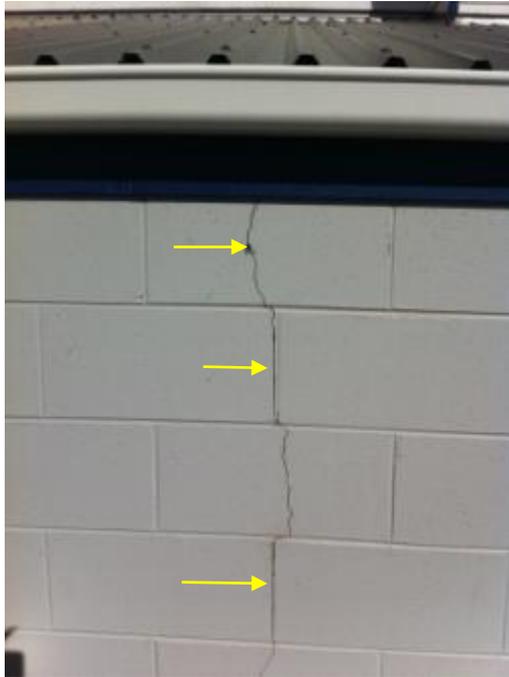
Photo 9: Further Cracking to North Wall Blocks

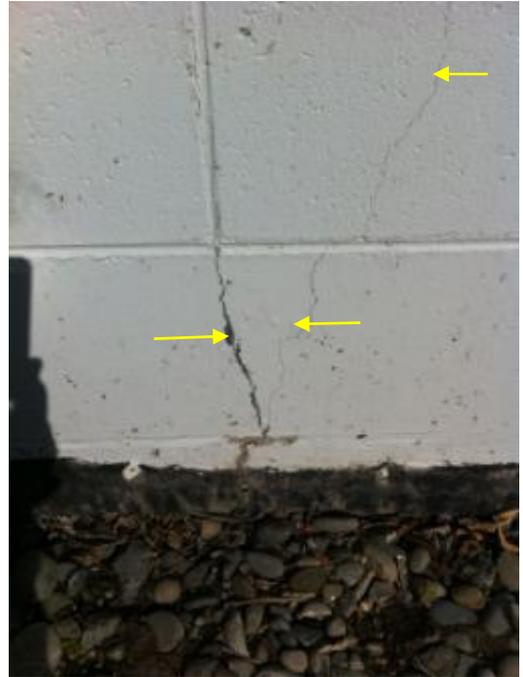
Photo 10: Cracking to Concrete Foundation

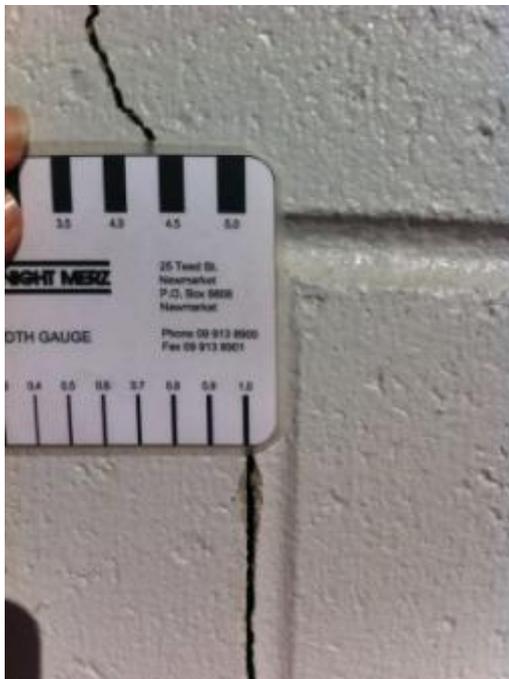
Photo 11: Close up of North Wall Cracking

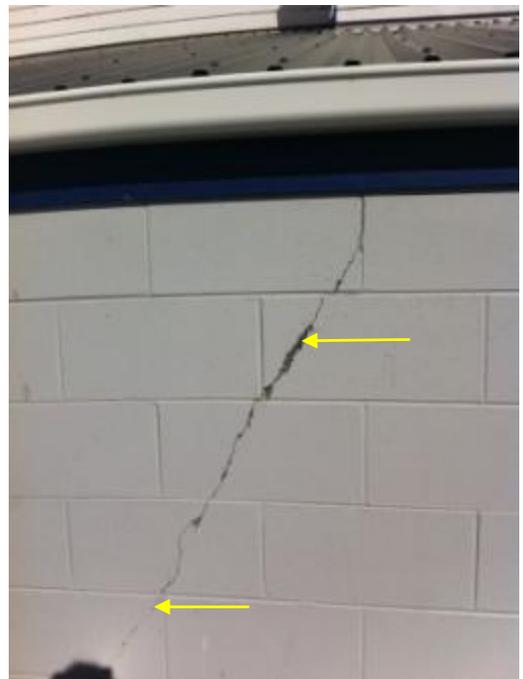
- 2) Diagonal crack present on the northern block - eastern end. Crack width varies from 0.3mm - 0.9mm wide. Minor spalling to the block face has occurred along the edges of this crack. Cracking spans the full height of wall and continues through the concrete foundation. Cracking reflected on both sides of the wall (PHOTO 12, 13, 14, 15 & 16).

Photo 12: Diagonal Cracking to North Wall Blocks

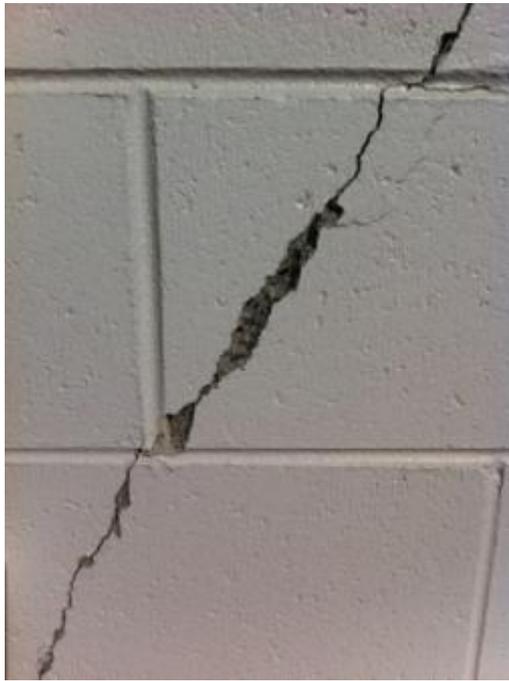
Photo 13: Close up Of Diagonal Cracking

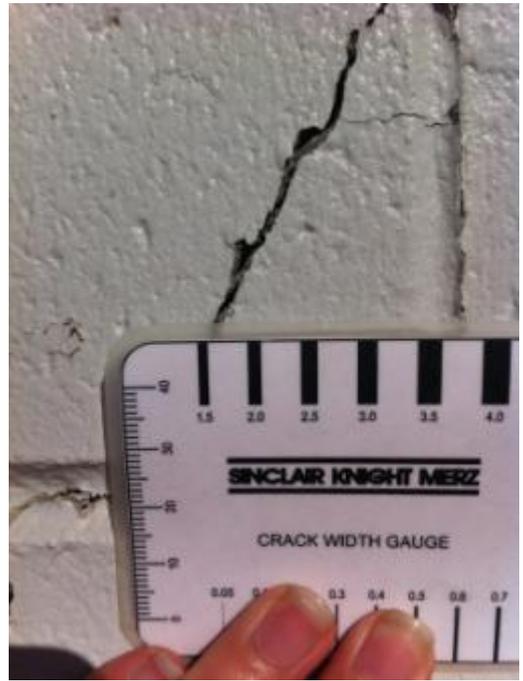
Photo 14: Close up Of Diagonal Cracking

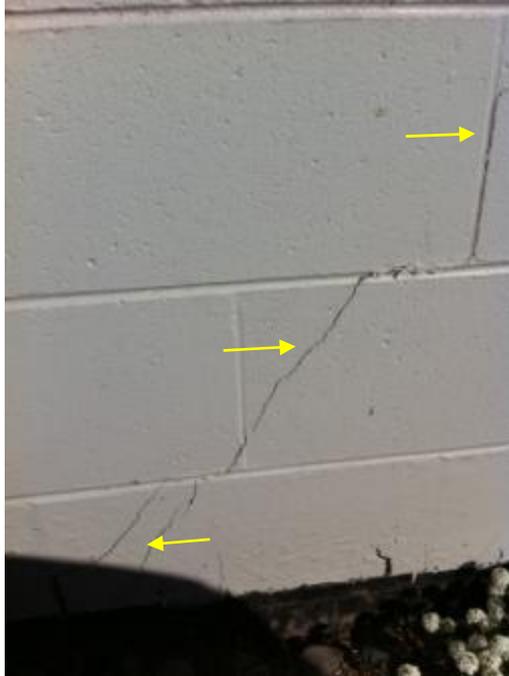
Photo 15: Lower Part of Diagonal Crack

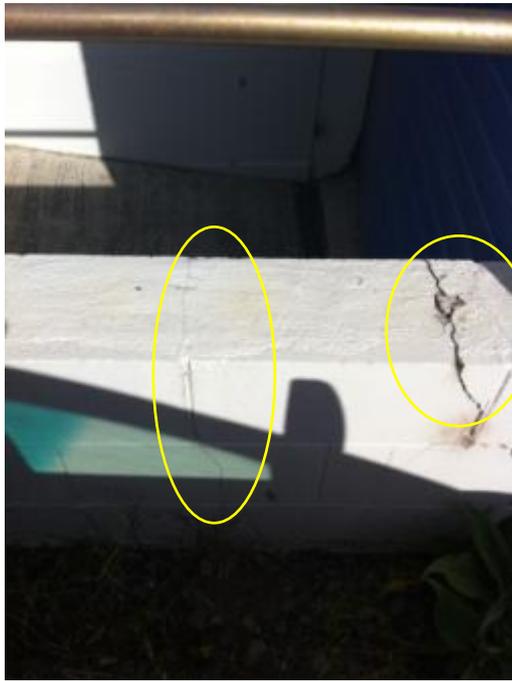
- 3) Various cracking present at the western end of the concrete block balustrade wall. Cracks range from 0.2mm – 1.0mm wide (PHOTO 17, 18 & 19). Cracking present along construction joint mortar where the concrete retaining wall and the northern block wall meet, crack width is approximately 5.0mm (PHOTO 20).

Photo 17: Cracking to Block Wall Balustrade

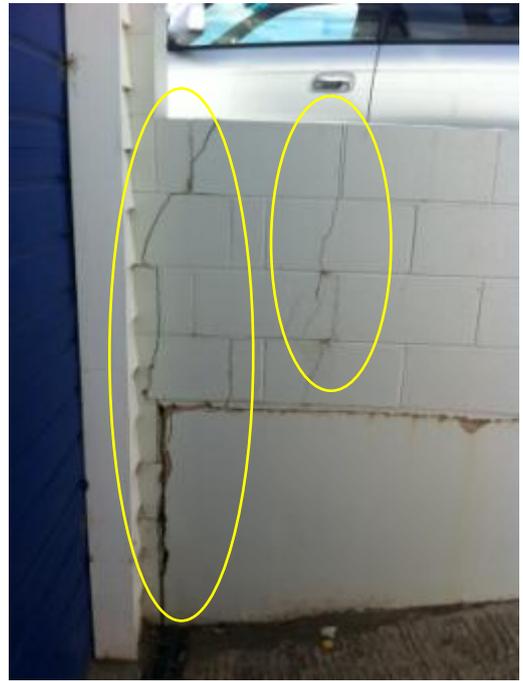
Photo 18: Cracking to Block Wall Balustrade

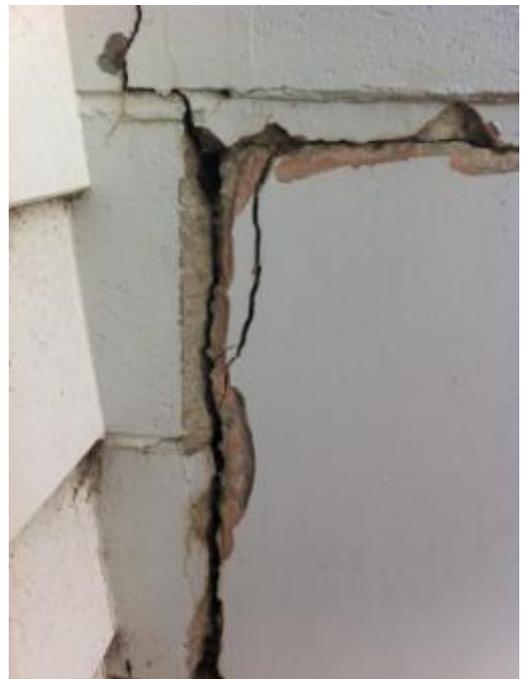
Photo 20: Cracking between Concrete Retaining Wall & Masonry Wall Joint

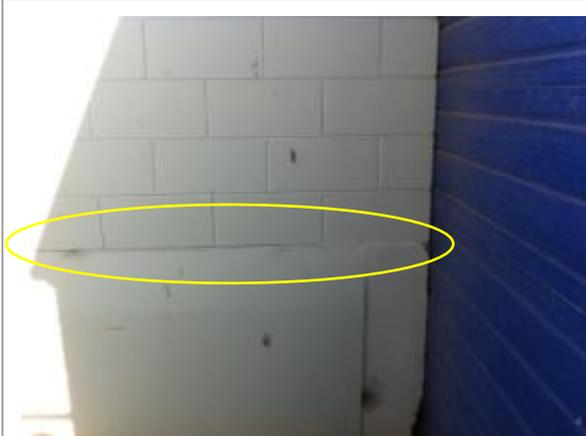
- 4) South side of Driveway: - Horizontal hairline cracking present along the concrete block and concrete foundation mortar joint, cracking continues around north-east corner (PHOTO 21 & 22).

Photo 21: Hairline Cracking Along Block Wall and Concrete wall Joint

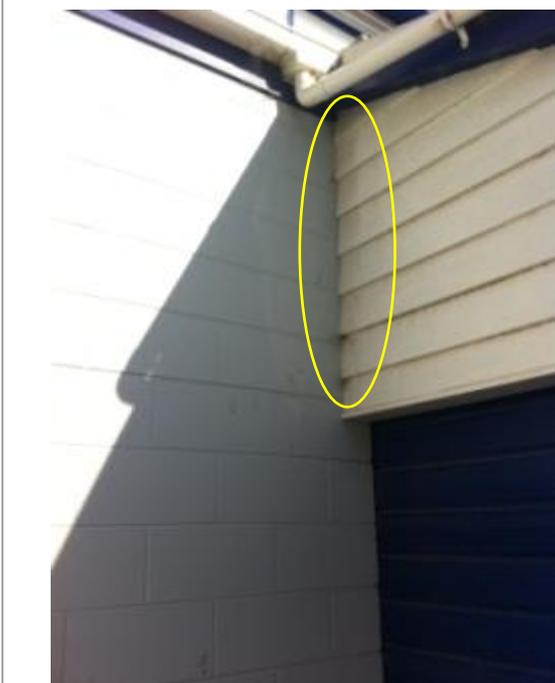
- 5) South side of Driveway: - Hairline cracking present along the block wall and timber wall joint in the northern corner (PHOTO 23 & 24).

Photo 23: Hairline Cracking Between Timber Cladding and Block Wall Joint

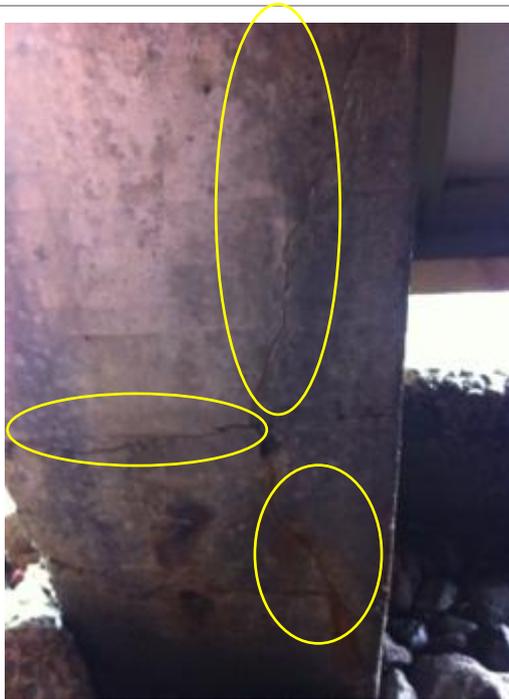
- 2) Minor spalling around cracking present in the middle of the 2nd concrete bearer from the east. Cracking was approximately 0.5mm wide. Note that not all bearers were checked for damage due to access and safety issues (PHOTO 34, 35 & 36).
- 3) Minor spalling and cracking present on the concrete pile located on the southern perimeter of the building, 2nd pile from the east. Cracking approximately 0.5mm wide. Note not all concrete piles were checked for damage (PHOTO 37 & 38).

Photo 37: Cracking and Spalling to Concrete Pile

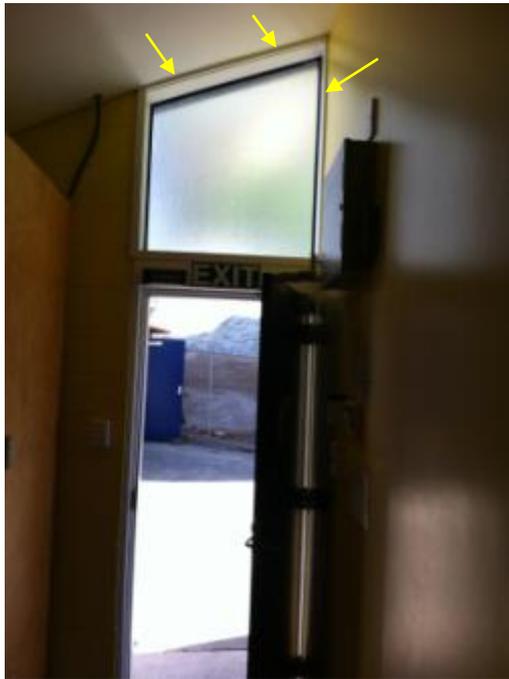
- 1) Hairline cracking present between the east wall window architrave and ceiling lining joint (PHOTO 39 & 40).
- 2) Hairline cracking present between the east wall window architrave and wall lining joint in the south-east corner (PHOTO 39 & 40).
- 3) Mitre joints on the western shower door architrave and the door leading to the stairs have opened up.
- 4) Hairline cracks present along the western wall ply lining and the plasterboard linings (PHOTO 41 & 42).

Photo 39: Cracking present Between South Wall Window architrave and Linings

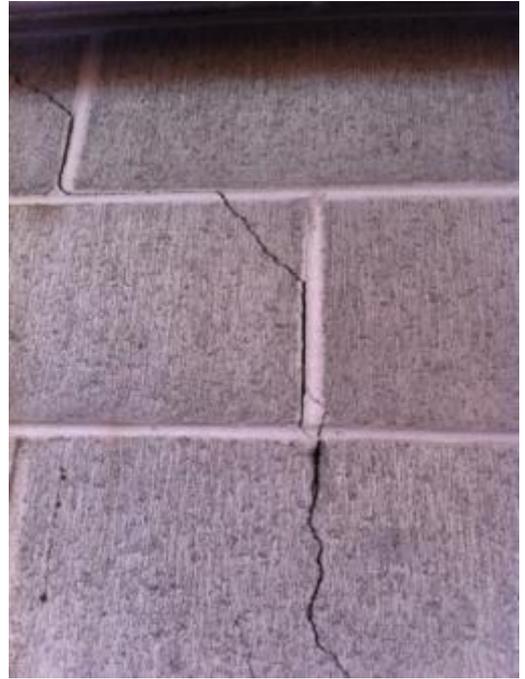
- 1) Cracking to northern block wall as noted above in external damage (PHOTO 44 & 45).
- 2) Mitre joints in the wooden balustrade trim for the steps leading down to the jet-ski shed have opened up (PHOTO 46).

Photo 44: Internal Cracking of Northern Block Wall

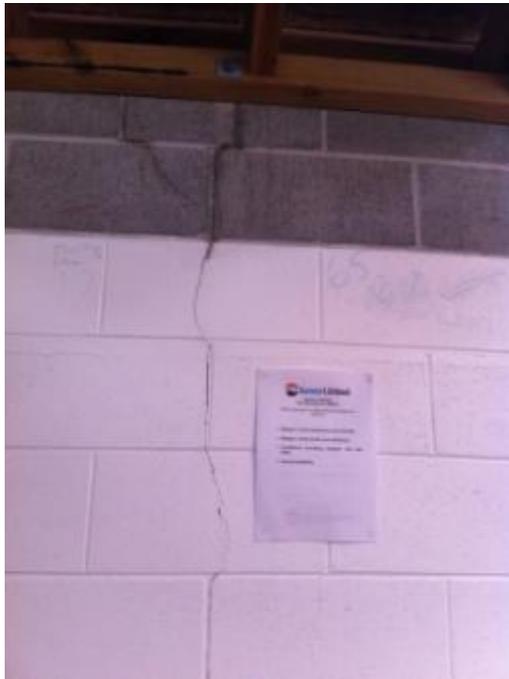
Photo 45: Internal Cracking of Northern Block Wall

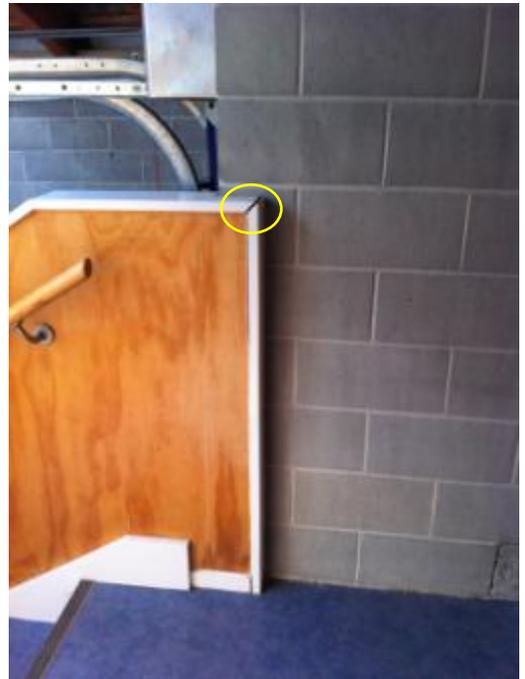
Photo 46: Mitre Joints in Wooden Balustrade Trim have Opened up

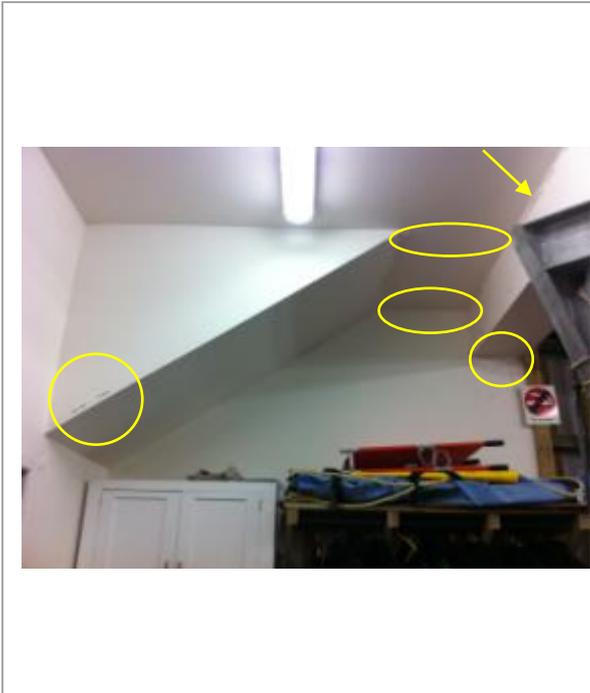
- 1) The following damage was observed on the south wall: -
 - Cracking present to wall lining under the floor beam (PHOTO 47 & 48).
 - Cracking present between the wall lining around the floor beam and ceiling lining joint (PHOTO 47 & 48).

Photo 47: Cracking to Linings on Southern Wall of Main Boat Shed

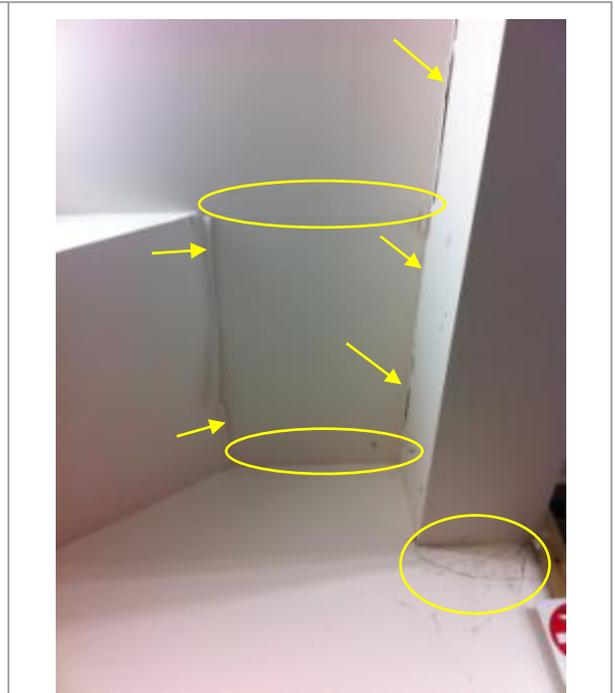
Photo 48: Close up of Cracking to Linings on Southern Wall of Main Boat Shed

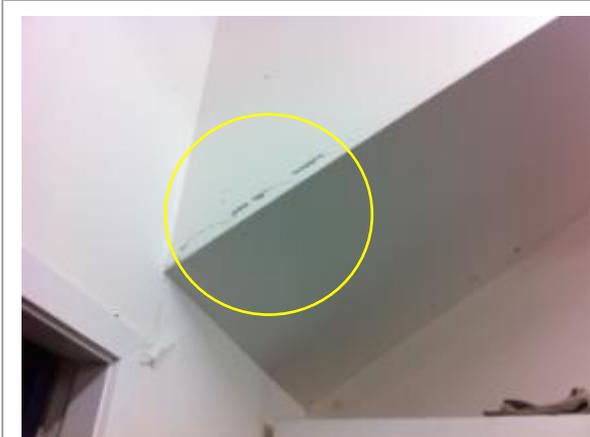
- Cracking present along ceiling lining joint radiating out from the underside of the stair (PHOTO 47 & 48).
 - Cracking in stair wall lining present near the eastern wall (PHOTO 49).

Photo 49: Cracking to Stair Wall Lining Joints near East Wall in Main Boat Shed

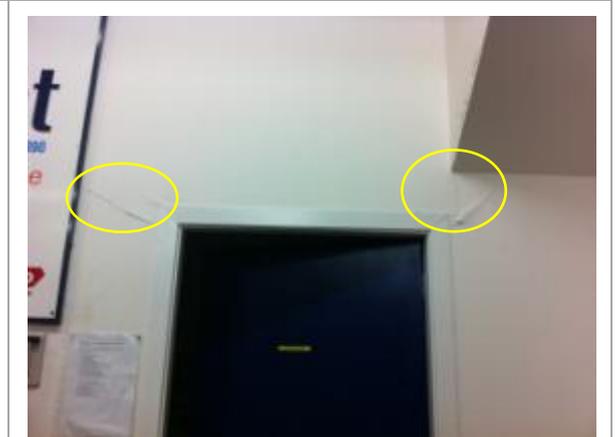
- 2) The following damage was observed on the east wall: -
 - Diagonal cracking in the wall lining radiating out from the top corners of the first aid room door, damage reflected on both sides of the wall (PHOTO 50).

Photo 50: Diagonal Cracking to Wall Lining above First Aid Room Door

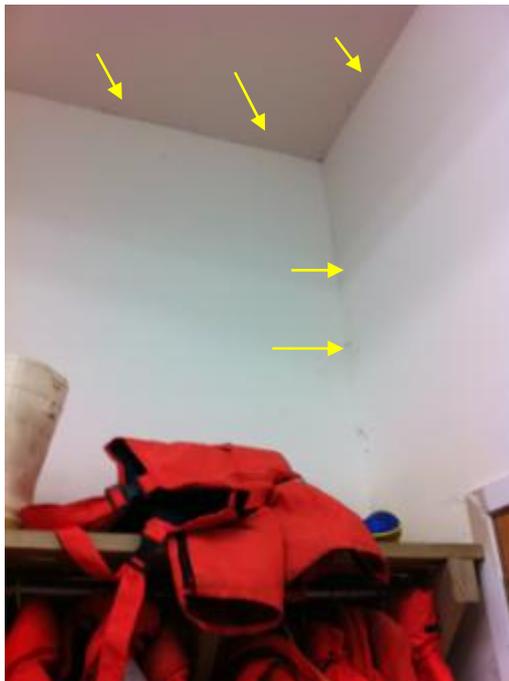
- Hairline cracking present along the lining joints in the north-east corner (PHOTO 53 & 54).
- 3) The following damage was observed on the north wall: -
- Vertical hairline crack at wall lining joint above personnel door (PHOTO 55).
 - Cracking present between the floor beam lining and both the ceiling lining and wall lining joints (PHOTO 56 & 57).
 - Hairline cracking at ceiling lining joints radiating out from the underside of the stairs (PHOTO 58).
 - Hairline cracking present around the steel UB portal column and the ceiling lining joint (PHOTO 59).

Photo 53: Hairline Cracking at Lining Joints in the NE Corner of Main Boat Shed

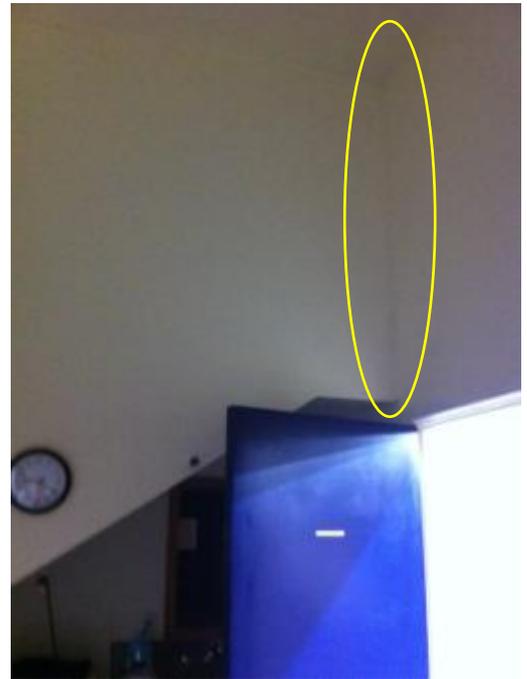
- 1) Hairline cracking at wall lining joint in the south-west and south-east corners (PHOTO 60, 61 & 62).
- 2) Diagonal cracking to wall lining at the stair re-entrant corner (PHOTO 63).
- 3) Vertical hairline crack at the wall lining joint located on the northern side of the east wall door (PHOTO 64).
- 4) Hairline cracking in wall linings radiating out from the top north corner of the east wall door (PHOTO 64).

Photo 60: Hairline Cracking in SW Corner of First Aid Room

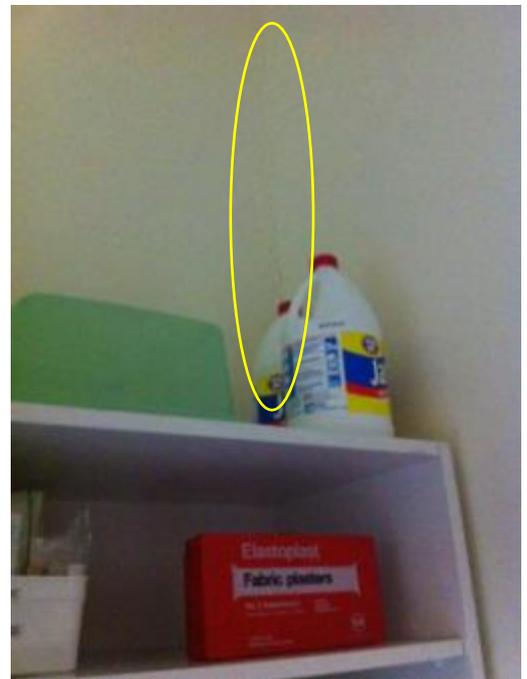
Photo 62: Hairline Cracking in SE Corner of First Aid Room

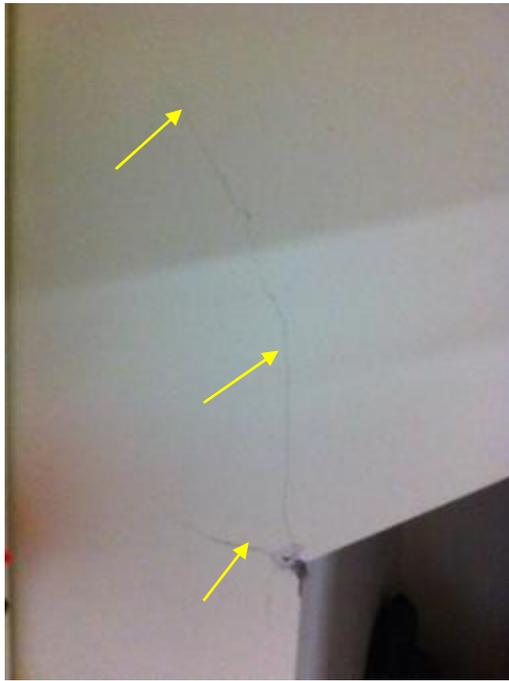
Photo 63: Diagonal Cracking at Stair Re-Entrant Corner in First aid Room

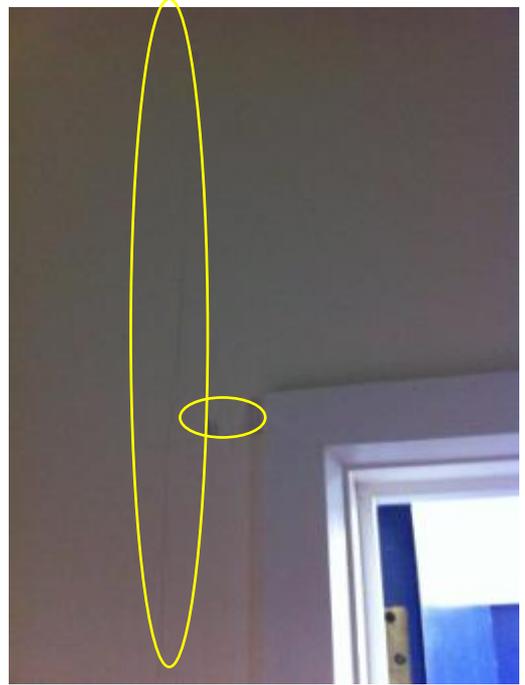
Photo 64: Vertical hairline Crack at wall Lining Joint Next to East Wall Door and Horizontal Crack Radiating out from Corner of Door in the First Aid Room

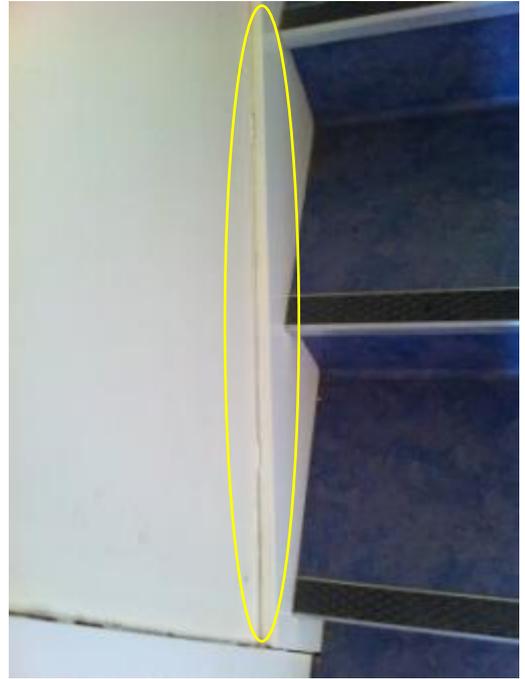
- 1) Cracking present along the timber stair skirting and the wall lining joint, typical (PHOTO 66).
- 2) Hairline cracking present between the main boat shed door architrave and the wall lining joint (PHOTO 67 & 68).
- 3) Severe diagonal cracking in the wall lining on the south wall (PHOTO 69, 70 & 71).
- 4) Horizontal hairline crack along wall lining joint on the north wall (PHOTO 72 & 73).
- 5) Vertical crack in wall lining near the north-west corner of the mid-height stair landing (PHOTO 74).
- 6) Vertical hairline crack in wall lining joint on the east wall of the mid-height stair landing (PHOTO 75).
- 7) Hairline cracking around ceiling bulkhead and the wall lining in the south-east corner of the mid-height stair landing (PHOTO 76).

Photo 66: Cracking Between Timber Stair Skirting and Wall Lining Joint in Eastern Stairwell

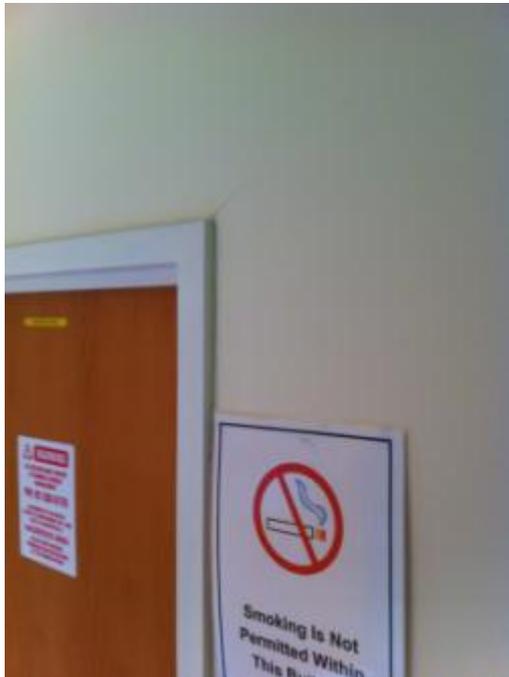
Photo 67: Cracking Between Wall Lining and Main Boat Shed Door Architraves

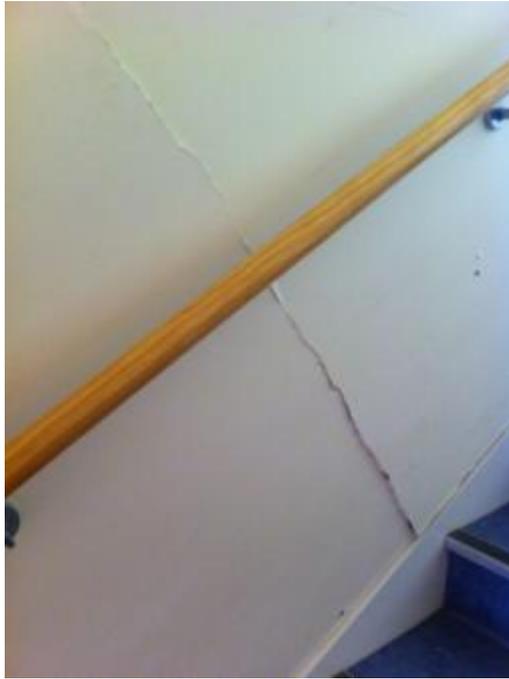
Photo 69: Severe Cracking to Wall Lining on the South Wall (Bottom of Cracking)

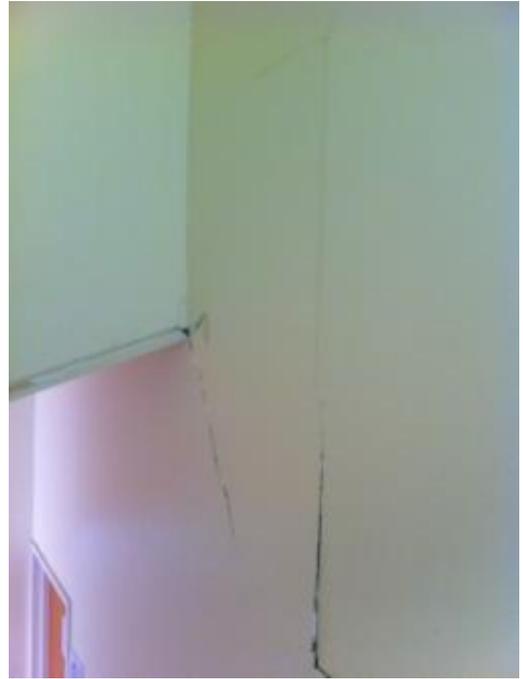
Photo 70: Severe Cracking to Wall Lining on the South Wall (Top of Cracking)

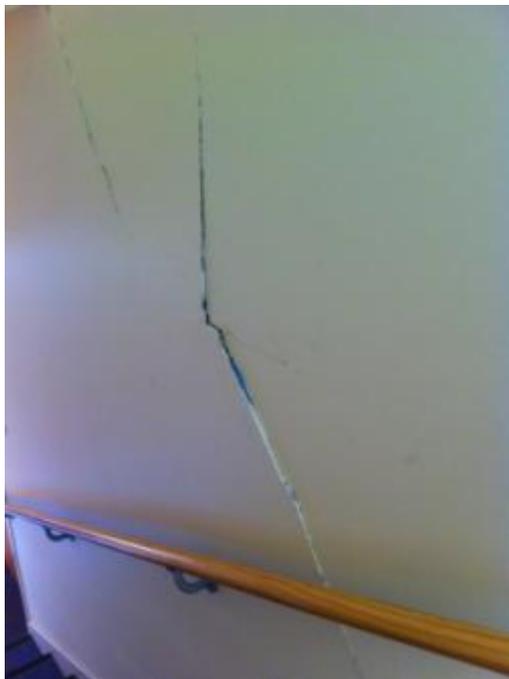
Photo 71: Close up of Cracking on South Wall

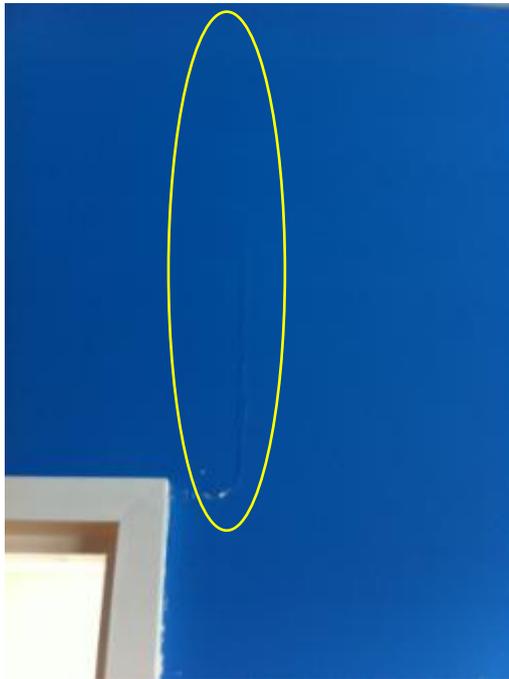
- 1) Vertical hairline crack at wall lining joint above the west corner of the south wall door (PHOTO 77).
- 2) Horizontal crack in wall lining joint spanning between the top corners of the west wall windows (PHOTO 78).
- 3) Mitre joints in the door architrave on the kitchen side have opened up (PHOTO 79 & 80).

Photo 77: Vertical Hairline Crack at Wall Lining Joint above Door in the Communications Room

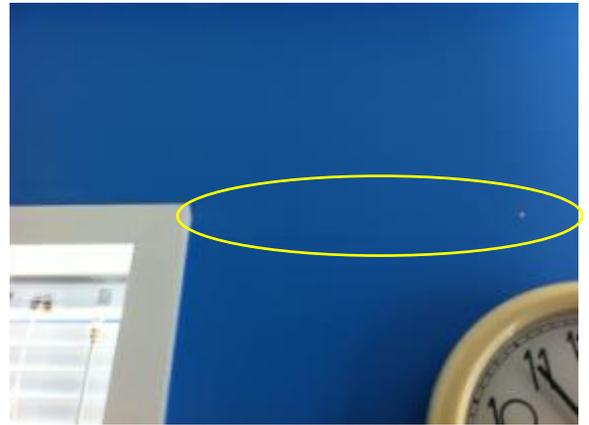
Photo 78: Horizontal Crack at Wall Lining Joint Between Windows in Communication Room

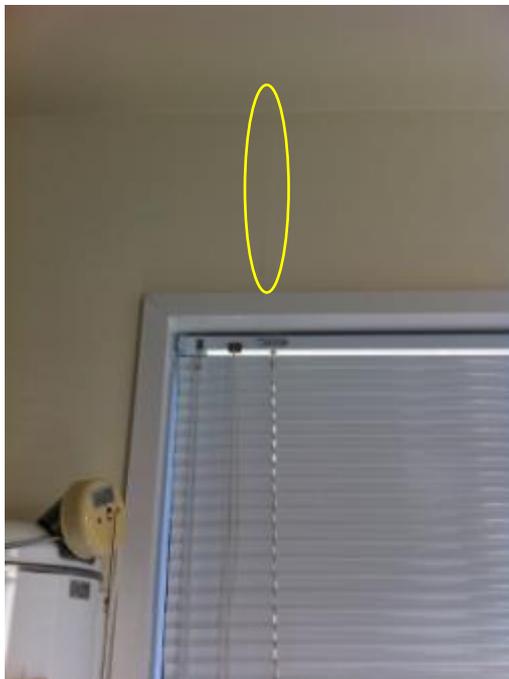
- 1) Mitre joints on the west wall door and window architraves have opened up (PHOTO 81 & 82).
- 2) Vertical hairline crack in the wall lining joint above the south wall window (PHOTO 83).
- 3) Hairline cracking present between the ceiling lining and the manhole trim.
- 4) Hairline cracking in wall lining joint in the south-west corner (PHOTO 84).

Photo 83: Vertical Hairline Crack at Wall Lining Joint on South Wall of Kitchen

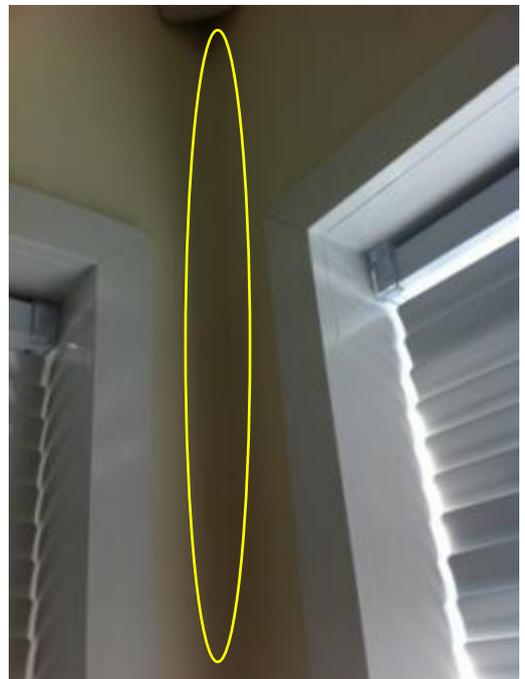
Photo 84: Hairline Cracking in SW Corner of Kitchen

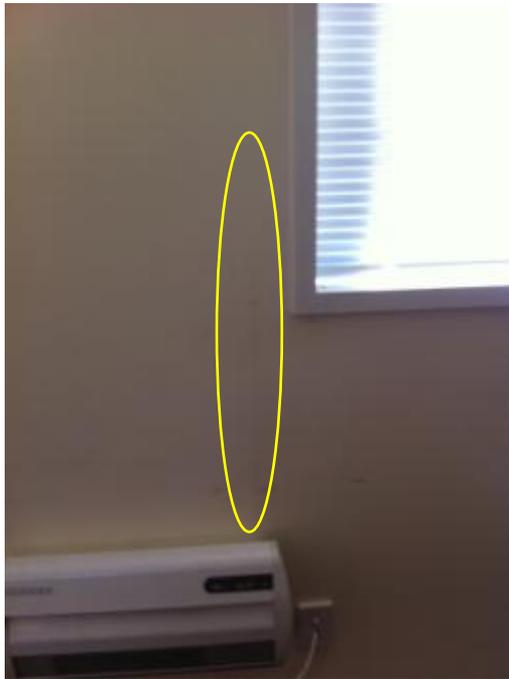
- 1) Vertical hairline crack in wall lining joint above the south wall window near the kitchen (PHOTO 85 & 86).
- 2) Hairline crack in wall lining joint above the north corner of the concertina door (PHOTO 87).
- 3) Hairline crack in wall lining joint under the central window on the northern wall (PHOTO 88).
- 4) Hairline crack in the wall lining joint next to the east window on the northern wall (PHOTO 89 & 90).
- 5) Hairline crack in the plasterboard lining near the top of the south stair (PHOTO 92 & 93).

Photo 89: Vertical Hairline Crack on North Wall of L1 Main Room

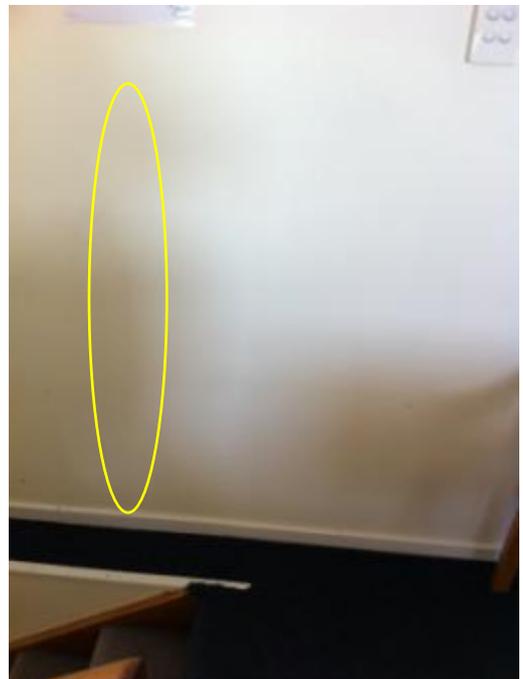
Photo 92: Vertical Hairline Crack at Wall Lining Joint Next to South Stair

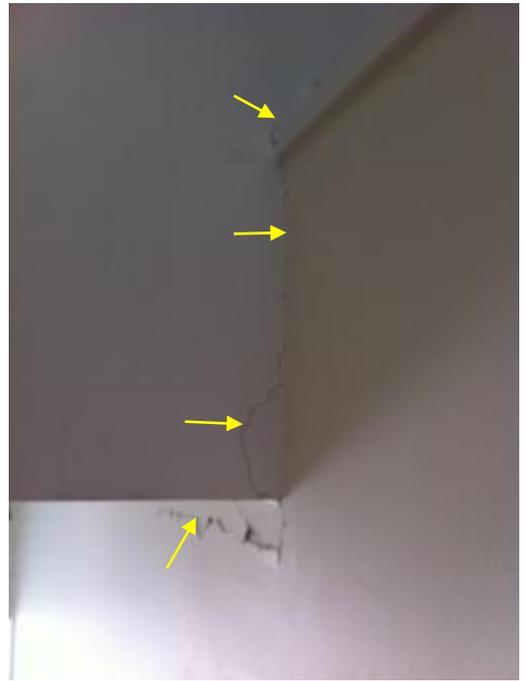
- 1) Cracking in wall lining on the south wall around the ceiling bulkhead (PHOTO 94).
- 2) Cracking between timber beam and timber brace joint on the east wall (located at the mid-height stair landing) (PHOTO 95 & 96).
- 3) Cracking present to the east wall window architrave in the south-east corner of the mid-height stair landing (PHOTO 97 & 98).
- 4) Cracking present in wall lining above east wall exit door at the base of the stair. Cracking radiates out from the south corner of the door and continues up to the window architrave (PHOTO 99).
- 5) Cracking present between the west wall exit door architrave and the wall lining joint (PHOTO 100 & 101).
- 6) Mitre joints on the first aid room door architrave have opened up (PHOTO 102).

Photo 94: Cracking in Bulkhead Linings in South Stair

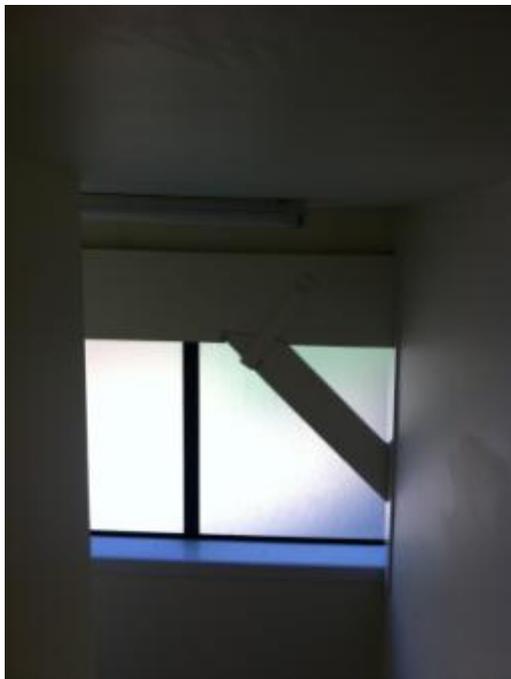
Photo 95: Cracking around Timber Brace in South Stair

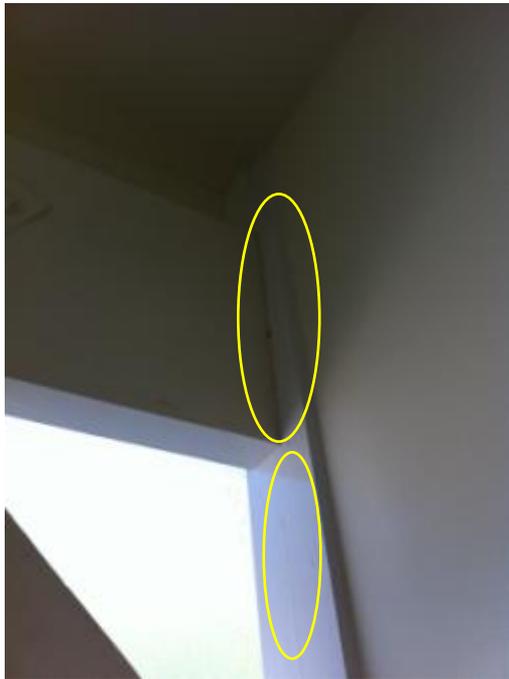
Photo 97: Cracking Present to Window Architrave in SE corner of South Stair

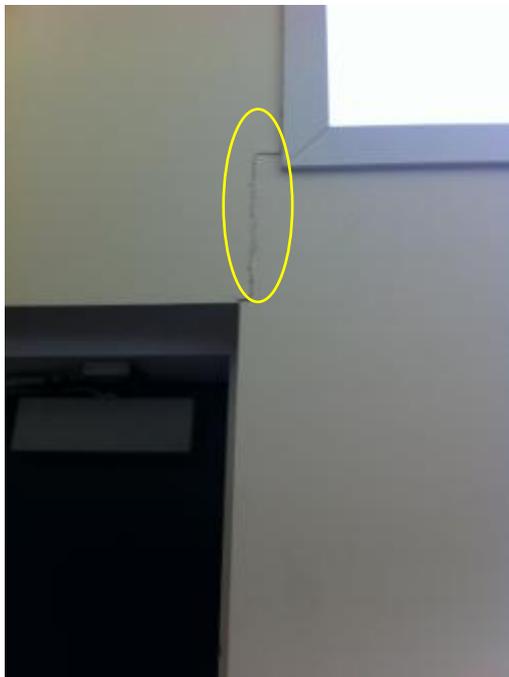
Photo 99: Cracking above East Exit Door in West Stair

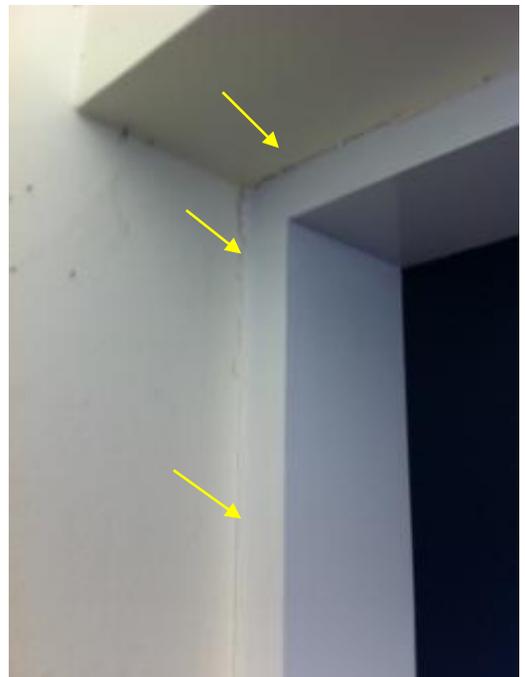
Photo 100: Cracking around East Exit Door
