**Scarborough Park Toilets  
PRK 1467 BLDG 002 EQ2**

**Detailed Engineering Evaluation**

**Quantitative Assessment Report**

Date: December 2012  
Reference: 6-QUCC1.20  
Status: Final

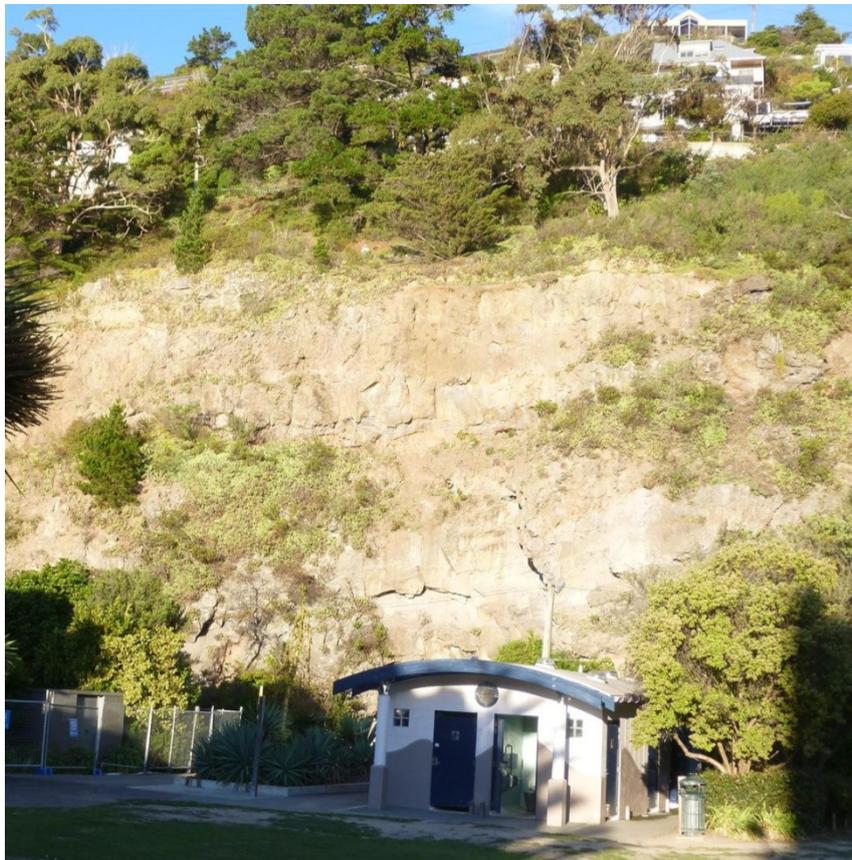
Rock face behind toilet facility

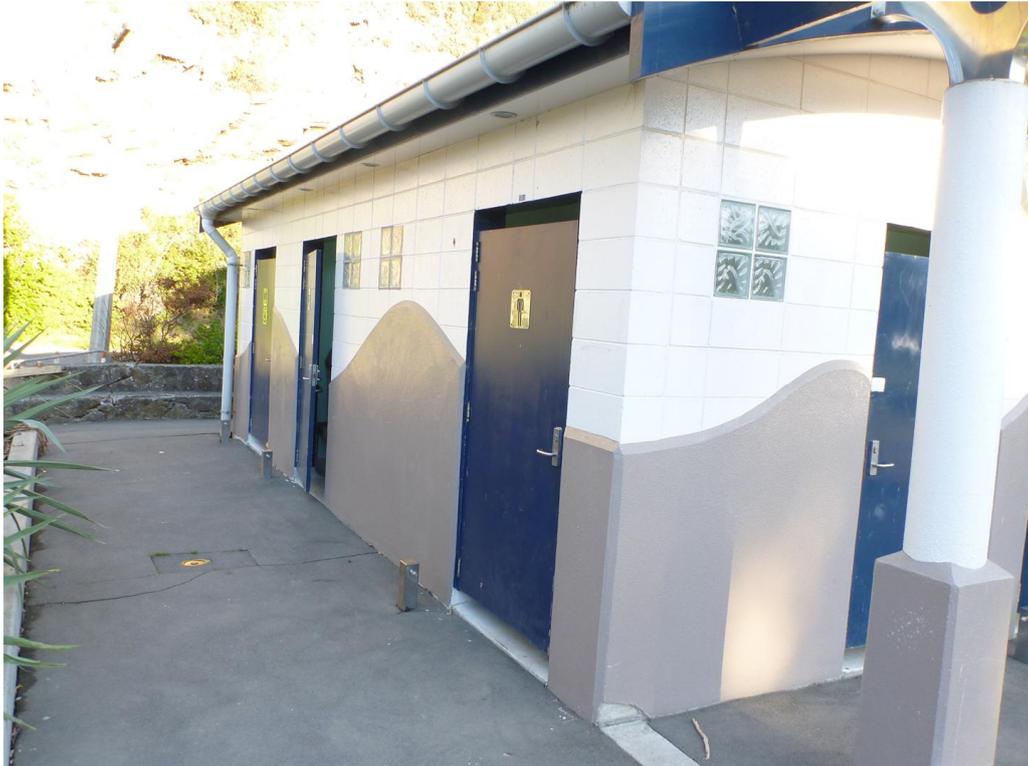
Right (north) wall (Note slab cracks. Note central CMU wall pier much stiffer)

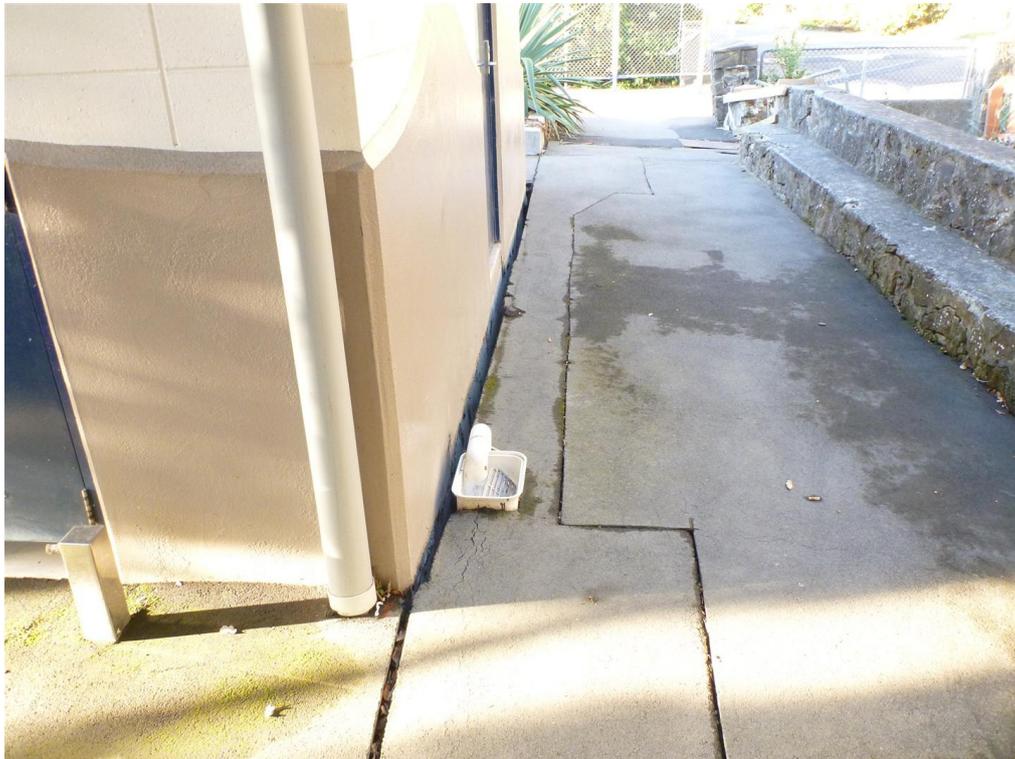
Rear (east) wall (Note the displacement of the building relative to surrounding slab)

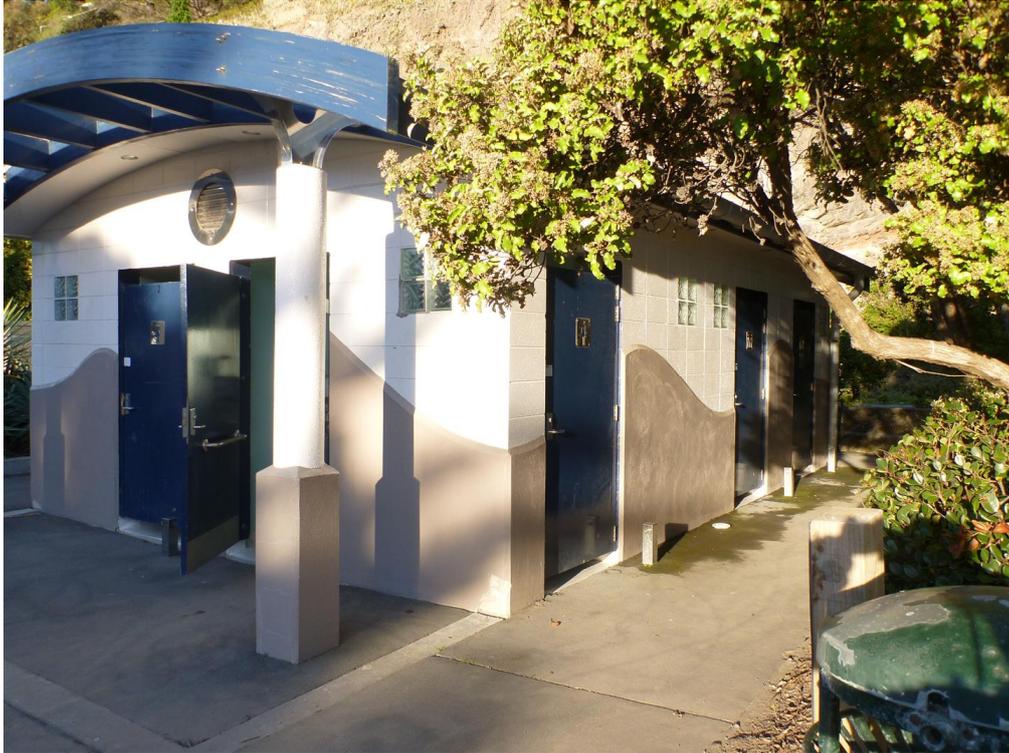
Front side (Note columns on separate foundation than building)

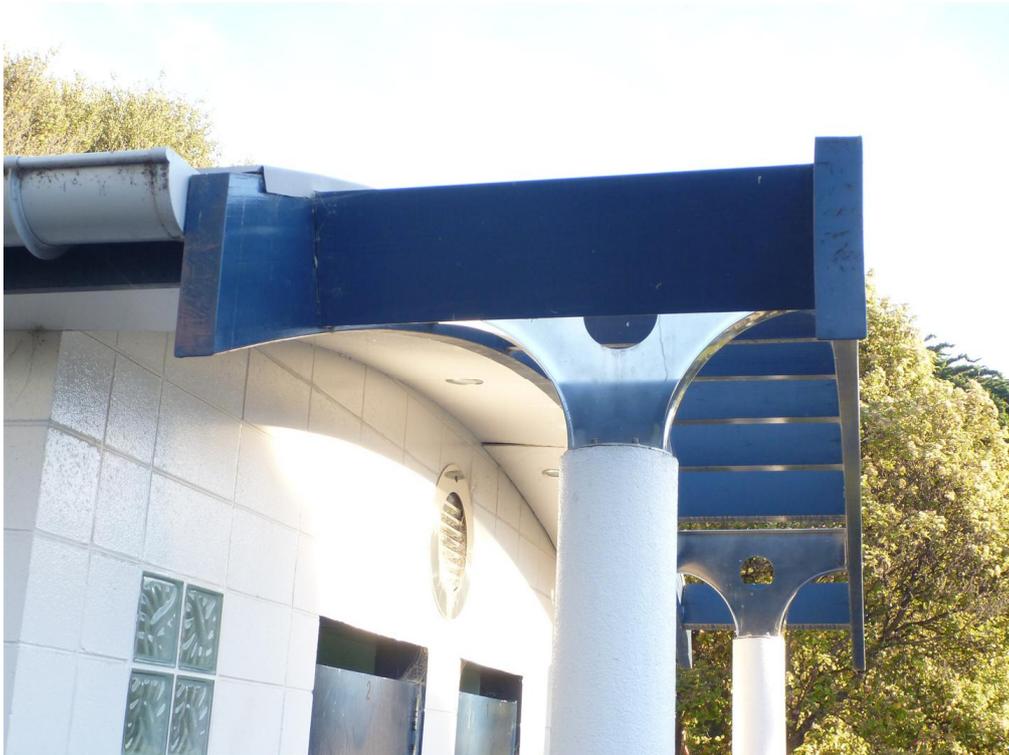
Front view showing column attachment and ceiling deformation

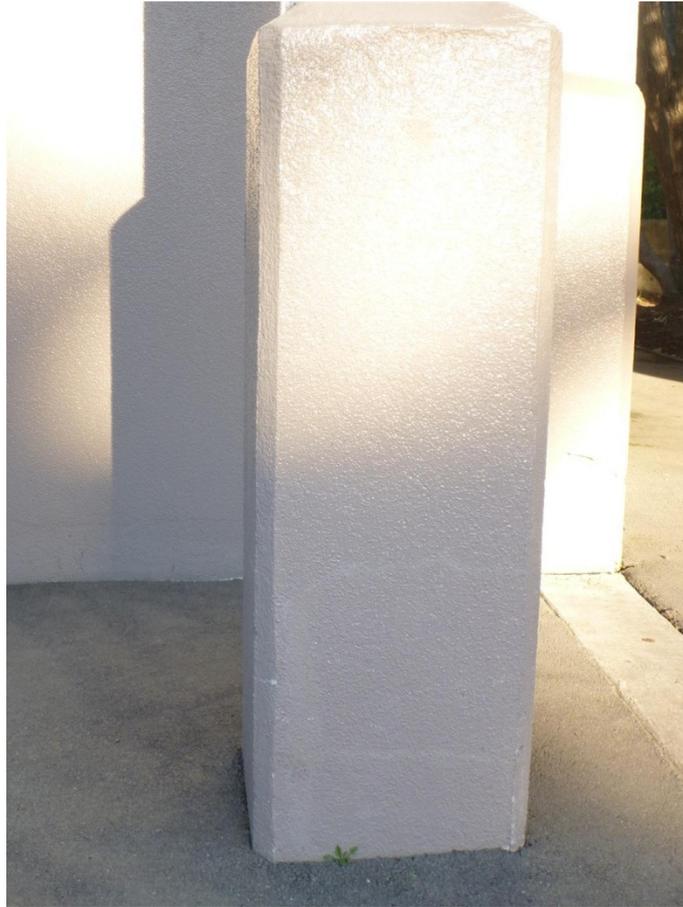
Column foundations isolated from rest of building

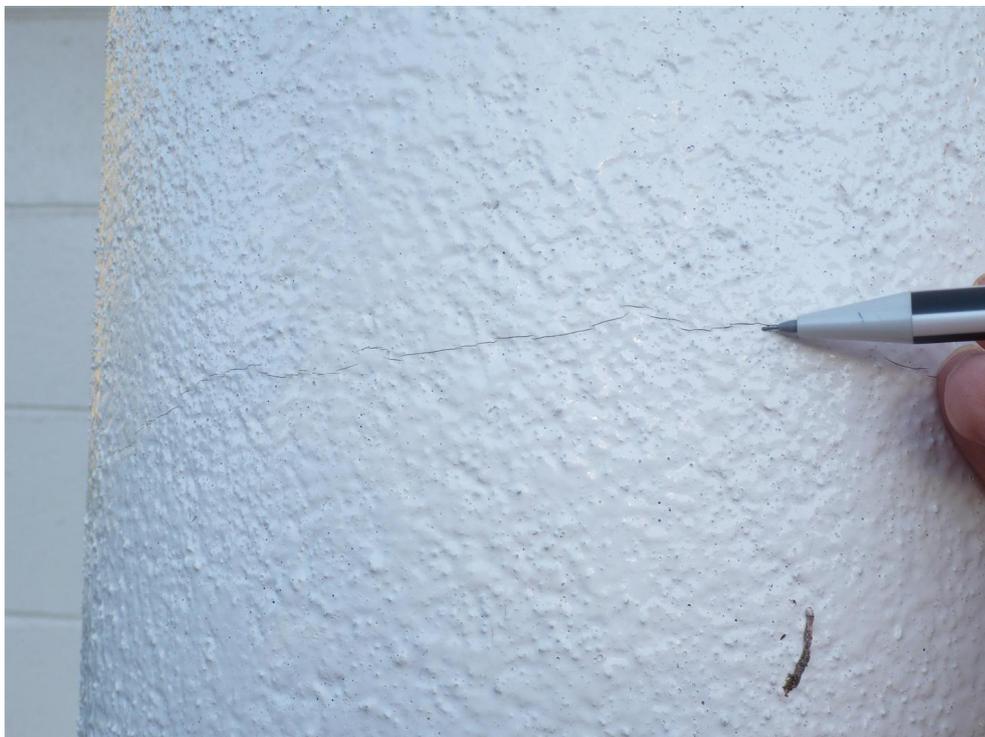
The cracks in the circular concrete columns appear to be due to the large displacements imposed on the top of the columns when the toilet building displaced westward in a sledding motion during the earthquake. This was due to the shallow and narrow foundations and the fact that the pier foundations of the columns are not connected to the building foundation.

Cracks in concrete column

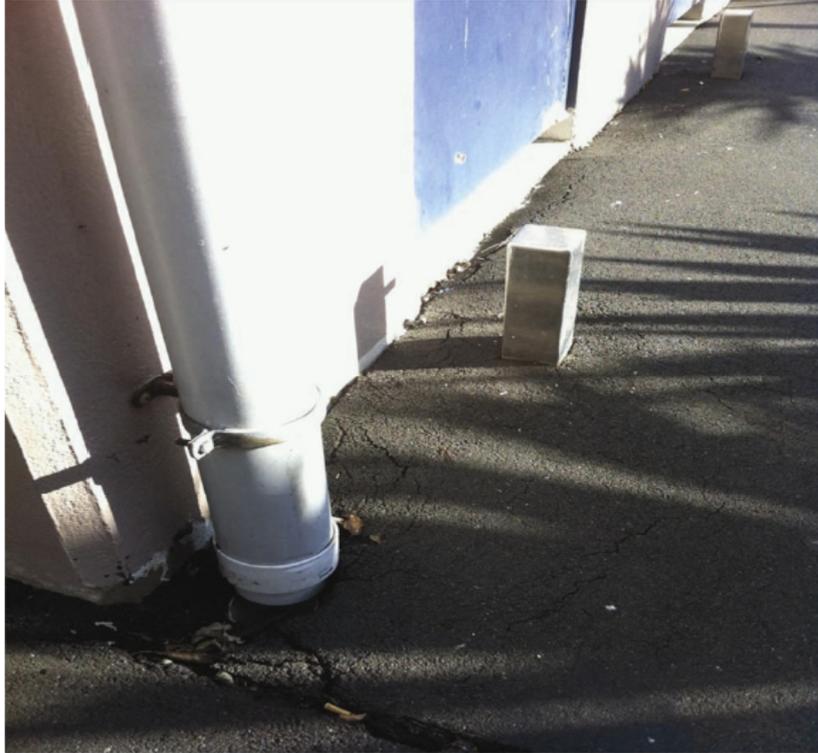
Separation between building foundation and footpath on the east side about 10-20mm

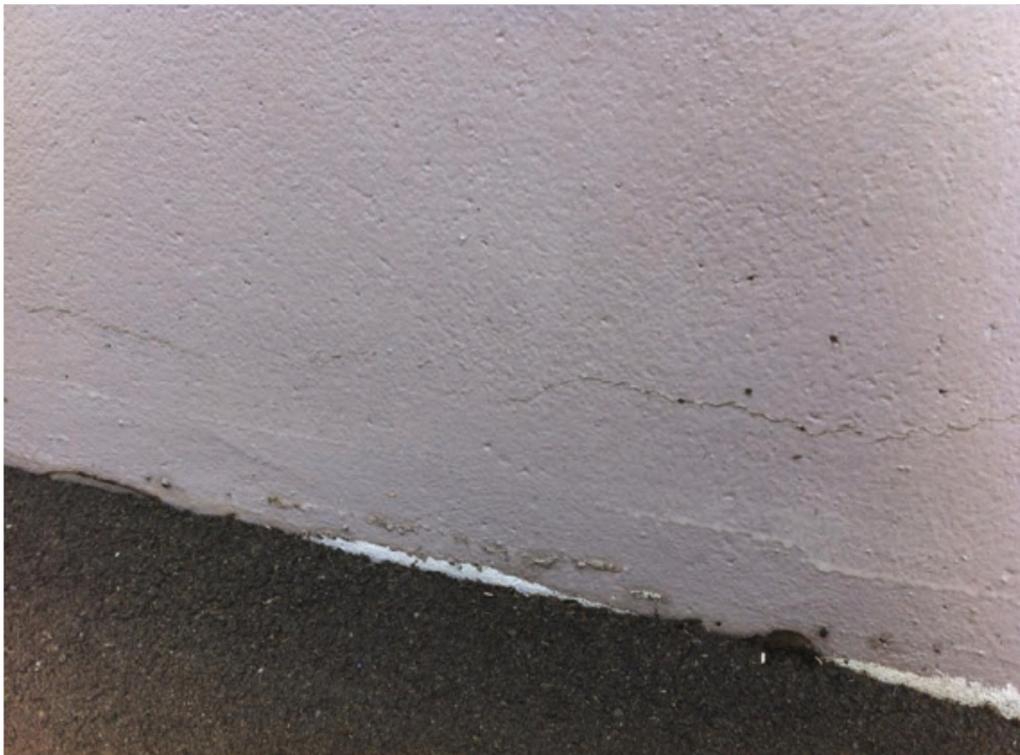
Hairline cracking at east side wall 1m long

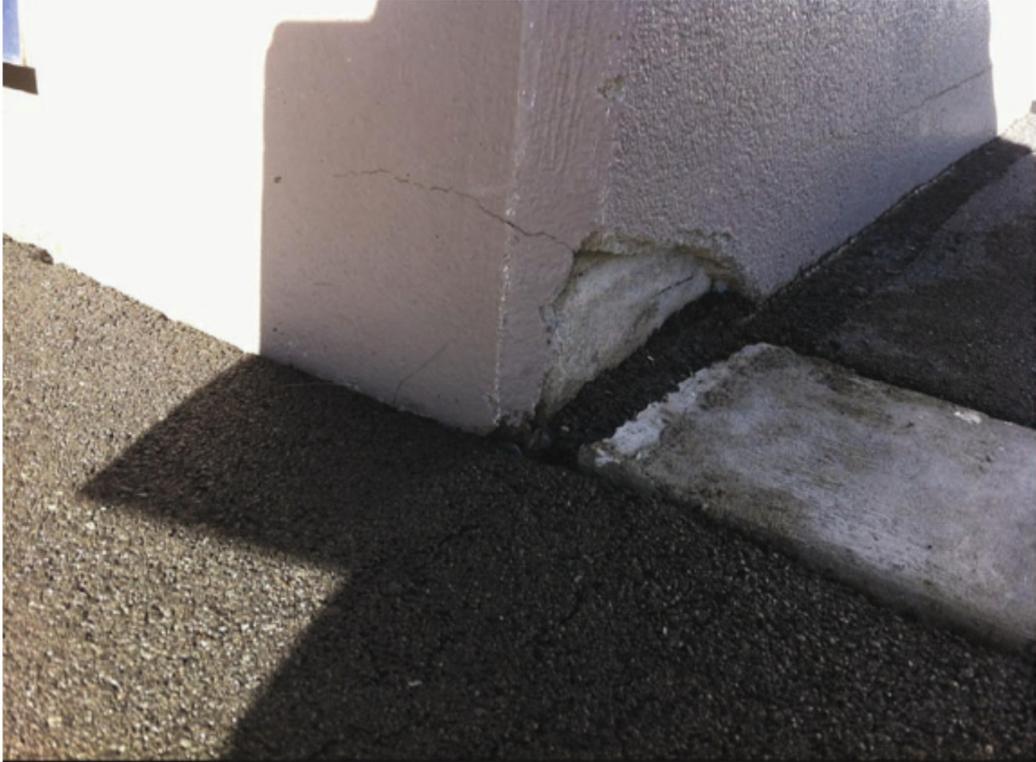
Hairline cracking and break away at the southeast corner

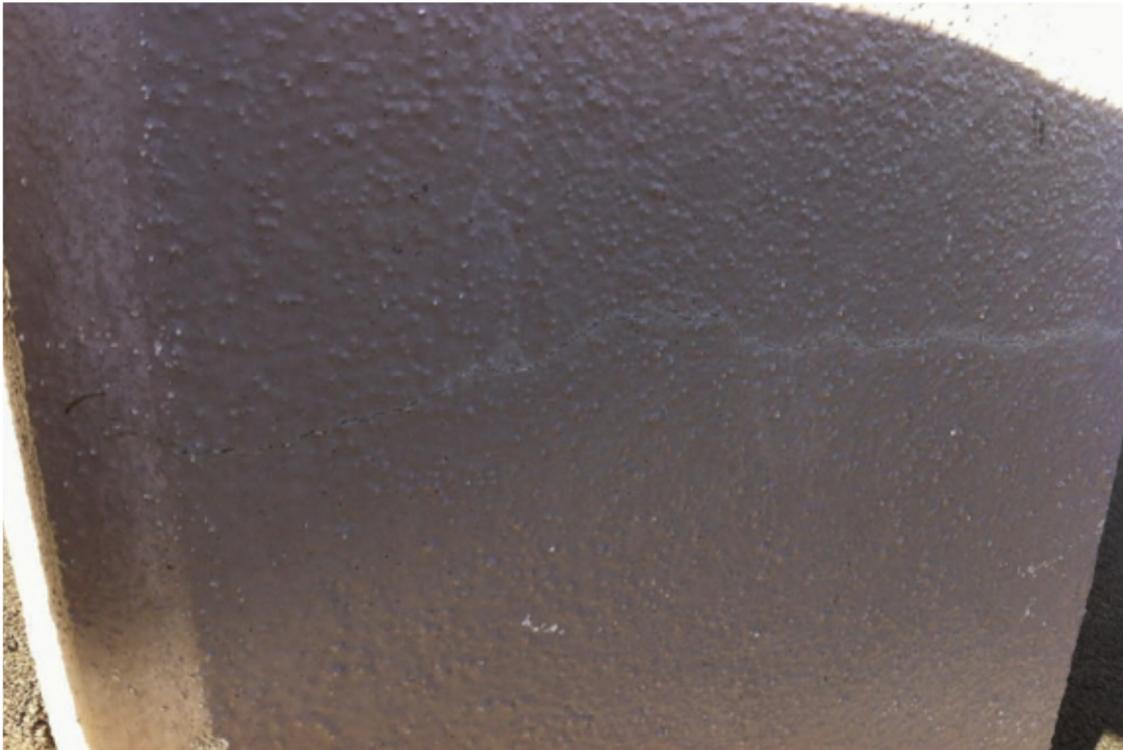
Hairline cracking on the southeast corner column

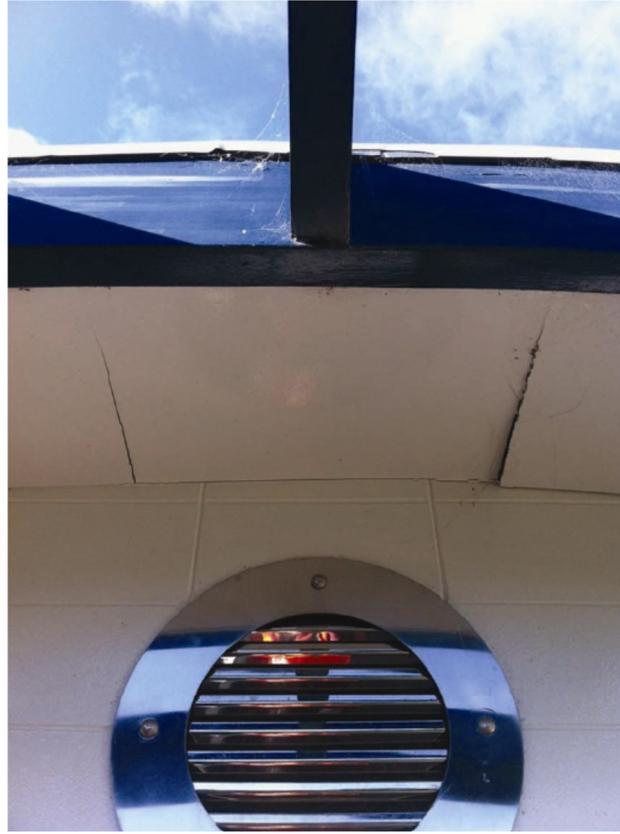
Movement in the eave on the south end

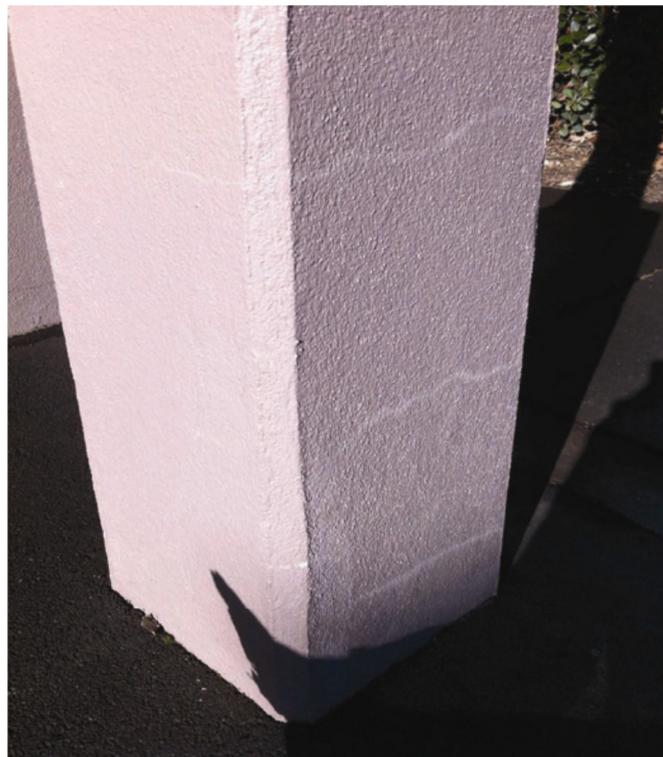
Hairline cracking on the southwest corner column

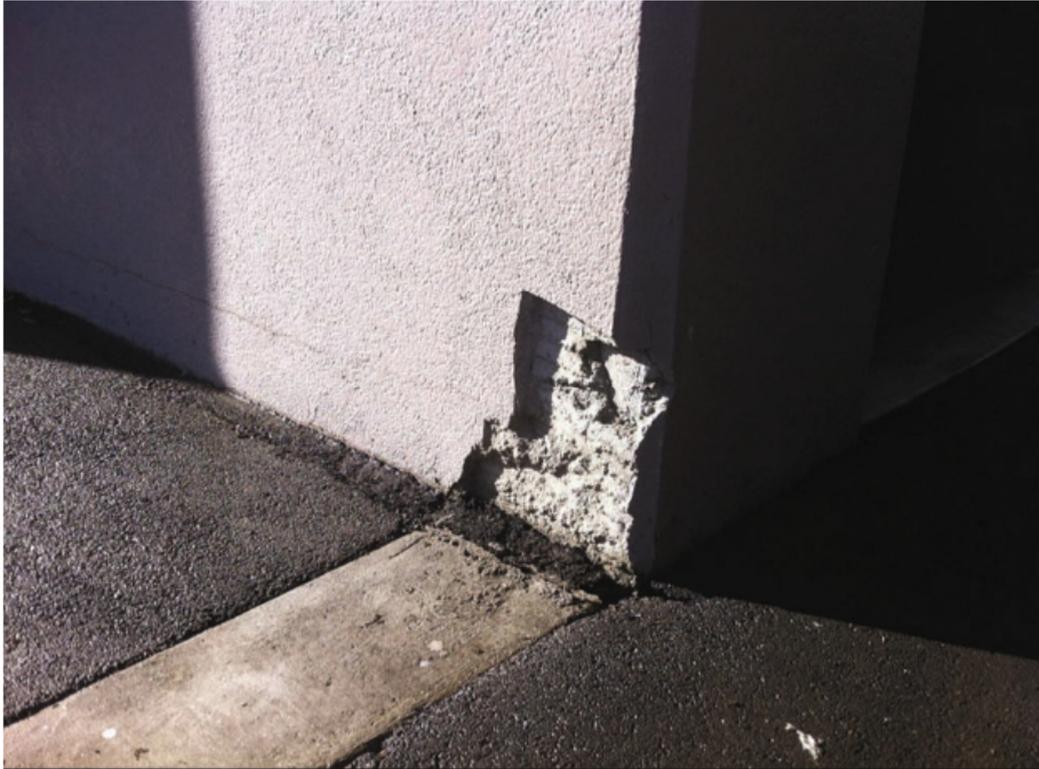
Hairline cracking and breakaway at the southwest corner

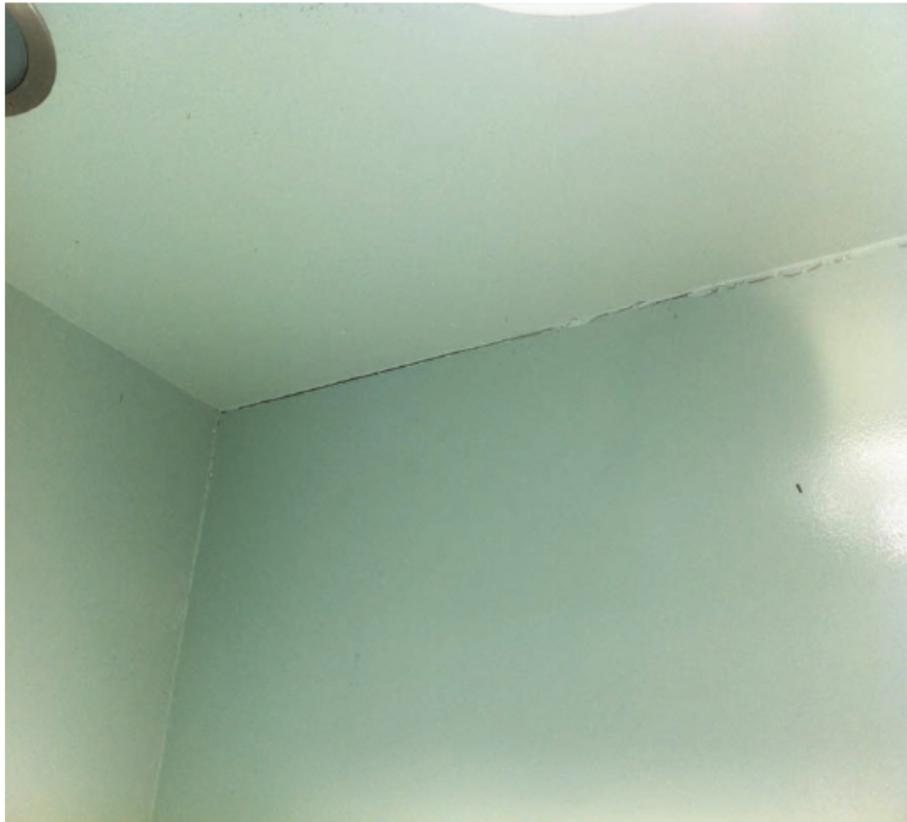
Cracking where the wall meets the ceiling in the southeast corner toilet

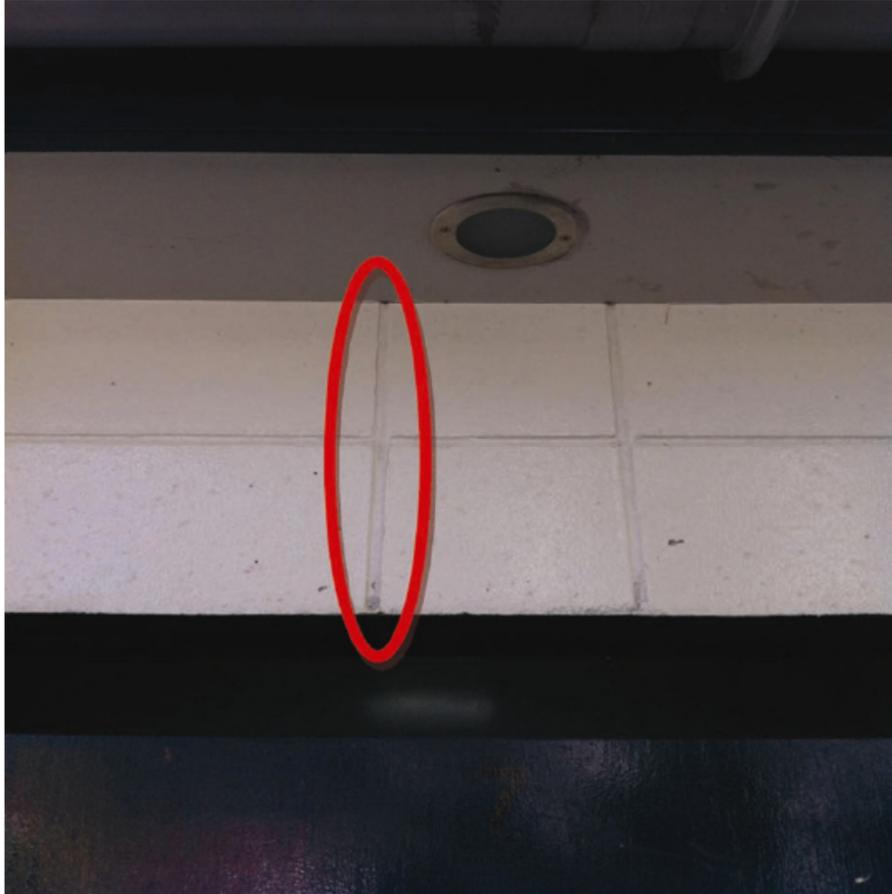
Cracking in mortar joint above door at midpoint on west wall

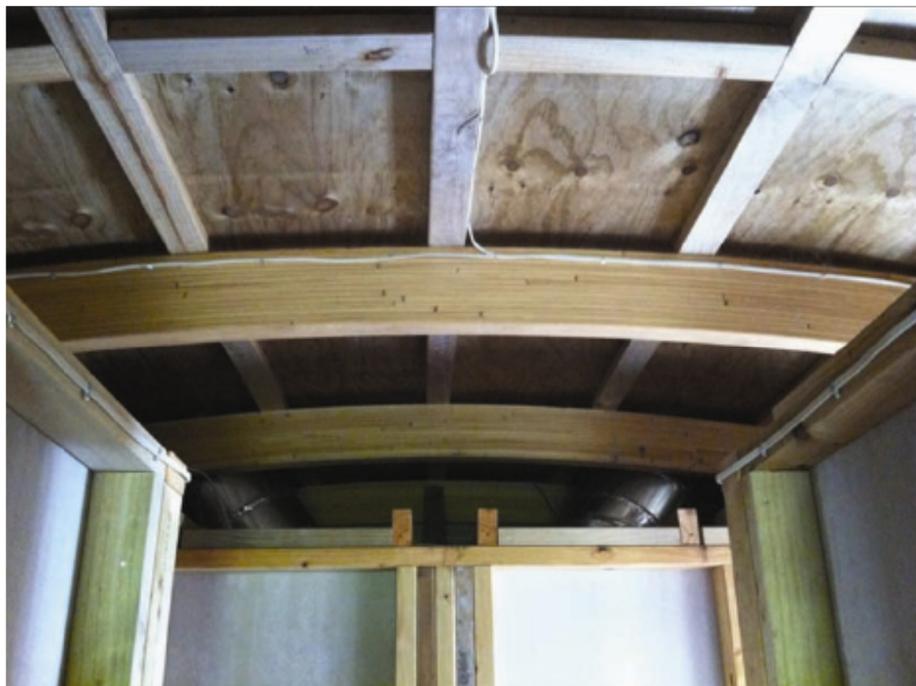
Furthermore, the roof diaphragm was designed to consist entirely of the villaboard ceiling sheathing but this ceiling sheathing is interrupted at the central service corridor and therefore has limited capacity. As a result, it has buckled and cracked during the Canterbury earthquake sequence.

Roof structure in the service corridor

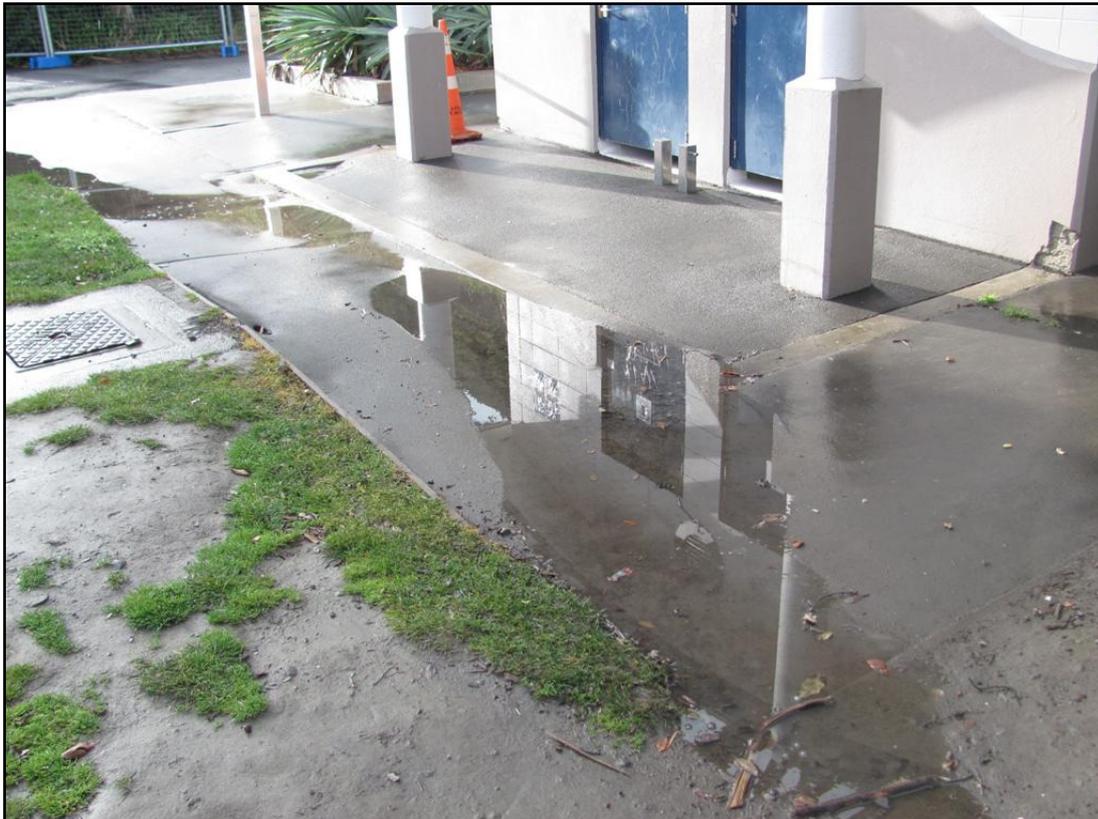
Photograph 4: View of the subsidence bowl in the asphalt pavement on the southwest corner of the toilet block.

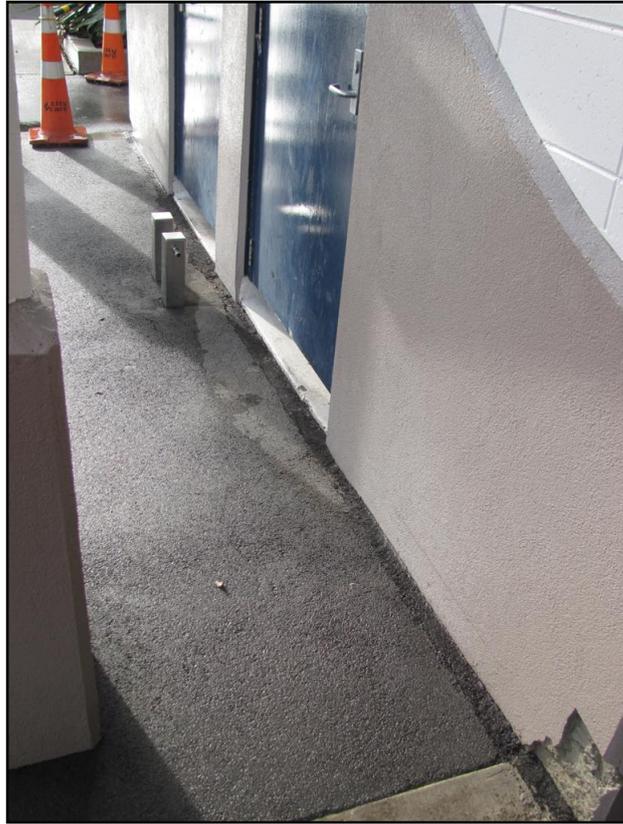
Photograph 5: View of horizontal separation of asphalt pavement from western edge of the toilet block footings (in-filled at time of site visit).

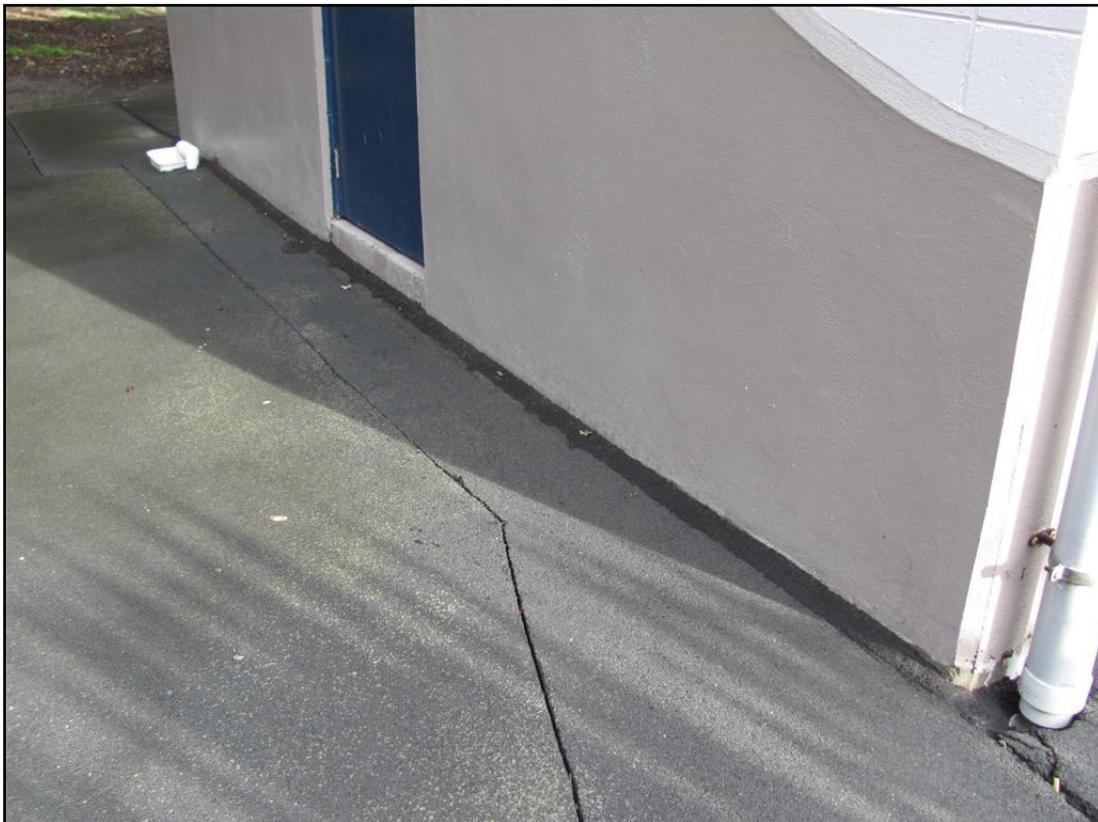
Photograph 6: View of horizontal separation of asphalt pavement from eastern edge of the toilet block footings (in-filled at time of site visit).

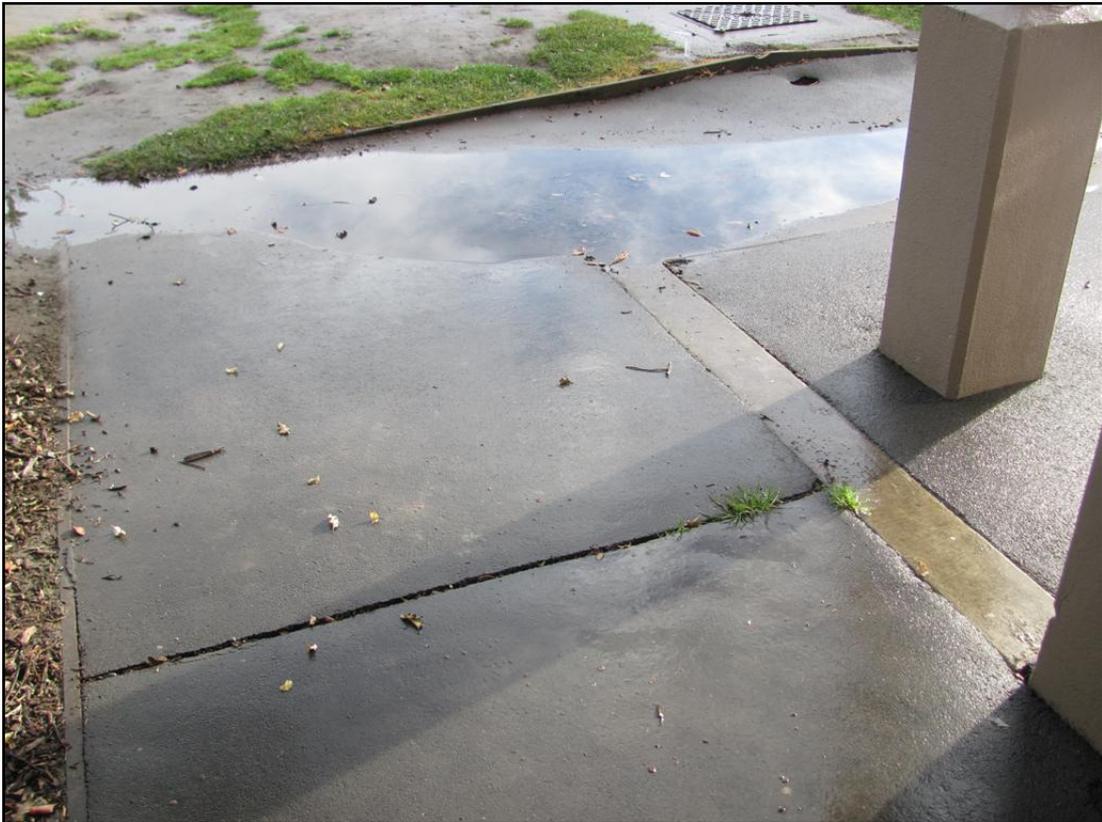
Photograph 8: View of 20mm wide crack in asphalt pavement located by the southwest corner of the toilet block.

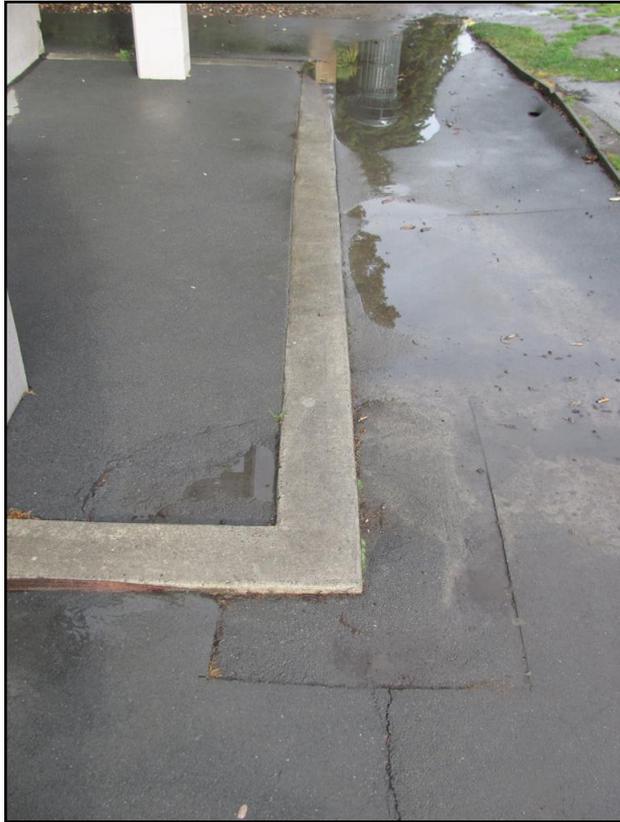
Photograph 9: View of View of 5mm wide crack in asphalt pavement located by the northwest corner of the toilet block.

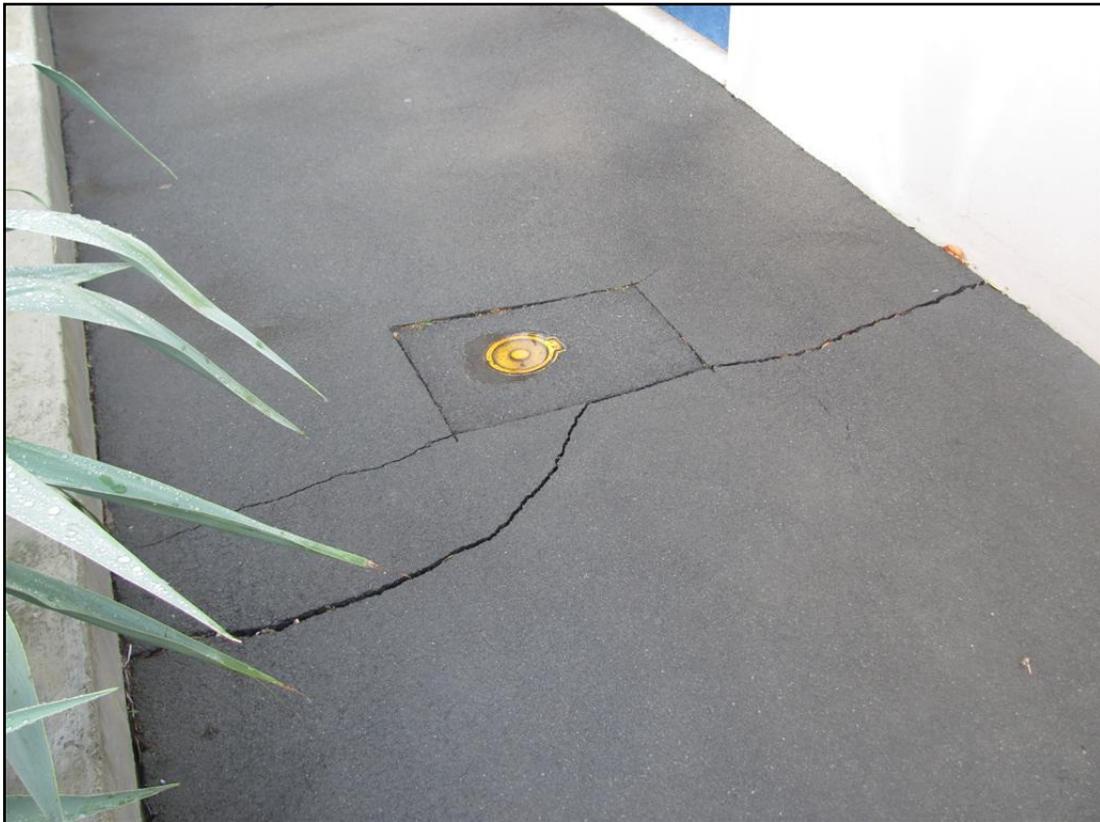
Photograph 10: View of the 10mm wide crack in the asphalt pavement located midway along the north facing side of the toilet block.

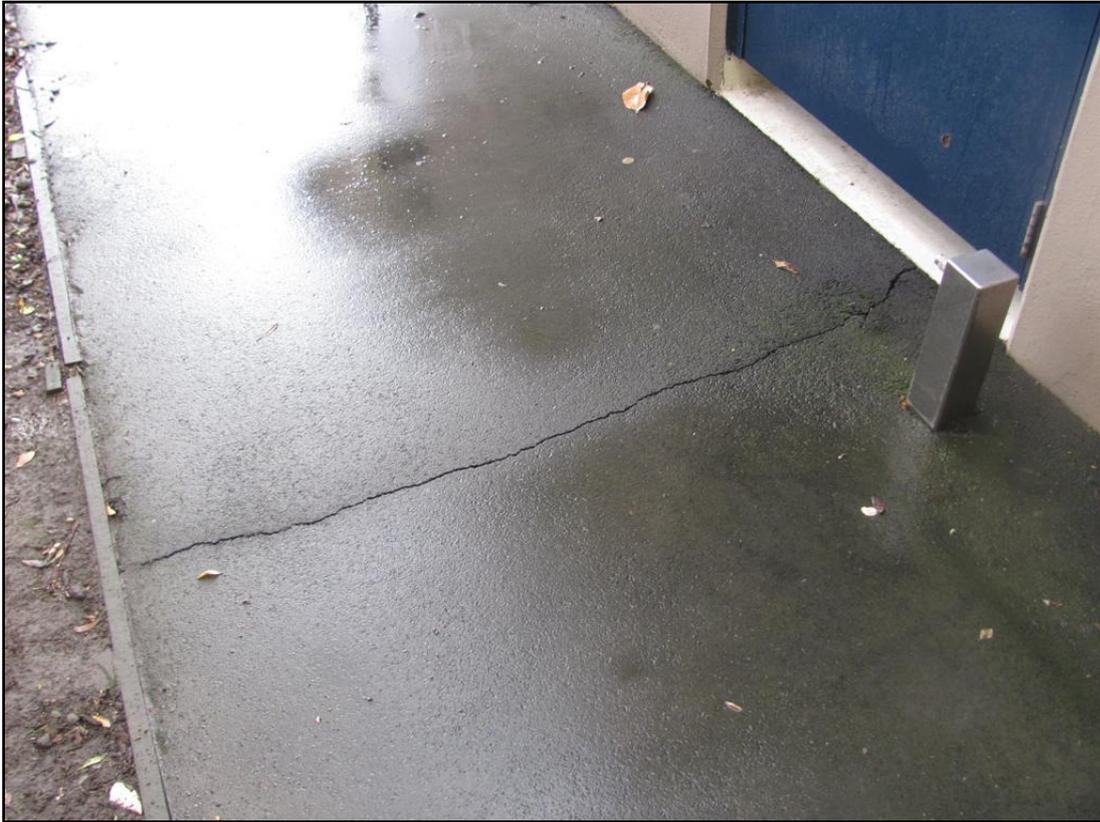
Photograph 11: View of the 5mm wide crack in the asphalt pavement located midway along the south facing side of the toilet block.

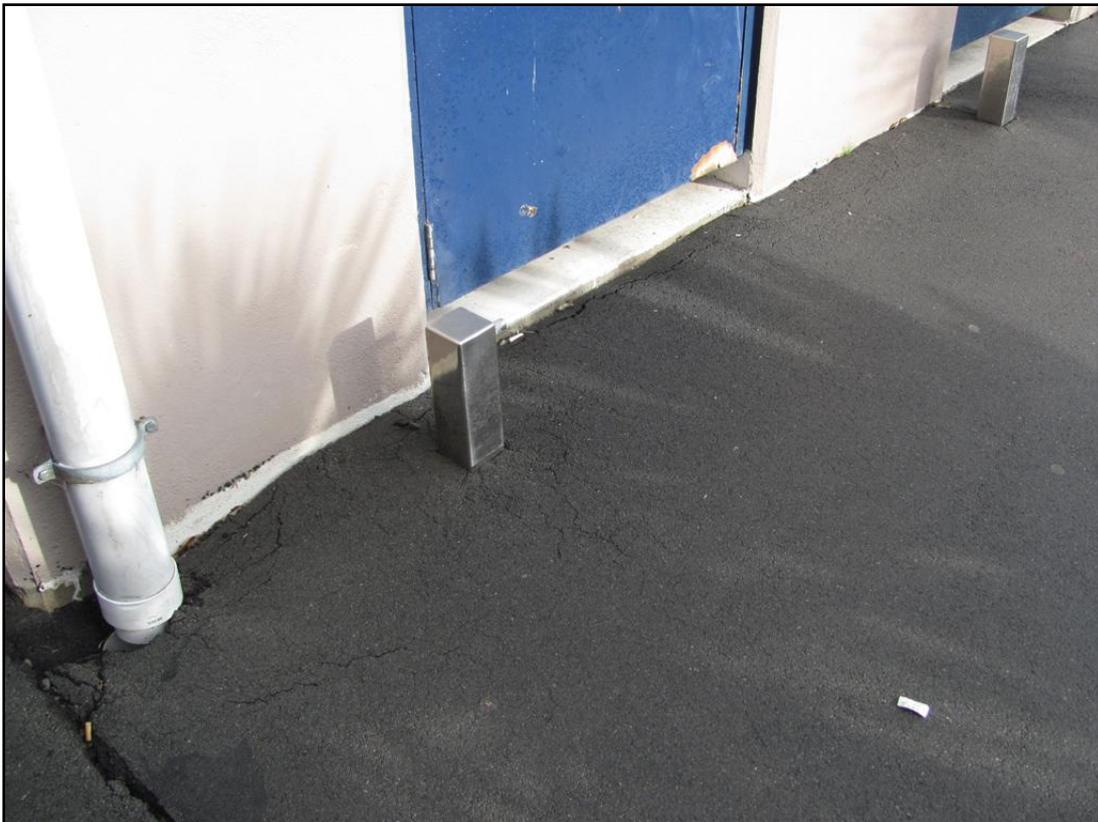
Photograph 12: View of between 20mm and 80mm of settlement of asphalt pavement along the northeast corner of the toilet block

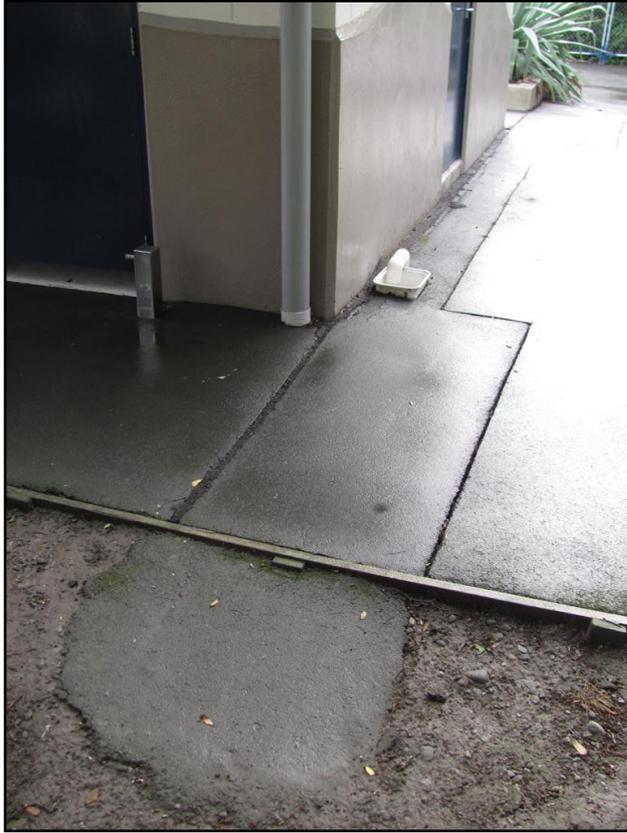
Photograph 13: View of the 20mm wide opening of asphalt pavement along eastern edge of the toilet block (possible trench to buried services).
