Seafield Park – Rabbit House  
Qualitative Engineering Evaluation

**Reference:** 230547

**Prepared for:**  
Christchurch City Council

**Address:** 105 Heyders Road, Christchurch

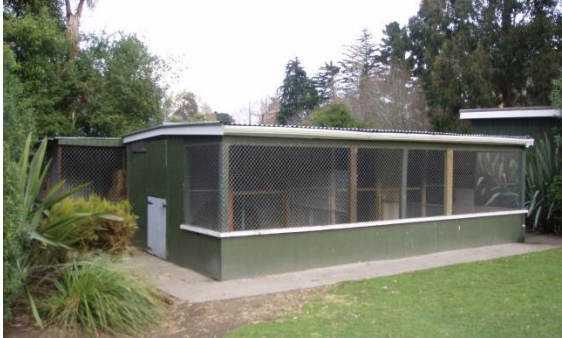
<p>Northeast view of the building.</p>

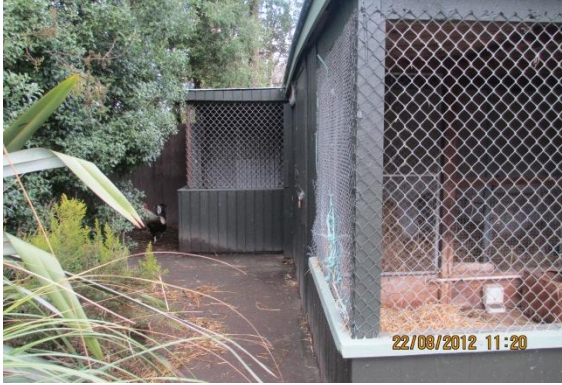
<p>A photograph showing the northeast view of a long, low building with a green-painted base and chain-link fencing on top. The building is surrounded by greenery and a lawn.</p>
<p>East end of the building.</p>

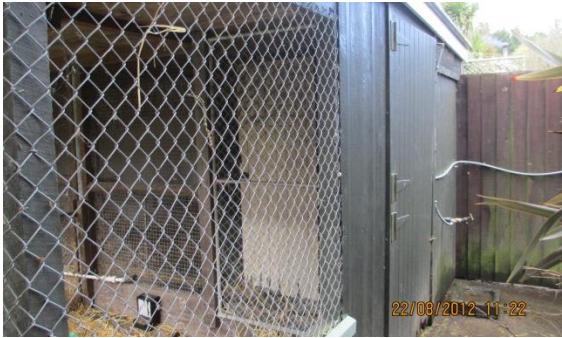
<p>A photograph showing the east end of the building, featuring a chain-link fence and a dark-colored door. The date and time stamp '22/08/2012 11:20' are visible in the bottom right corner.</p>
<p>West end of the building.</p>

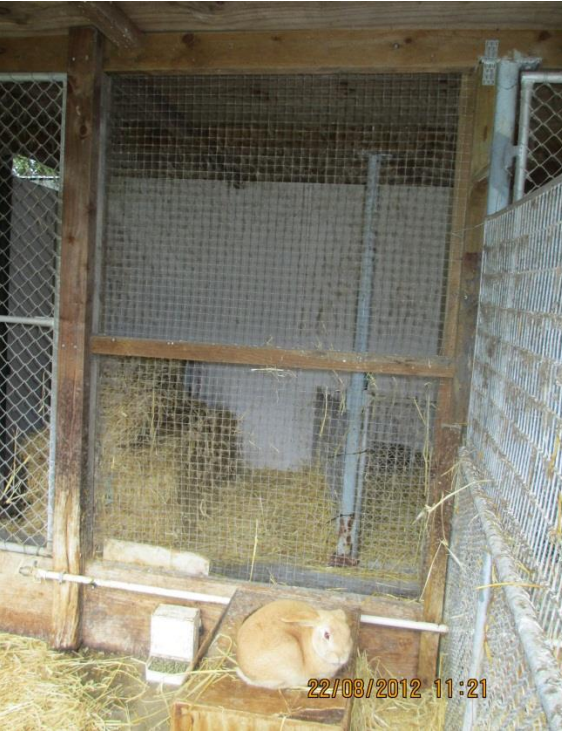
<p>A photograph showing the west end of the building, featuring a chain-link fence and a dark-colored door. The date and time stamp '22/08/2012 11:22' are visible in the bottom right corner.</p>
<p>Internal view of the building.</p>
