Seafield Park – Hexagonal Aviary
Qualitative Engineering Evaluation

Reference: 230548

Prepared for:
Christchurch City Council

Date: 2 July 2013

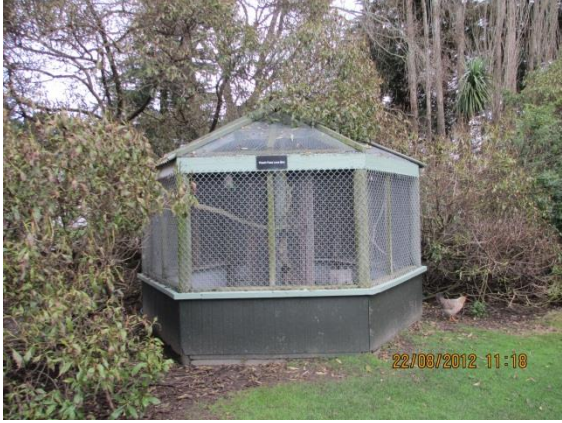
<p>Southwest view of the aviary complex.</p>

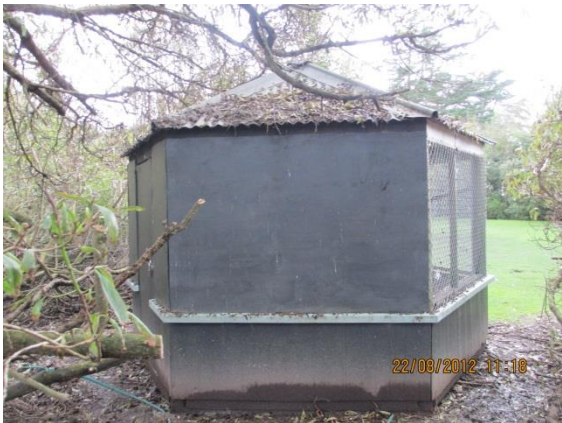
<p>Internal top view of the aviary complex.</p>

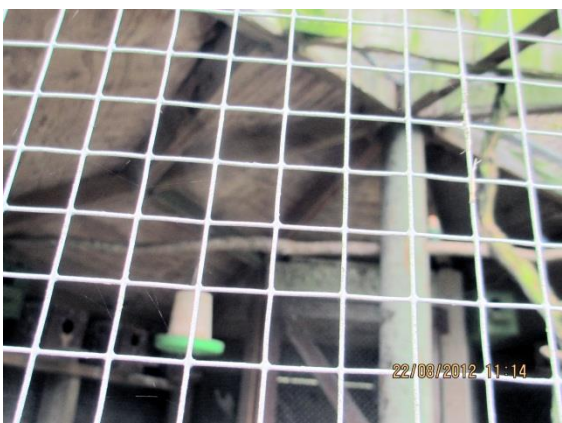
<p>Internal view of the aviary complex.</p>
