CHRISTCHURCH CITY COUNCIL  
PRK\_1124\_BLDG\_001 EQ2  
Selwyn Reserve – BLD 1 Toilets  
58 Brougham St, Addington

QUALITATIVE ASSESSMENT REPORT

FINAL

- Rev B
- 23 May 2013

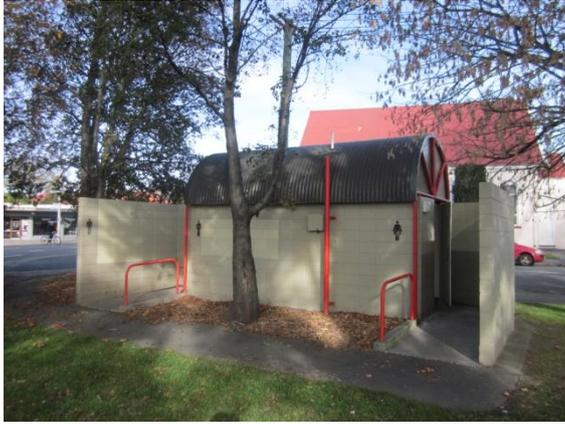
Photo 1: The north elevation of the building

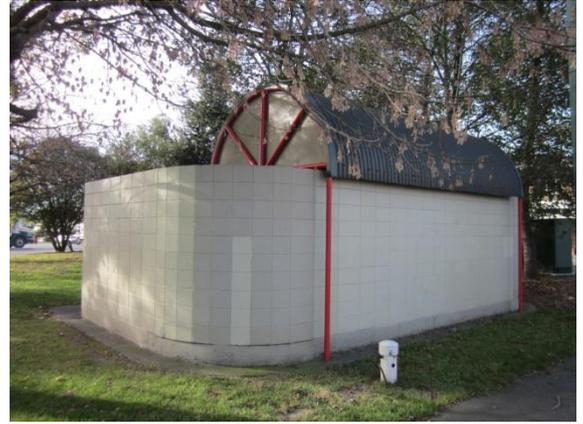
Photo 2: The west and south elevations of the building

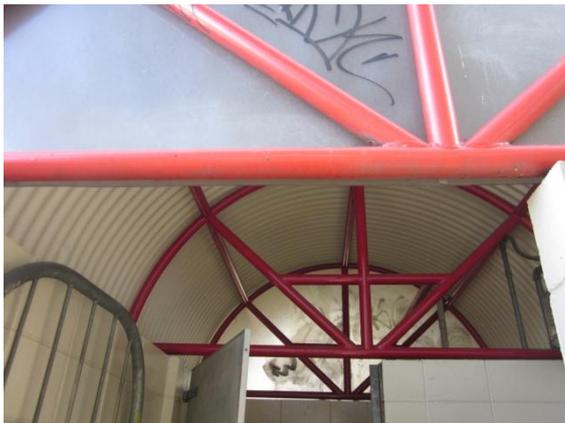
Photo 3: The steel canopy framing

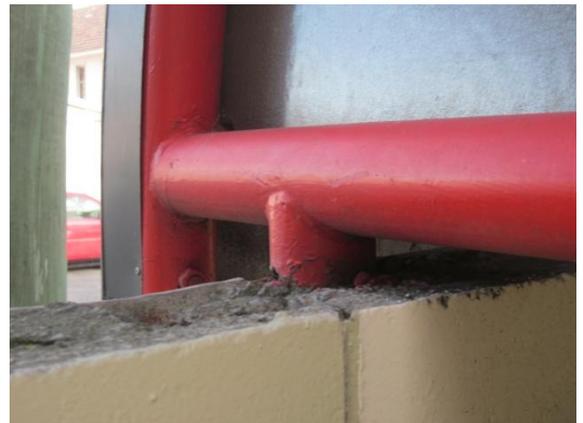
Photo 4: Detail of the steel posts cast in to the walls of the building

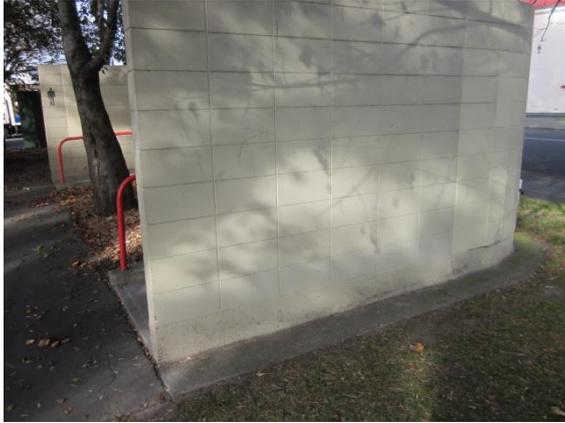
Photo 5: The narrow external concrete slab on the west, south and east sides of the building

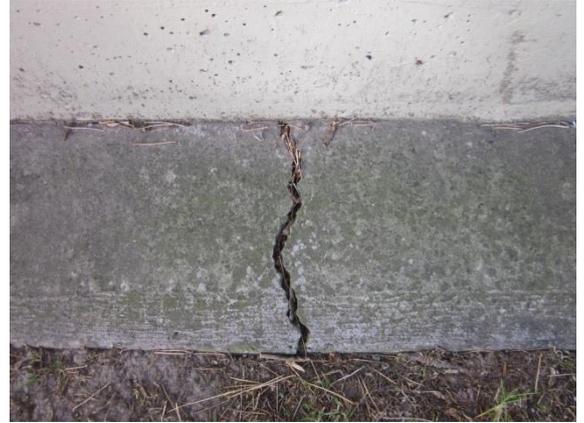
Some cracking was found in the external concrete slab around the perimeter of the building. The cracking looks to be existing and is likely to have been exacerbated by the recent earthquakes.

Photo 6: Existing cracking in the narrow slab that have been exacerbated by the recent seismic activity

<b>Recommendations</b>	Level of repair/strengthening required: <input type="text" value="minor non-structural"/>	Describe: <input type="text" value="Replacement of external concrete slab"/>
Building Consent required: <input type="text" value="no"/>		Describe: <input type="text"/>
Interim occupancy recommendations: <input type="text" value="full occupancy"/>		Describe: <input type="text"/>
Along	Assessed %NBS before: <input type="text" value="100%"/>	%NBS from IEP below
	Assessed %NBS after: <input type="text" value="100%"/>	If IEP not used, please detail assessment methodology: <input type="text" value="Qualitative Assessment carried out includes NZSEE IEP (refer to SKM report)"/>
Across	Assessed %NBS before: <input type="text" value="100%"/>	%NBS from IEP below
	Assessed %NBS after: <input type="text" value="100%"/>

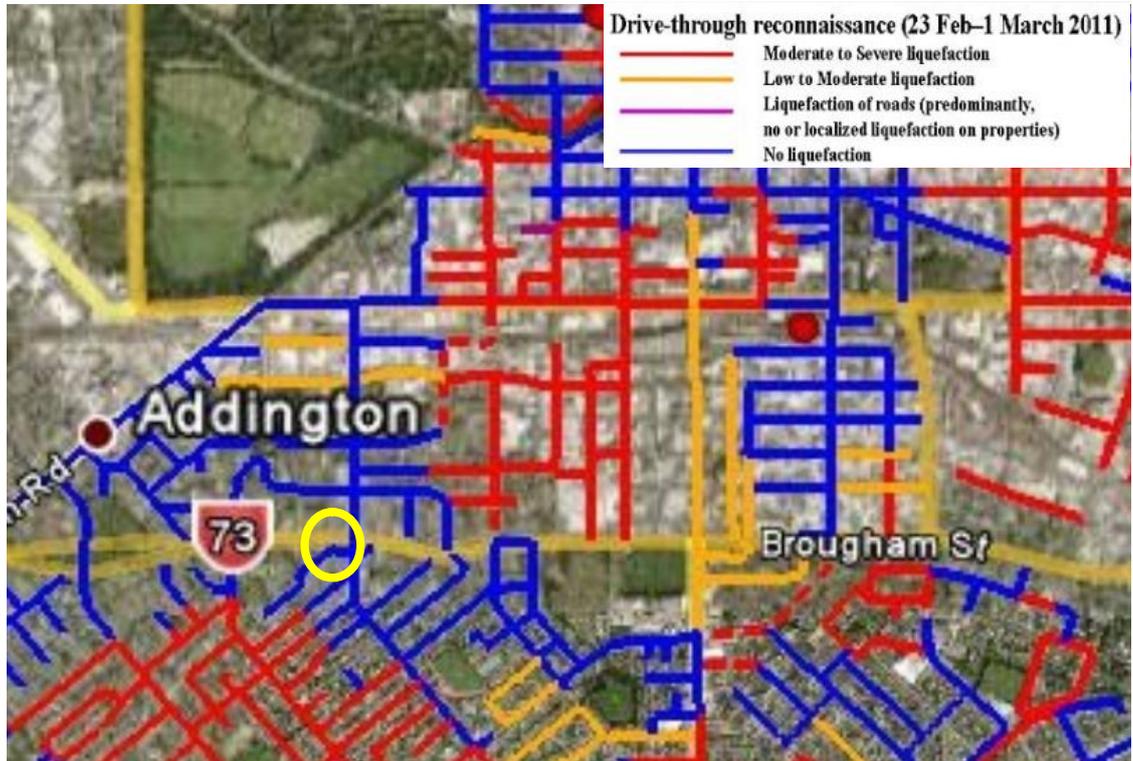
■ **Figure 4 – Liquefaction map (Cubrinovski & Taylor, 2011). Site marked in red.**

Following the 22 February 2011 event drive through reconnaissance was undertaken from 23 February until 1 March by M Cubrinovski and M Taylor of Canterbury University. Their findings show no liquefaction was noted near Selwyn Street and Somerset Crescent side of the site.

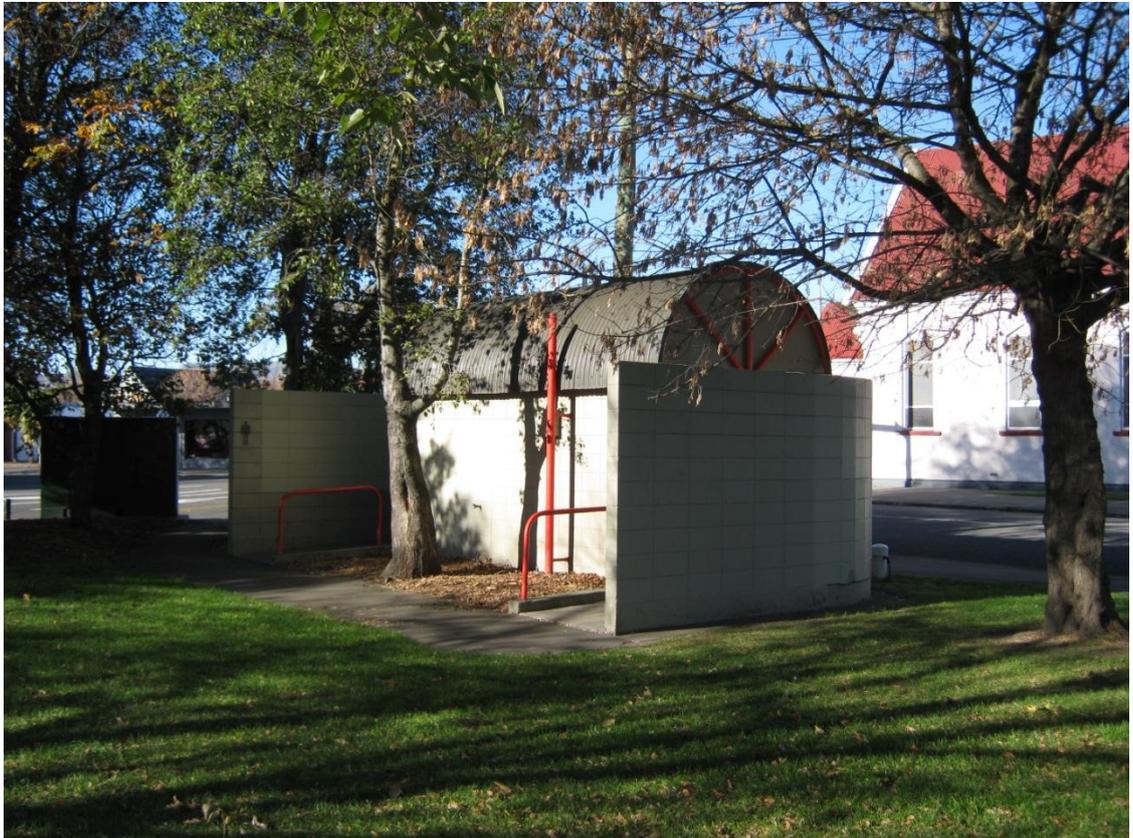
The structure was noted to be a concrete block construction with a concrete slab on grade foundation and metal roofing. The park ground area was undulating; however this is likely to be a landscaping feature. The surrounding road area was observed to be in good condition. Minor cracking of the park paths were noted, potentially due to ground motions experienced from the 22 February 2011 and other recent earthquakes.

No evidence of liquefaction or other land damage was apparent from the external site walkover.

■ **Figure 7 - Overview of the toilets and surrounding land area**

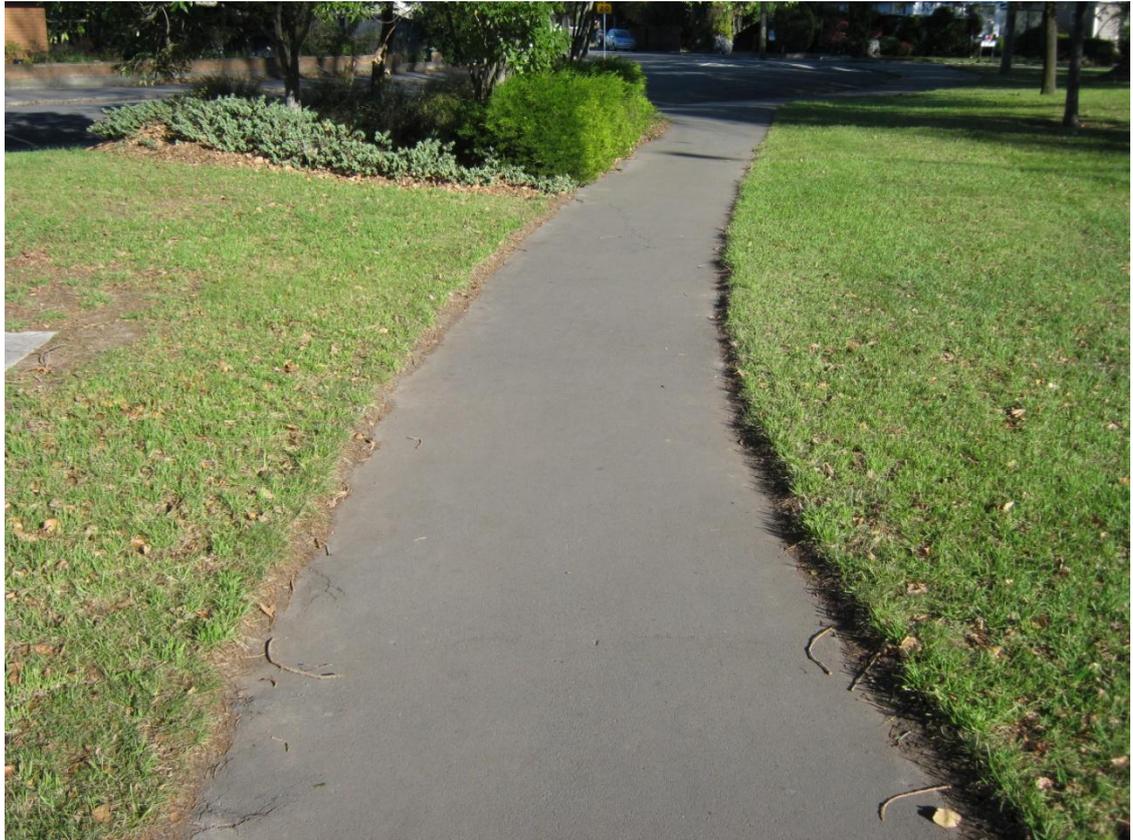
■ **Figure 8 - Minor cracking of the path asphalt surface**
