Christchurch City Council
PRK_1327_BLDG_002 EQ2
Toilet
179 Shaw Ave, New Brighton

QUANTITATIVE REPORT
FINAL

- Rev B
- 25 September 2013

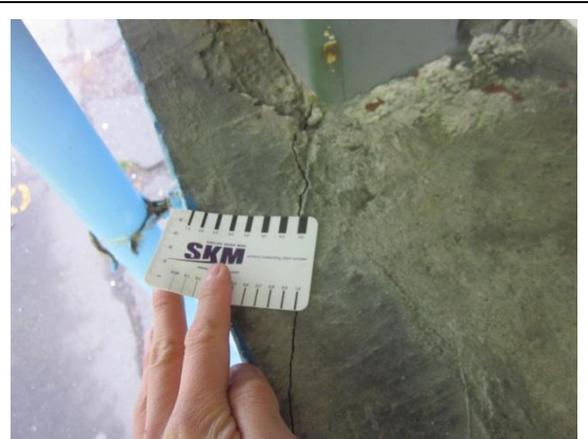
- 1) Minor step cracks in brick work on southeast corner (photo 20)
- 2) 1mm Crack beside RHS concrete connection on northeast corner (photo 18)

Photo 18: View of RHS column northwest corner (3) showing 1mm crack

- a) There is no damage to the building that would cause it to be unsafe to occupy.
- b) Damage is repaired using acceptable crack injection methods.
- c) Barriers around the building are not necessary.

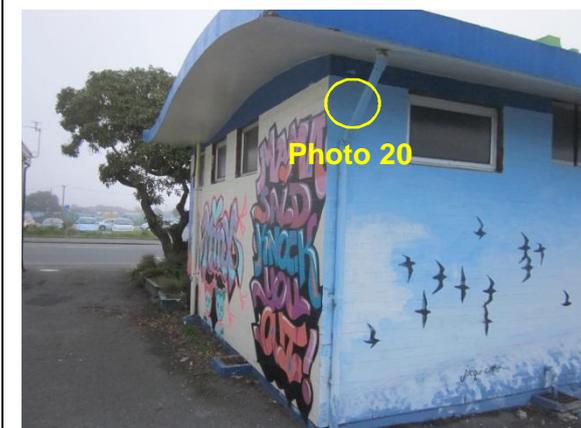
Photo 19: View of southeast corner of building

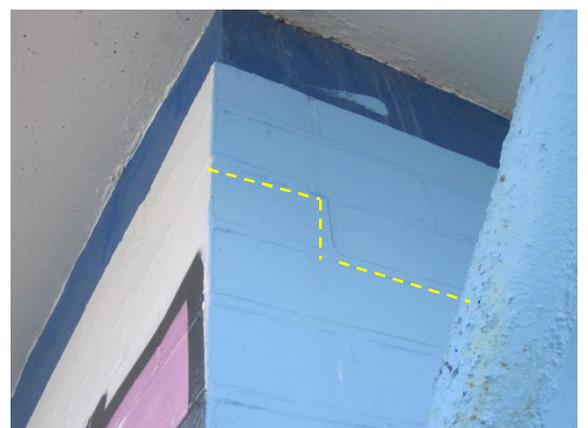
Photo 20: Close up view from photo 19 showing minor step cracks
