**Sign of the Kiwi Rangers House
PRK 1823 BLDG 001 EQ2**
Detailed Engineering Evaluation
Qualitative Report
Version FINAL

Corner of Summit and Dyers Pass Roads

Christchurch City Council

Date
6/11/ 2012

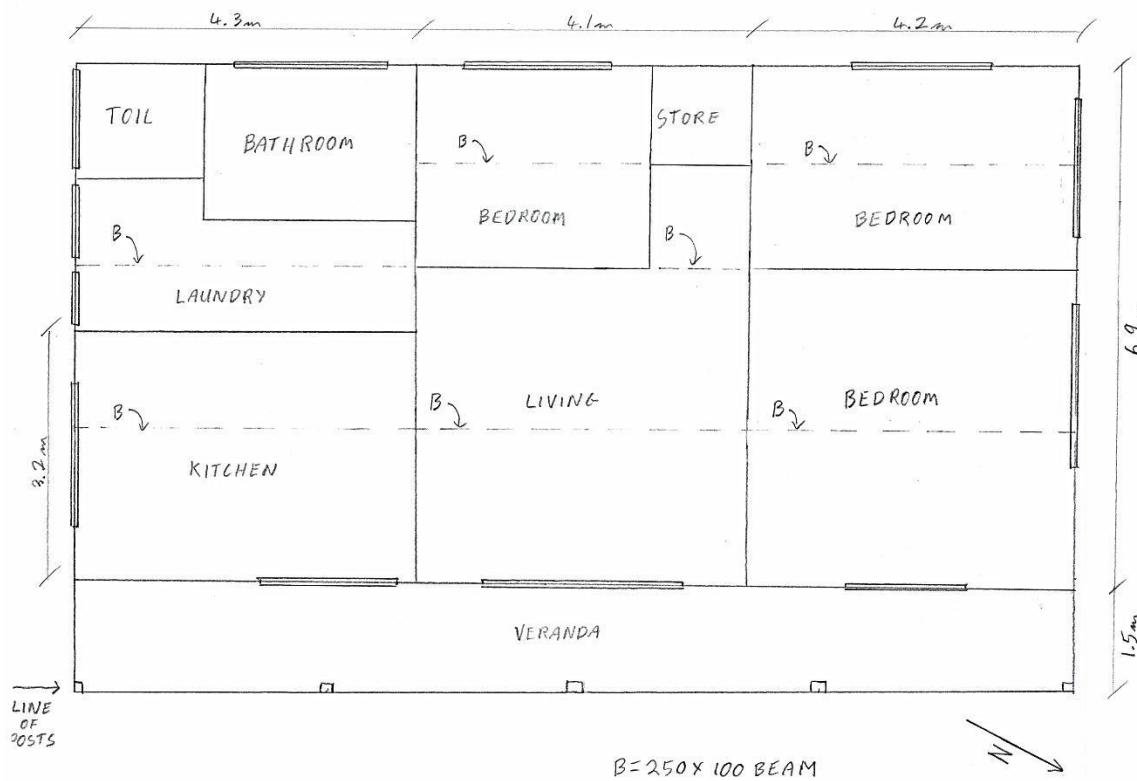
Figure 2 Plan Sketch Showing Structural Layout

The building is a single level structure formed from laminate timber and was constructed from kitset manufactured by "Fraemohs". Walls are formed by stacking members, seated by tongue and groove, into post tensioned panels which interlock at wall intersections. Wall construction is consistent throughout. The roof consists of metal cladding over an interlocking timber ceiling, supported by walls and beams. Ground floor is formed by tongue and groove on joists, supported by bearers and subsequently timber piles.

The building is approximately 12.6m in length by 6.9m in width, with an additional 1.5m of veranda along the front of the structure. The apex sits 3.5m above floor level, with a further 1m to ground level. The

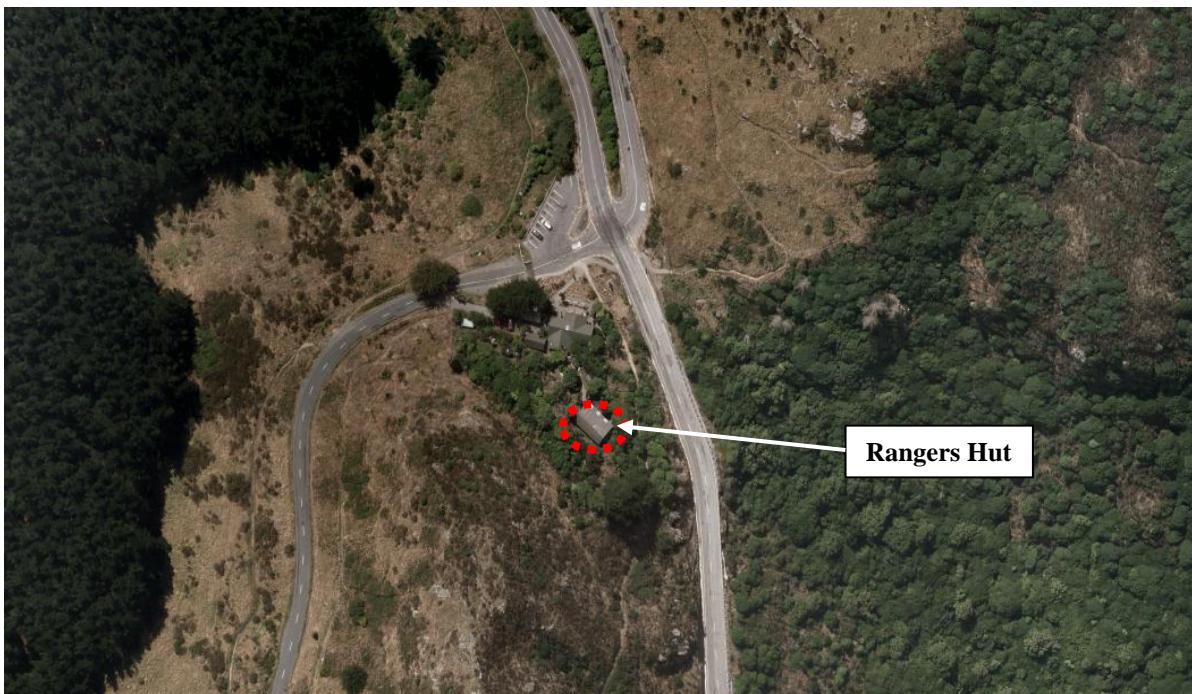
Figure 3 Post February 2011 Earthquake Aerial Photography²

Aerial photography taken following the 22 February 2011 earthquake shows no signs of liquefaction outside the building footprint or adjacent to the site, as shown in Figure 3.

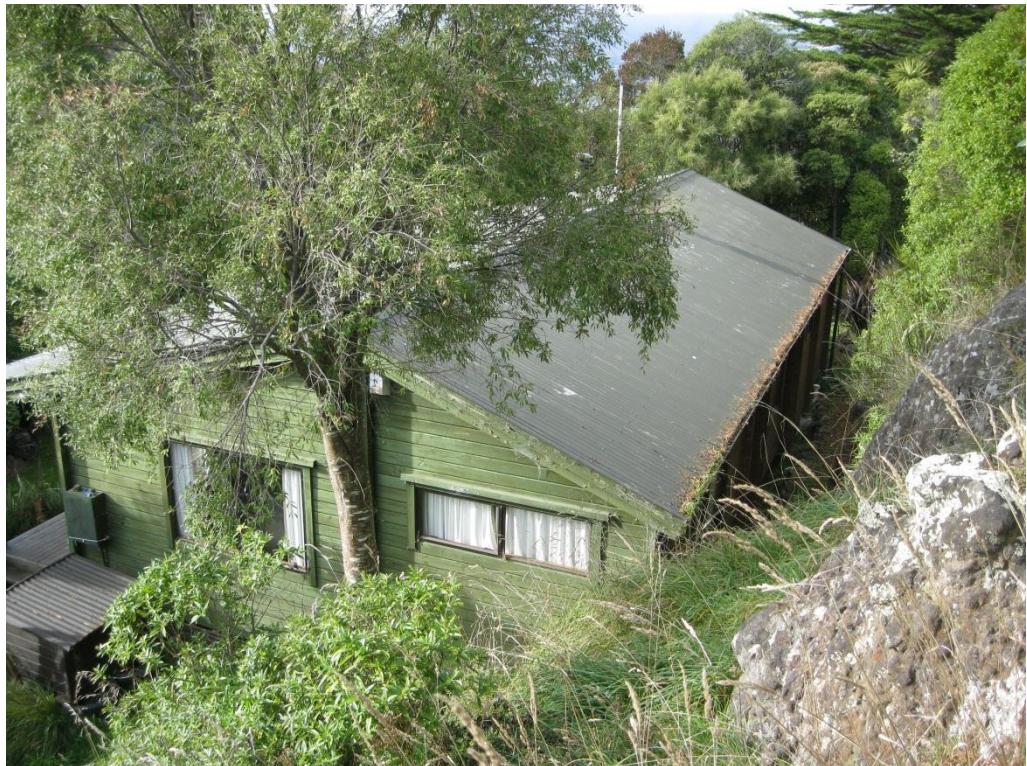
The topography of the site and presence of discontinuous bluffs above create a potential rockfall hazard. Several fallen boulders have been mapped on the hillside above the site.

Photograph 3 View from slope above(Potential rockfall hazard in foreground).

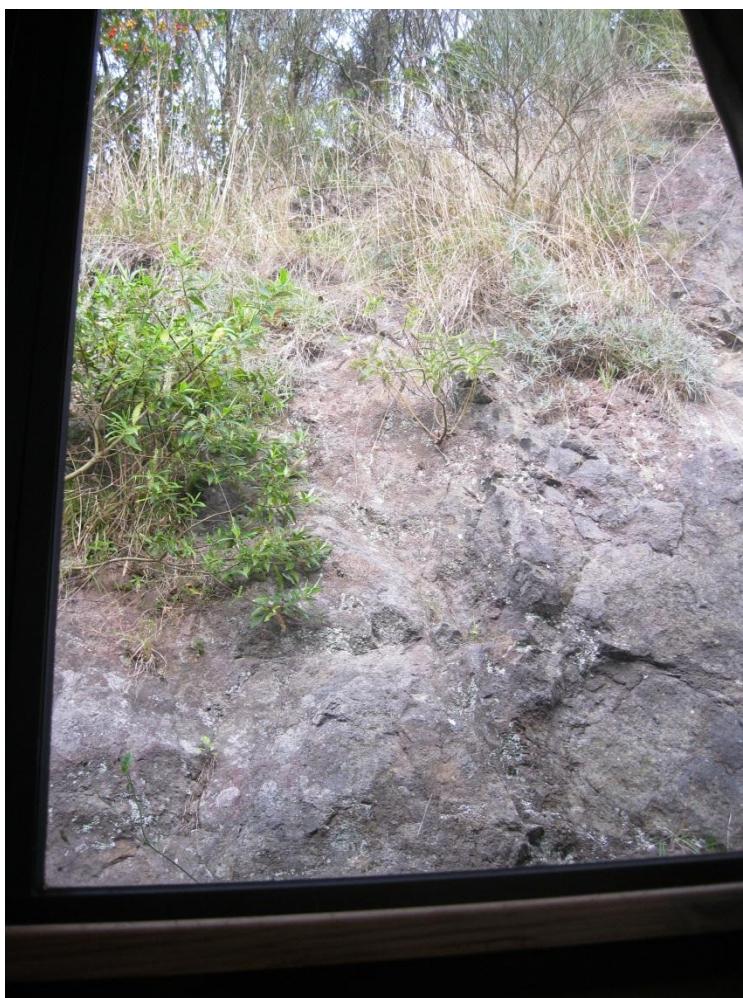
Photograph 4 View of cut face from interior.

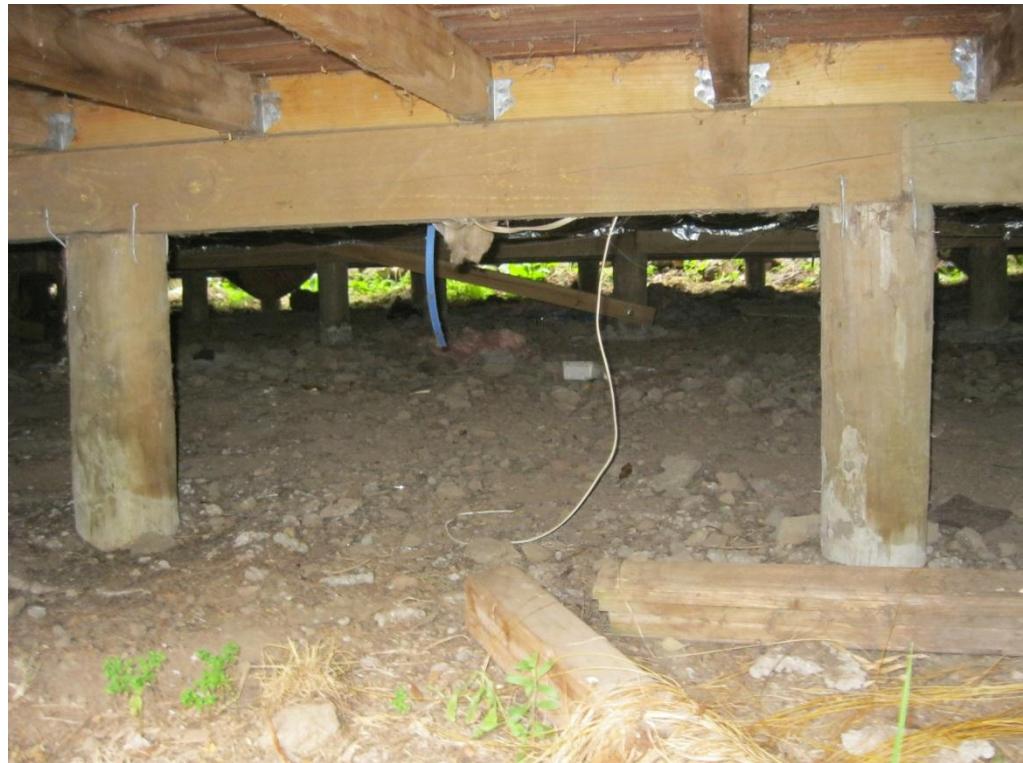
Photograph 5 Braced pile to the rear.

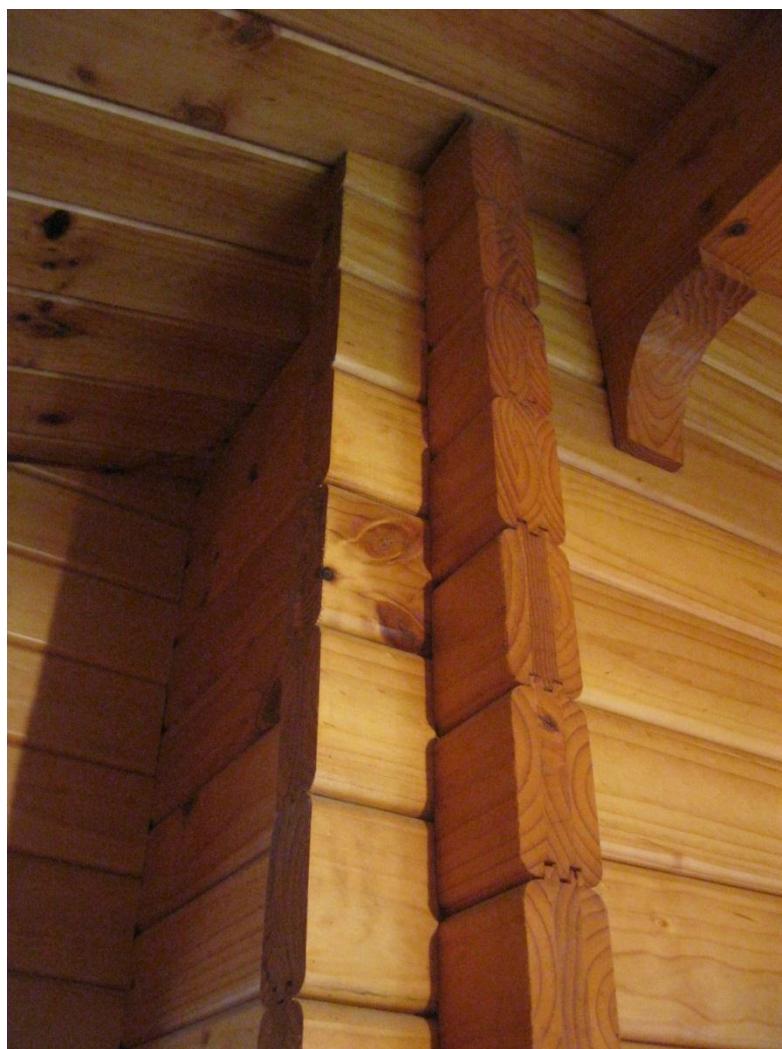
Photograph 6 Laminate timber panels interlocking at corner / roof beam seen above.
