Sir John McKenzie Memorial  
Library  
Qualitative Engineering Evaluation

**Reference:** 228361  
**Prepared for:**  
Christchurch City Council

**Address:** 393 Riccarton Road

**Revision:** 2  
**Date:** 18 December 2012

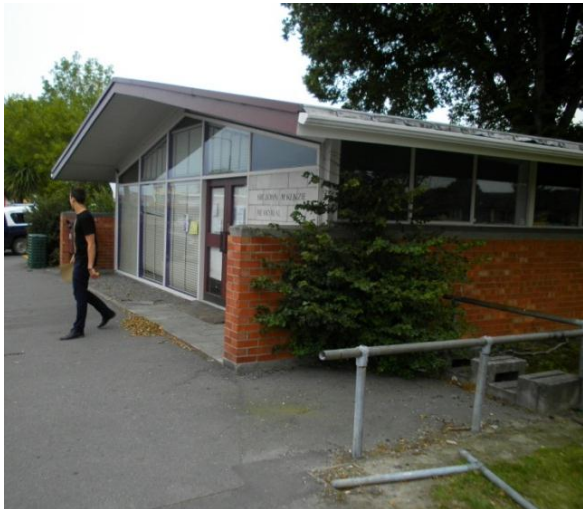
<p>West elevation of the Sir John McKenzie Memorial Library.</p>

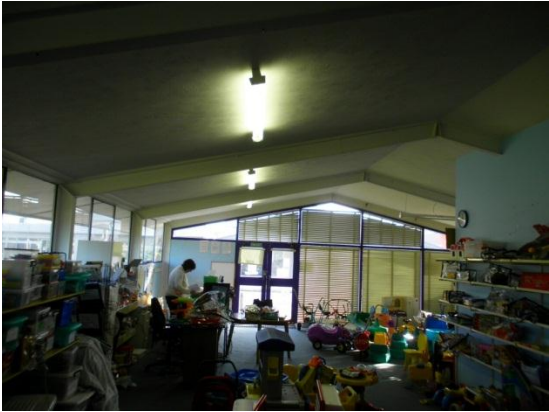
In general damage observed to Sir John McKenzie Memorial Library was of a minor nature. All the observed damage was located in the brittle double brick side walls and slab at the junction between the old part of the library and where the later addition connects to it. The most significant damage observed was to the double brick side walls and this consisted of a crack in the joint where the wall has been extended for the addition. At the same point on the interior a step occurs all the way across the floor slab for the library. This step may have been present prior to the quakes but according to library staff it has been worsened by the shakes.

<p>Crack in double brick perimeter wall at joint to extension.</p>

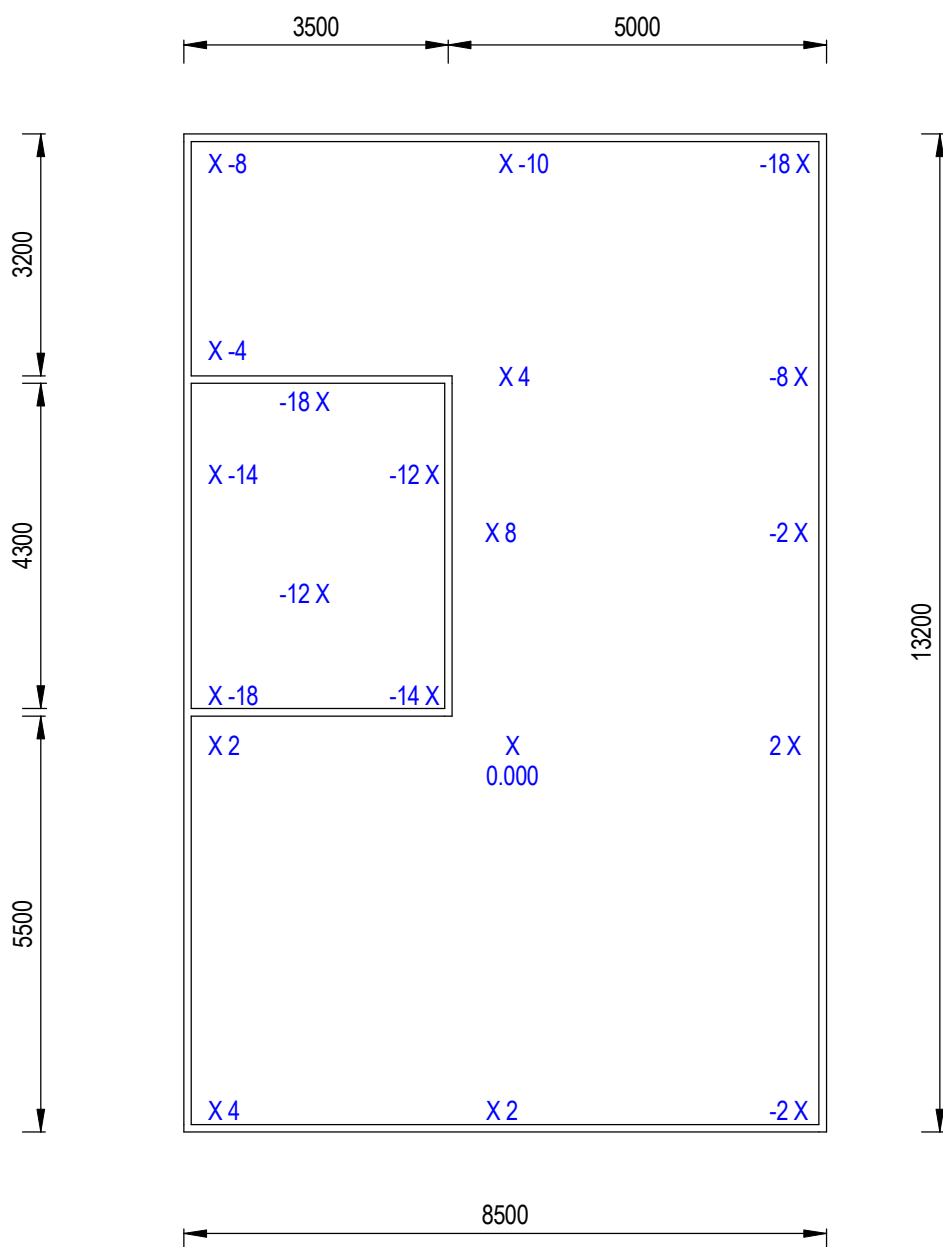
PROJECT
SIR JOHN MEMORIAL LIBRARY 393 RICCARTON ROAD
TITLE
LEVEL SURVEY

A floor level survey was undertaken to establish the level of unevenness across the floors. The results of the survey are presented on the attached sketch in Appendix A. All of the levels were taken on top of the existing floor coverings which may have introduced some margin of error.

The results from the levels survey indicate that the floor levels are within the above guidelines.
