Sir John McKenzie Memorial
Library
Qualitative Engineering Evaluation

Reference: 228361
Prepared for:
Christchurch City Council

Functional Location ID: BU 1525 001 EQ2

Date: 18 December 2012

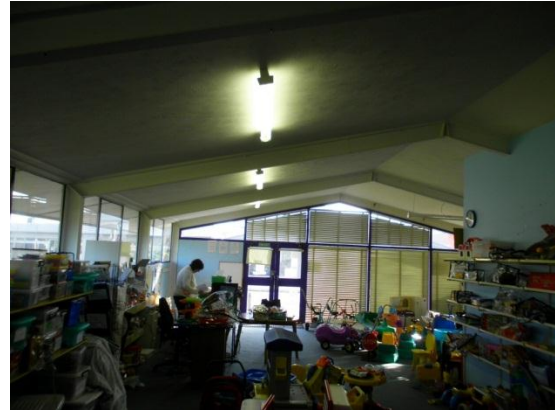
In general damage observed to Sir John McKenzie Memorial Library was of a minor nature. All the observed damage was located in the brittle double brick side walls and slab at the junction between the old part of the library and where the later addition connects to it. The most significant damage observed was to the double brick side walls and this consisted of a crack in the joint where the wall has been extended for the addition. At the same point on the interior a step occurs all the way across the floor slab for the library. This step may have been present prior to the quakes but according to library staff it has been worsened by the shakes.

Crack in double brick perimeter wall at joint to extension.

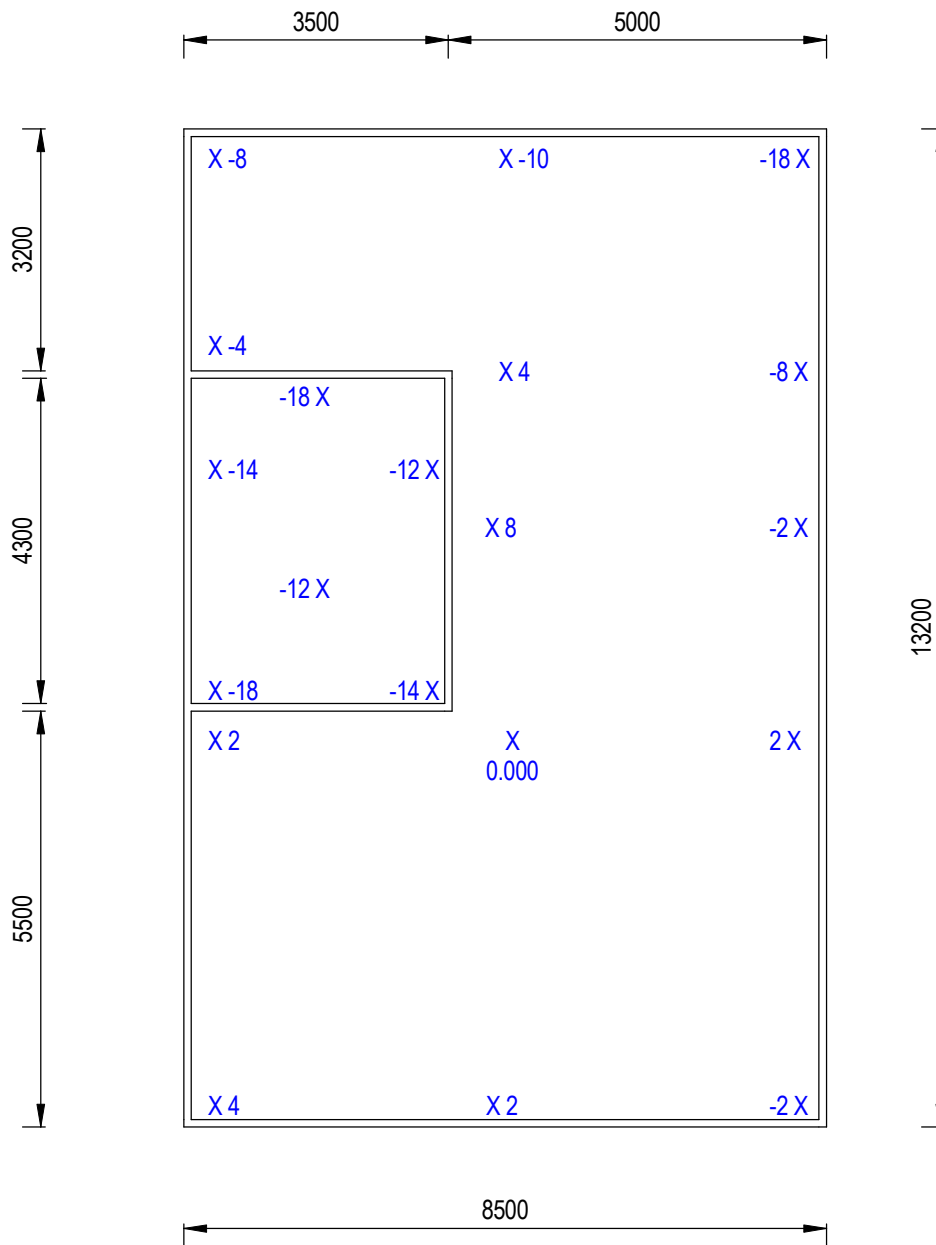
PROJECT
SIR JOHN MEMORIAL LIBRARY 393 RICcarton ROAD
TITLE
LEVEL SURVEY

The results from the levels survey indicate that the floor levels are within the above guidelines.
