Project: Sockburn Creche
Qualitative Engineering Evaluation

Prepared for: Christchurch City Council

Date: 15 October 2013

Building Name : Sockburn Creche

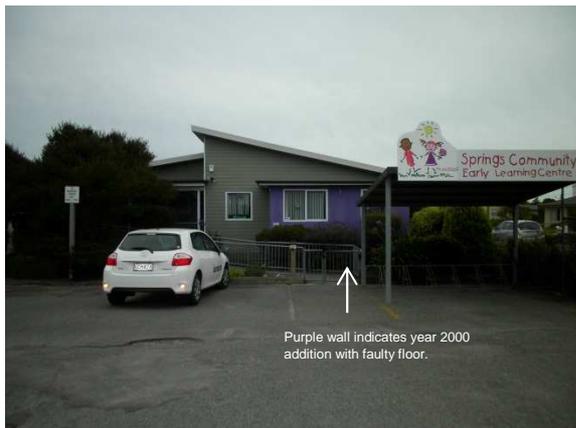
Building consent records indicate that in the year 2000 a small addition to the south west corner of the building was constructed. An image of the plans is attached in Appendix A. It was noted on site that the floor for this area was very soft and that there was a noticeable step between the original floor and the addition. Subfloor framing in this was visible and it appears that the floor joists for the addition are inadequately supported and have come loose due to the earthquakes.

Purple wall indicates year 2000 addition with faulty floor.

Damage and loss of support to the floor of the addition in the south west corner of the building has occurred. It is recommended that a new bearer and new piles are installed to reinstate support and bring the floor back to level.

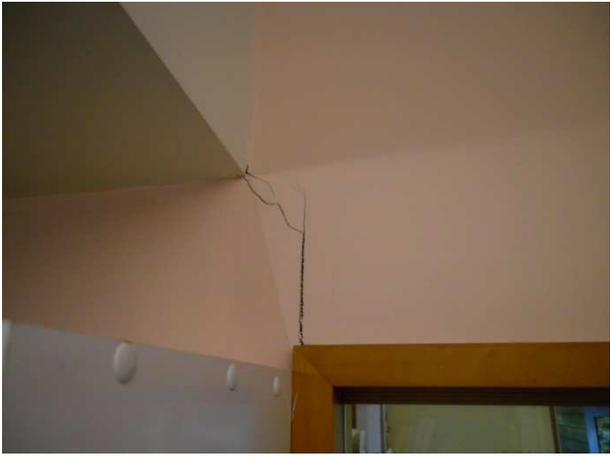
Minor cracking to the gypsum wall board linings is not considered significant and will not greatly reduce the buildings capacity to resist lateral loads.

Crack adjacent to door opening in office.

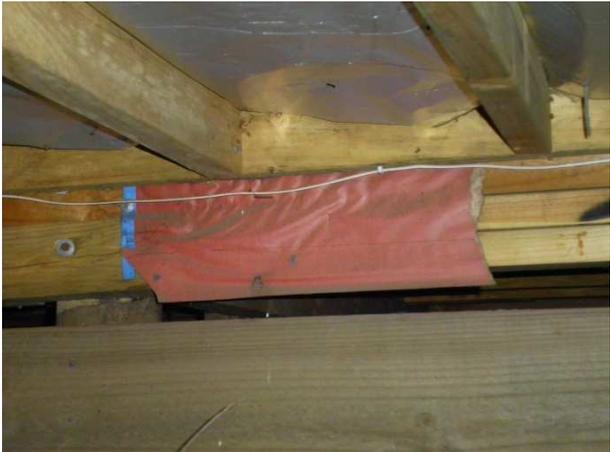
The partial failure of support for the floor for the addition in the southwest corner of the building, in addition to the earthquakes, is due to poor structural documentation and poor construction. It appears that the joists for the addition have relied on the existing structure for support and yet the connection to the structure was not specified. Inadequate support installed by the builders has failed allowing the floor to sag.

Sagging floor structure below office at south end.

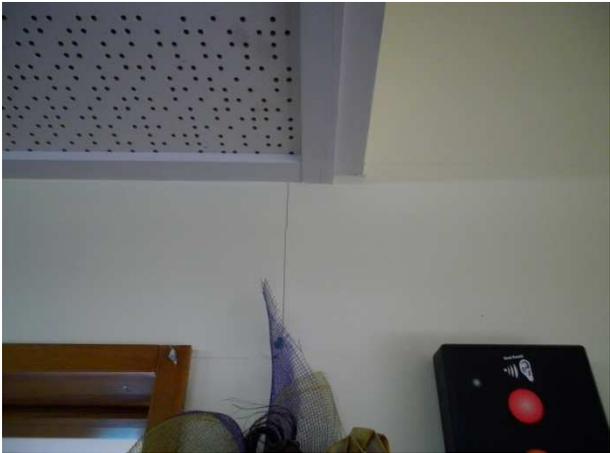
As noted above the Sockburn Creche is a single story, lightweight timber structure with simple and well defined load paths. This is a building type and configuration that can be resilient and appears to have performed well during the Canterbury Earthquakes to date. The building has a ductile failure mechanism laterally where loads are resisted by gypsum lined timber walls. Loads are transferred to the walls from the roof by the ceiling diaphragm. This mechanism is somewhat inhibited by the fact that the ceiling diaphragm for Building A does not extend its full length.

Vertical crack in wall at end of ceiling diaphragm Building A

The ceiling diaphragm for Building A terminates 6.0m short of the northern end of the structure. It is recommended that, as part of any strengthening measures, the ceiling diaphragm is extended the full length of the building.
