**Sockburn Depot – North East End Store**  
**BU 1531-008 EQ2**  
**Detailed Engineering Evaluation**  
**Quantitative Assessment Report**  
**CHRISTCHURCH CITY COUNCIL**

# Sockburn Depot – North East End Store Detailed Engineering Evaluation Quantitative Assessment Report

Date: September 2012  
Reference: 6-QUCCC.68  
Status: Final

149 Main South Road, Christchurch,

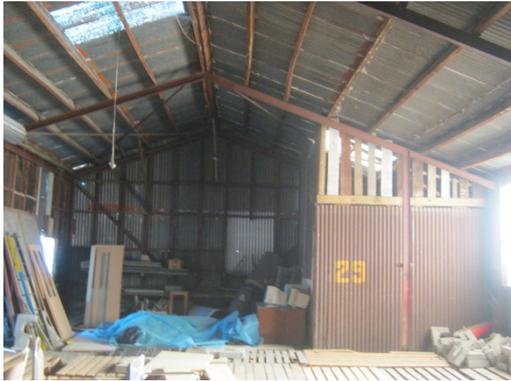
<p>4.</p>	<p>Internal view of the north end wall</p>

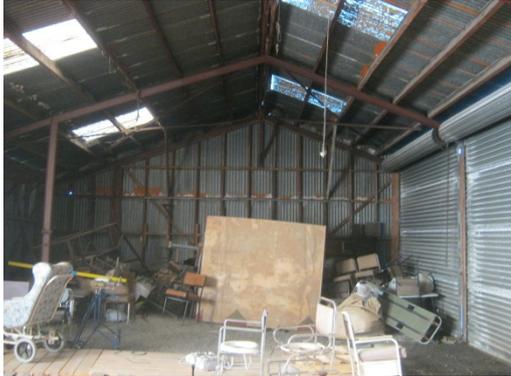
<p>5.</p>	<p>Internal view of the south wall</p>

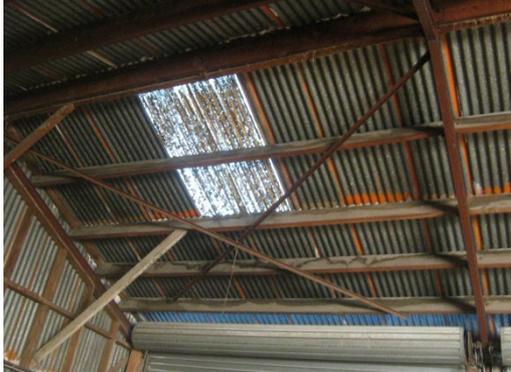
<p>6.</p>	<p>Diagonal roof bracing (note they are cut off to allow installation of the roller door)</p>

- a) Repairing the timber frame iron-clad walls, and upgrading of the diagonal wall bracing members for resisting north-south loads.
- b) Improving the diagonal roof bracing, particularly where member elongation has occurred, to reinstate the load path.
- c) Investigation of the foundations and possible strengthening if required.

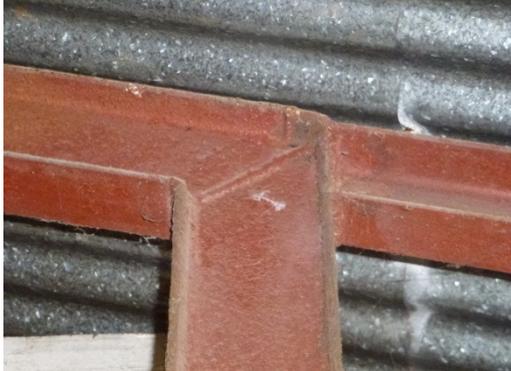
<p>7.</p>	<p>Portal Knee detail (east side) – Tapered Flange Beam (125TFB) with Parallel Flange Channel (100PFC)</p>

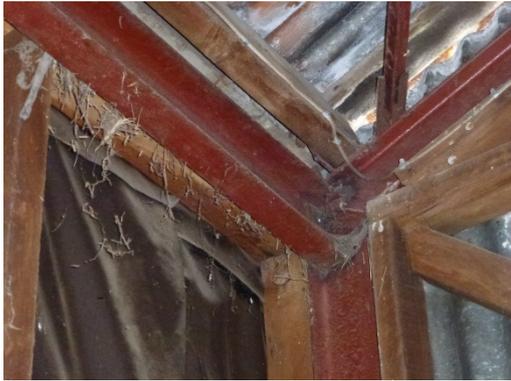
<p>8.</p>	<p>Portal Knee detail (north west end) – Tapered Flange Beam Portal (125TFB) with Parallel Flange Channel Chord (150PFC) and Equal Angle Roof Brace (EA50x50)</p>

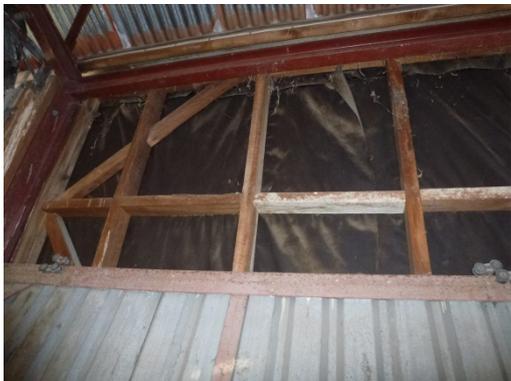
<p>10.</p>	<p>Timber framing with diagonal wall bracing</p>

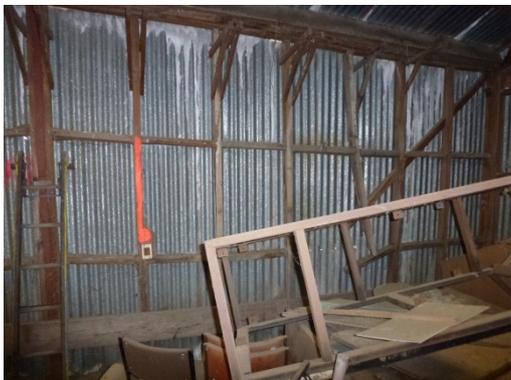
Some historical damage to the wall cladding and timber bracing struts was observed. We note that this damage has compromised the load path for resisting north-south lateral loads.

Due to damage to the diagonal bracing elements in the eastern wall, the north-south lateral loads must be resisted by the portal frame columns bending out-of-plane. Due to the small column size this results in excessive longitudinal displacements. The foundation details for these columns are unknown.

<p>11.</p>	<p>Timber framing with discontinuous/insufficient diagonal wall bracing</p>
