**Sockburn Service  
Centre  
PRO 1531-005**

**Detailed Engineering Evaluation  
Quantitative Assessment Report**

**149 Main South Road**

Date: January 2014  
Reference: 6-QUCCC.68  
Status: Final – Revision B

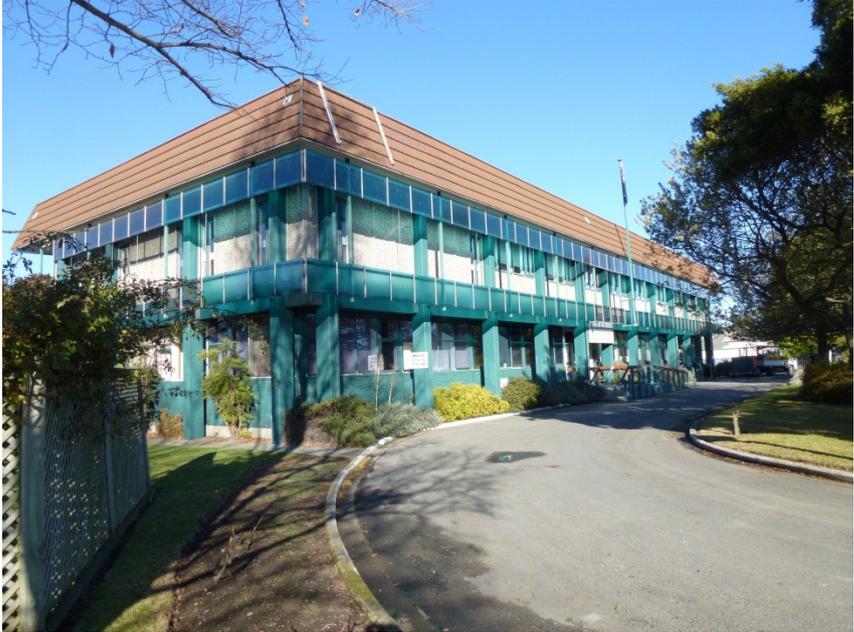
CCC Sockburn Service Centre - Main South Road		
No.	Item description	Photo
1.	Front view of building, looking south

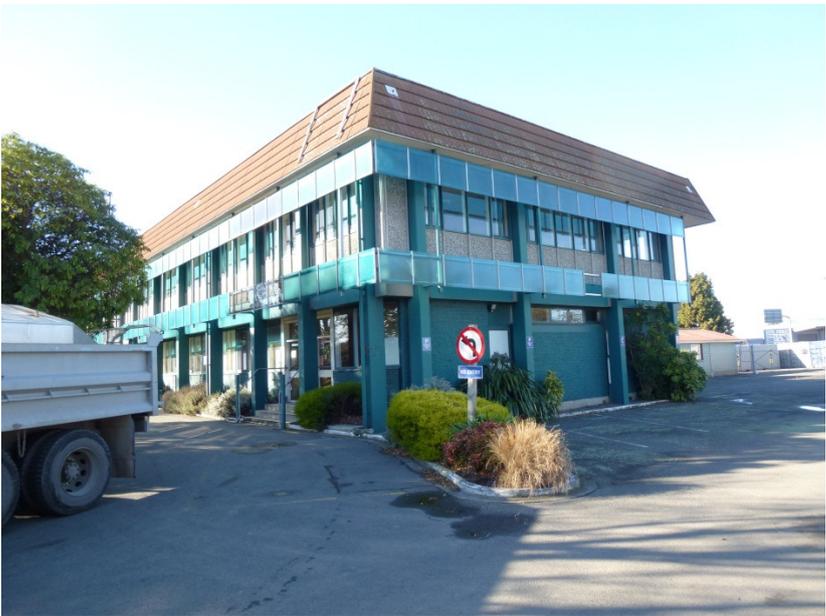
2.	Front view of building, looking east

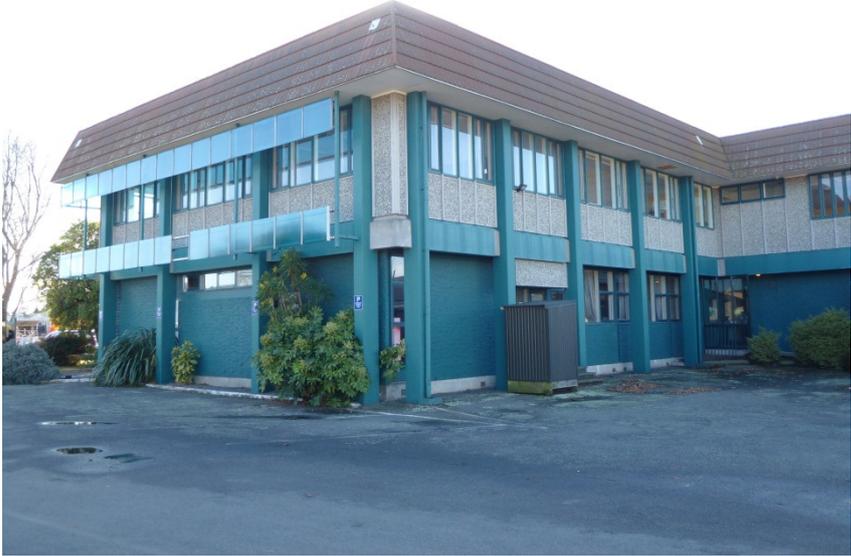
<p><b>3.</b></p>	<p>Rear view of building, looking north</p>

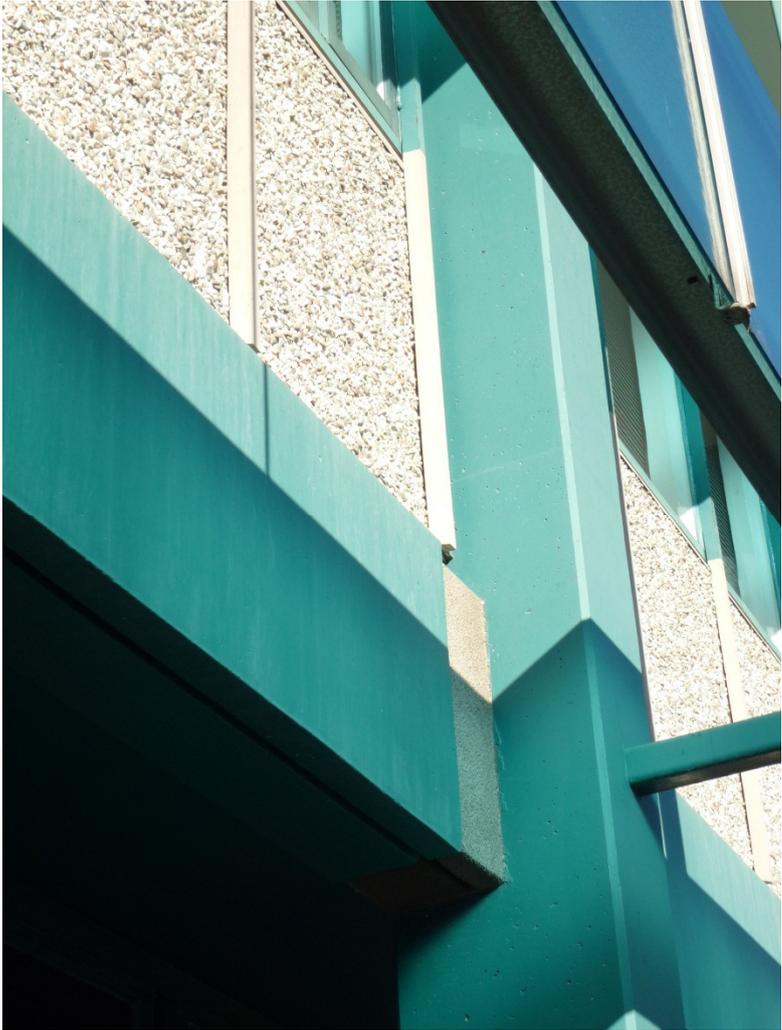
- b) At the first floor of the perimeter concrete frames, the beams are connected to the column with a welded reinforcement detail at the top and bottom of the beams. Therefore, a brittle failure could occur at these joints, leading to sudden collapse of portions of the roof and floor structure. At larger force levels, this could result in total collapse of the building.

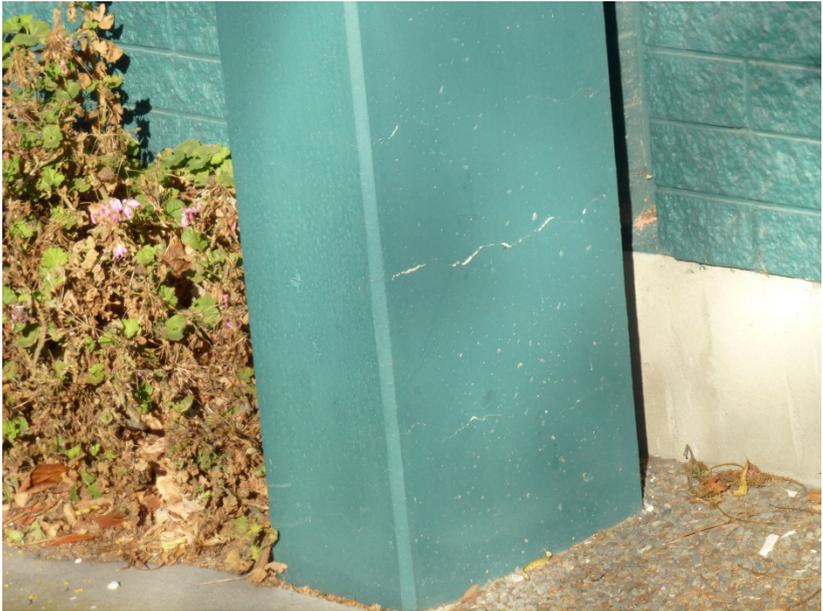
Cracks in the concrete columns were observed at several locations, typically near the bottom of the column; refer to Photographs 5 and 6 of Appendix 1. Cracks and spalling of the corner of the concrete strong room are seen in Photographs 7 and 8. Shoring is currently in place at this location.

<p><b>5.</b></p>	<p>Example of crack in concrete column. This column is on the north east side of the building</p>

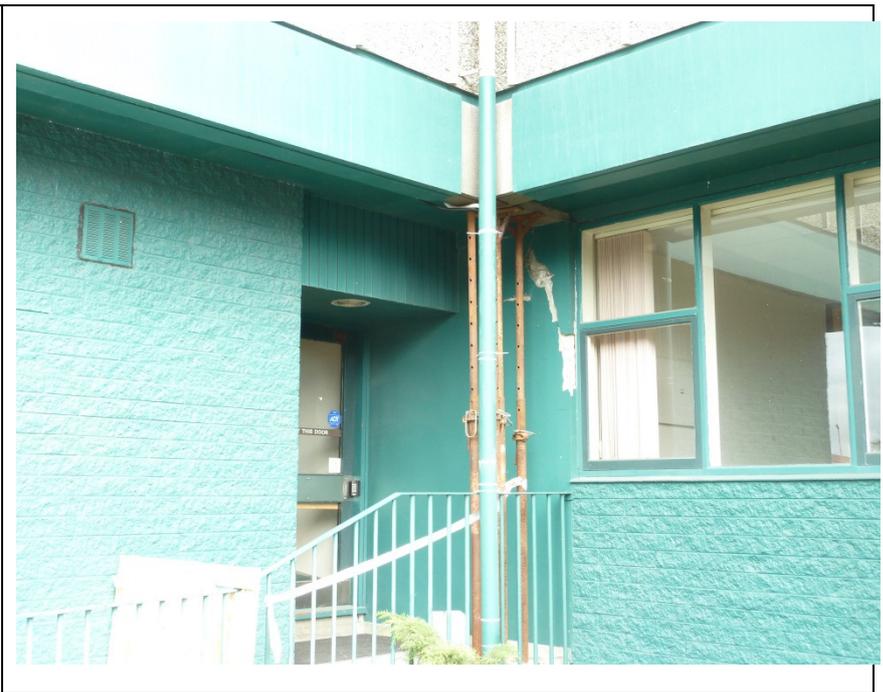
<p><b>7.</b></p>	<p>Cracks in corner of Strong Room at southeast entrance</p>

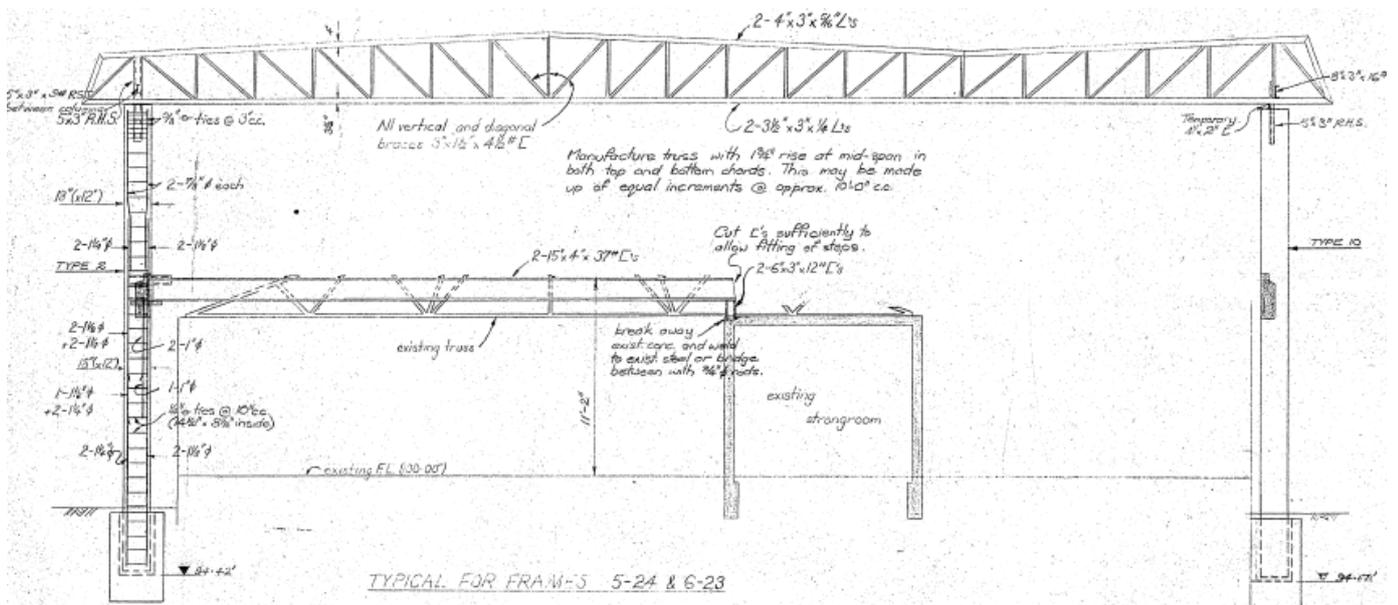
Figure A2-4 Structural building section at strong room

- a) The connections of structural elements at the first floor to the tops of the strong room walls have an apparent small amount of weld. As the strong room walls are much stiffer than the perimeter concrete frames, these connections will attract a large percentage of the seismic forces until their capacity has been exceeded. The failure mode is likely to be sudden and brittle. Once the capacity has been exceeded, further horizontal drift could result in localised collapse of the central section of the first floor structure.
