Somerfield Playcentre Building
BU 1129-002 EQ2
Detailed Engineering Evaluation
Quantitative Report
Christchurch City Council

Detailed Engineering Evaluation Quantitative Report

Date: October 2012
Reference: 6-QUCCC.59
Status: Final

47 Studholme Street, Somerfield, Christchurch

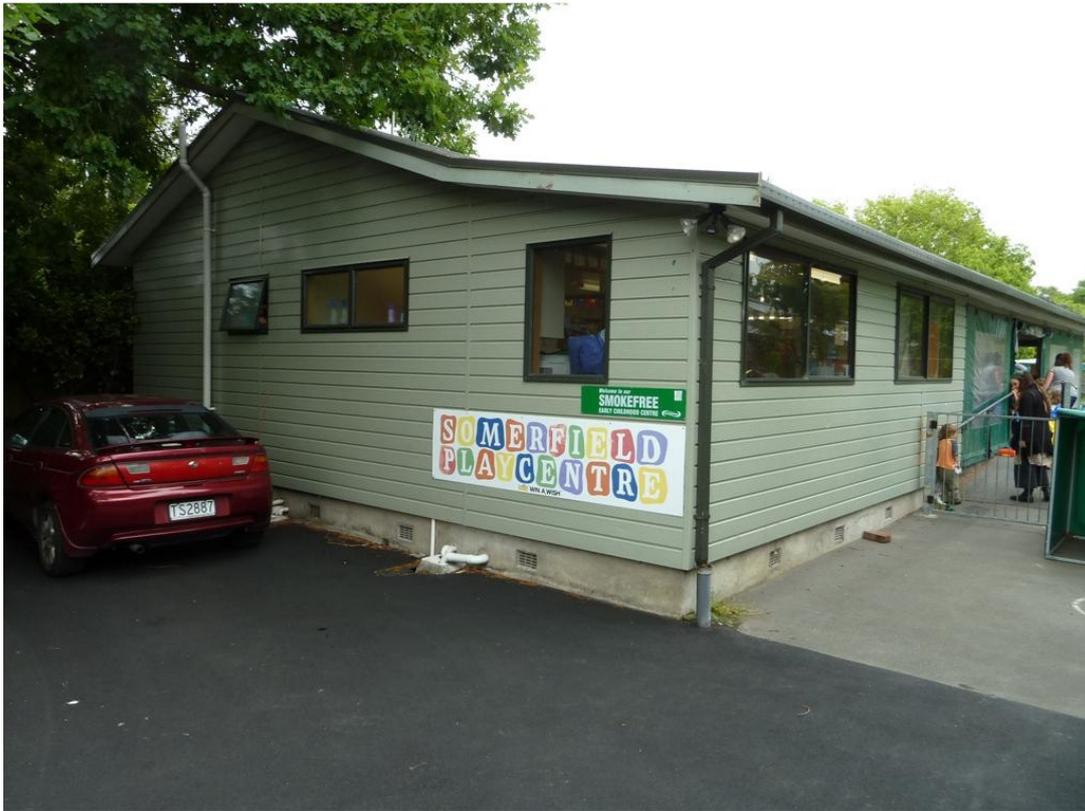
Photo 1 – South-east elevation of building

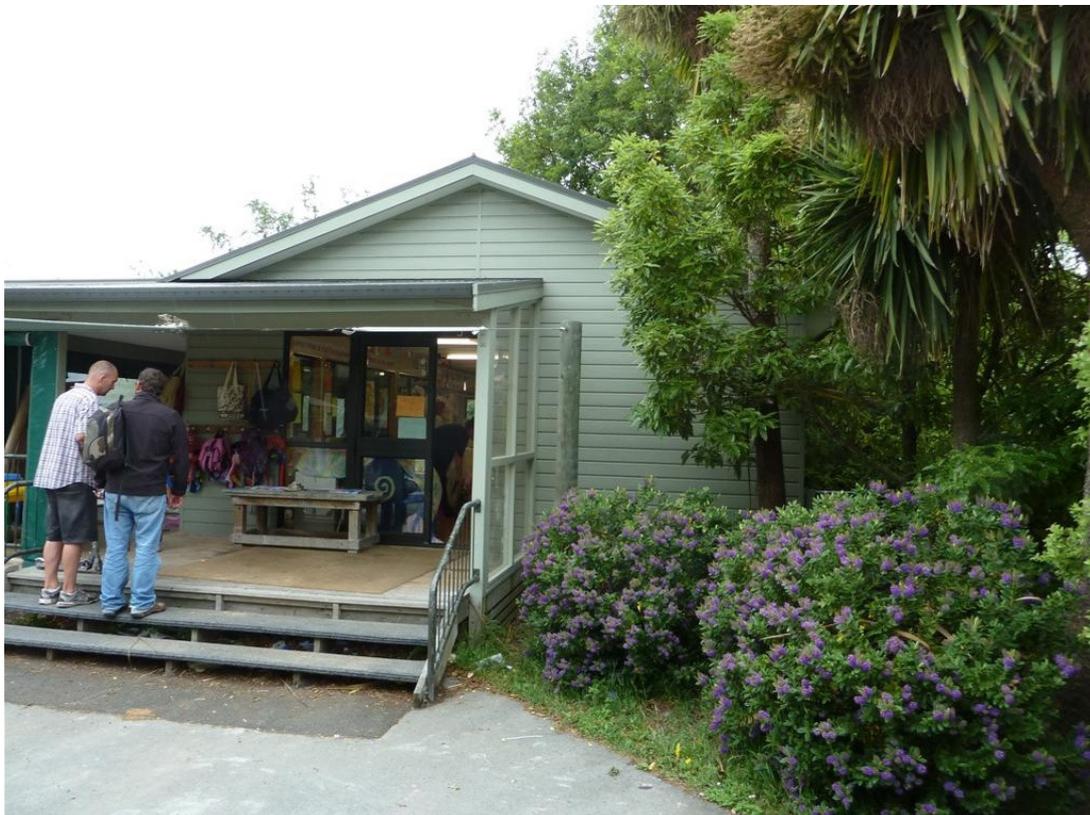
Photo 2 – North-west elevation of building

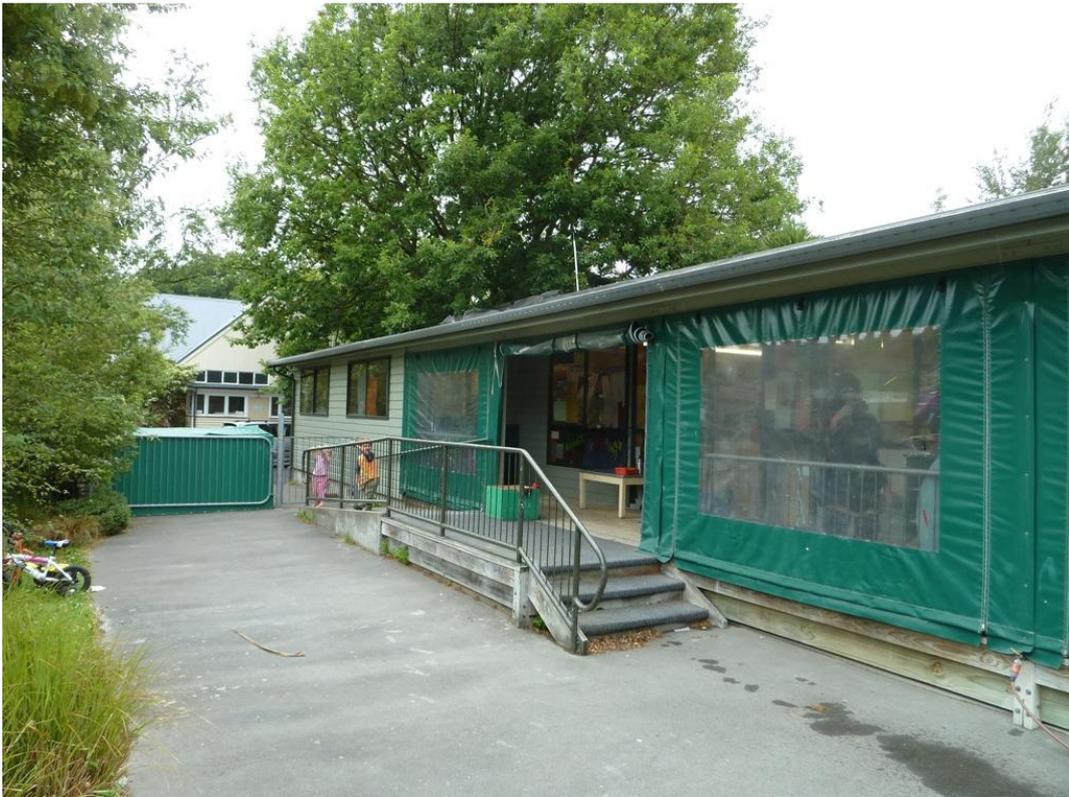
Photo 3 – North-east elevation of building

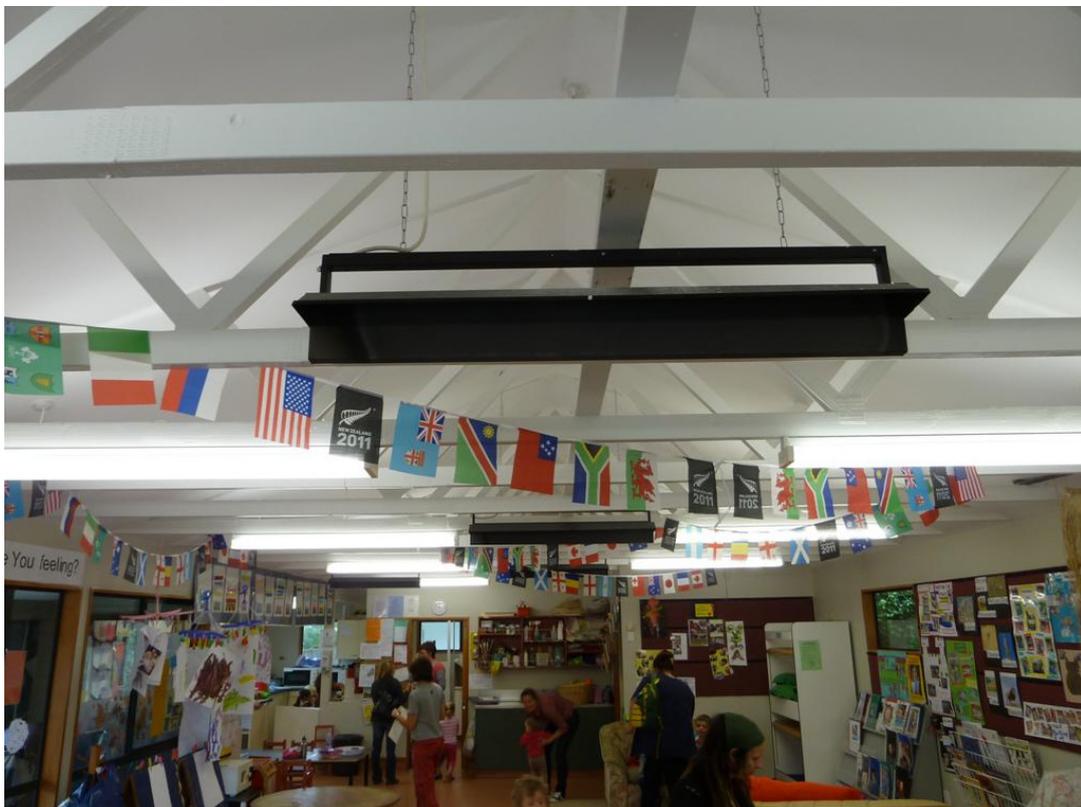
Photo 4 – Exposed truss arrangement in the main play room of the building

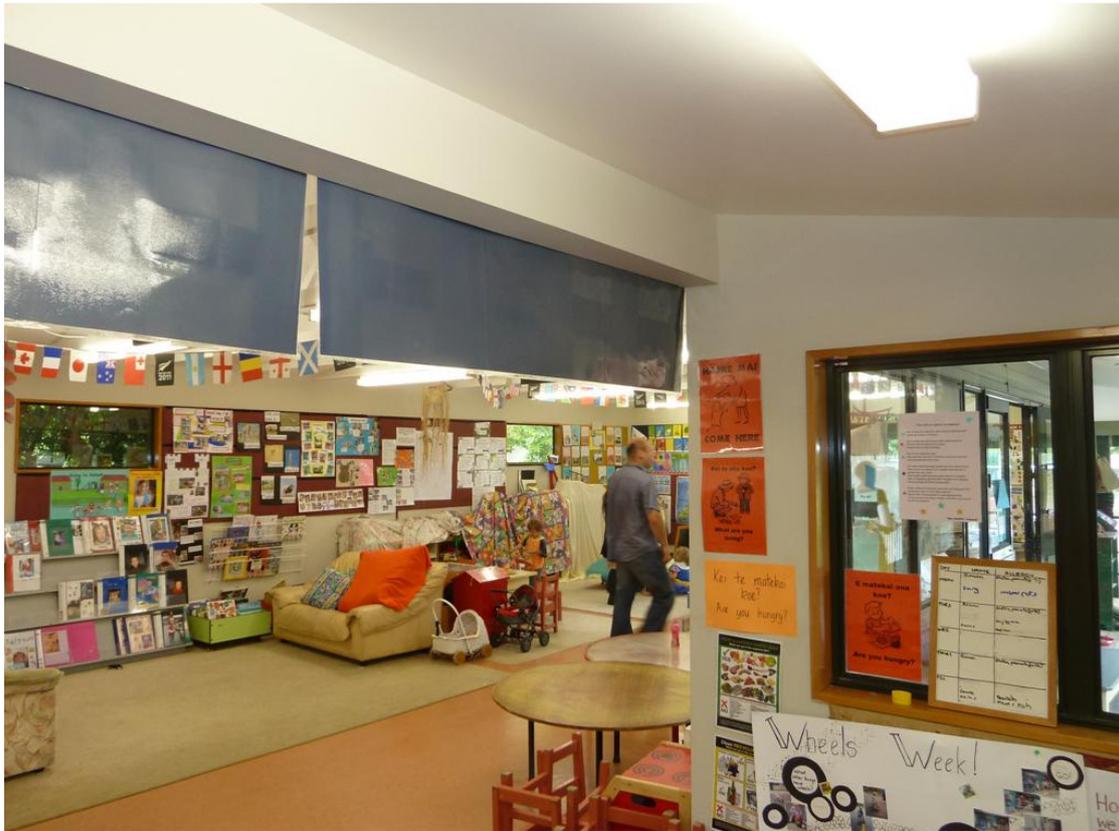
Photo 5 – Internal view from the play / eating area

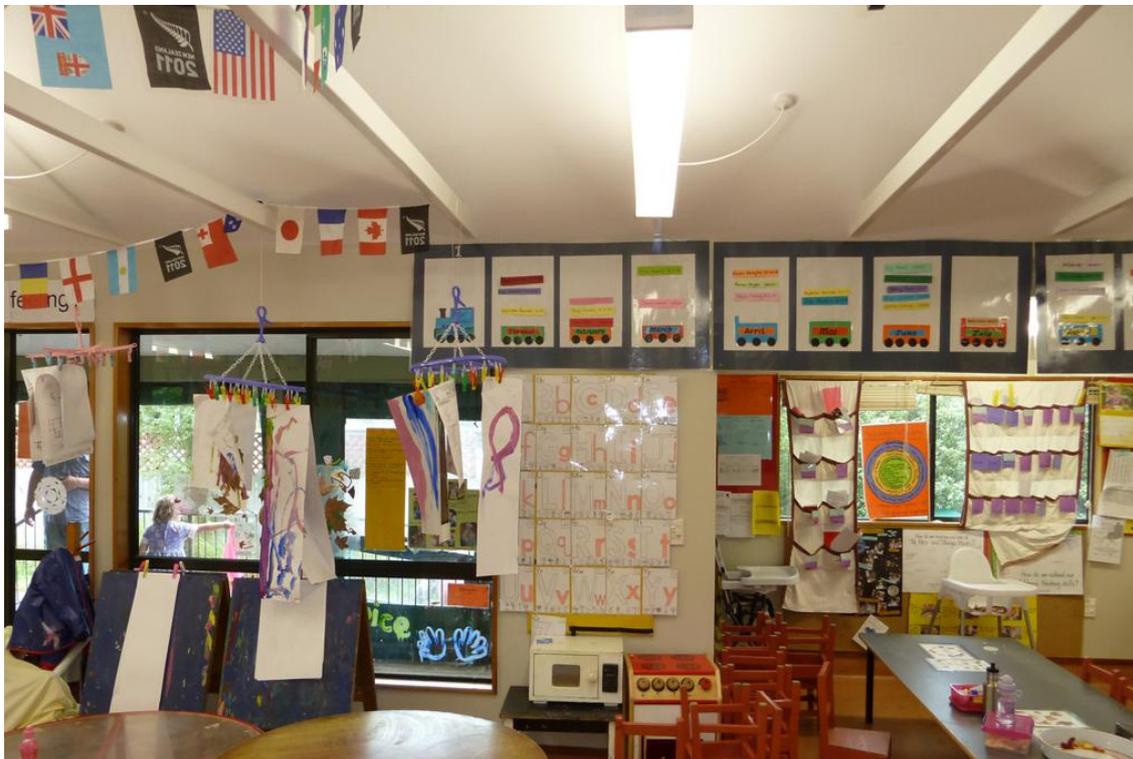
Photo 6 – Internal view of the main play room

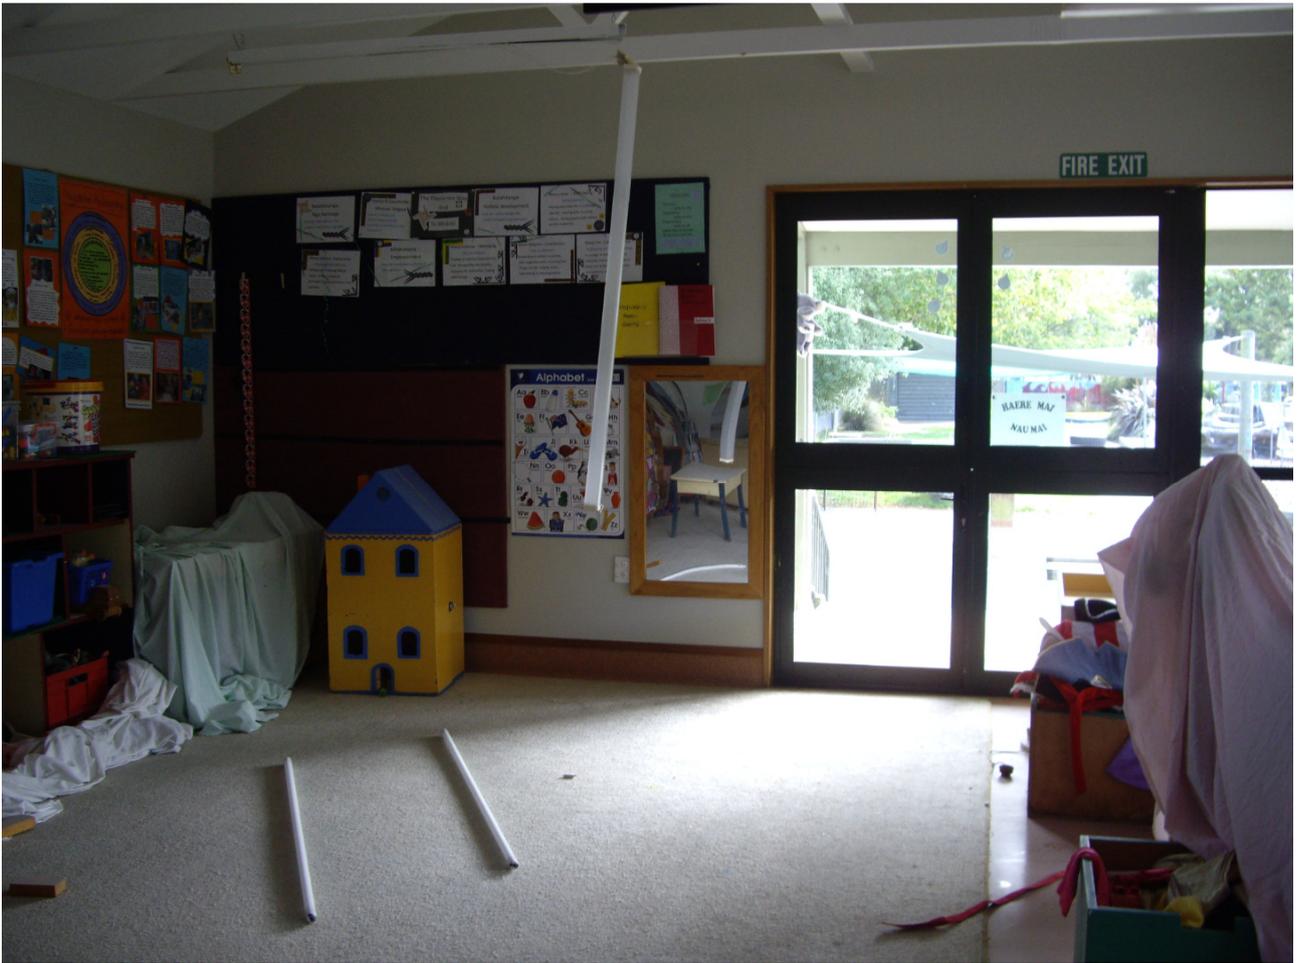
There were some ceiling lights that had fallen to the floor and overhead lights hanging loose in the building. However, there was no significant structural damage found in or around the Somerfield Playcentre building structure.

Photo 7 – Internal or overhead lights hanging loose or fallen in the building

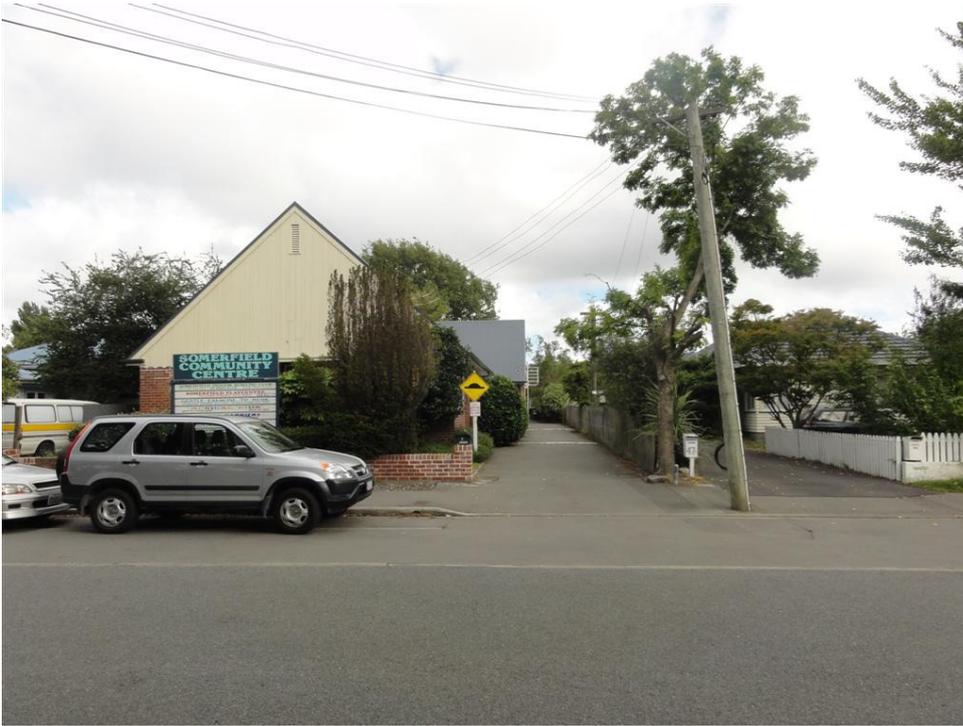
Photo 1: Street elevation, Somerfield Community Centre, 47 Studholme St.

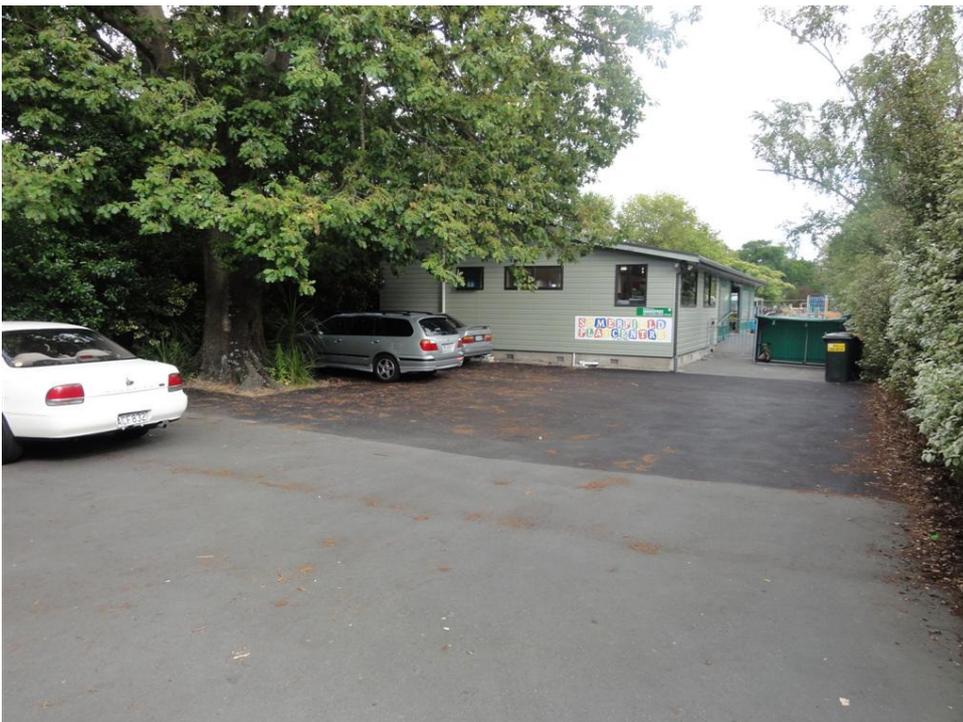
Photo 2: Playcentre down driveway, behind community centre. Note new asphalt.

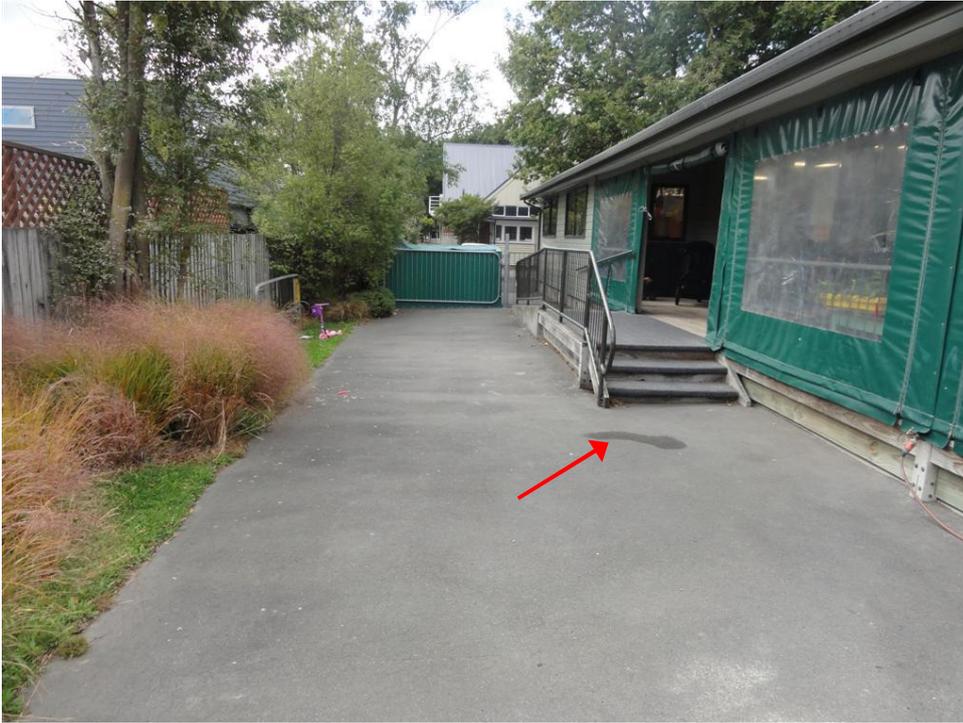
There appears to have been minor movement (up to 10mm) of the ground illustrated by the repaired asphalt areas.

Photo 3: Localised settlement of asphalt (<10mm).

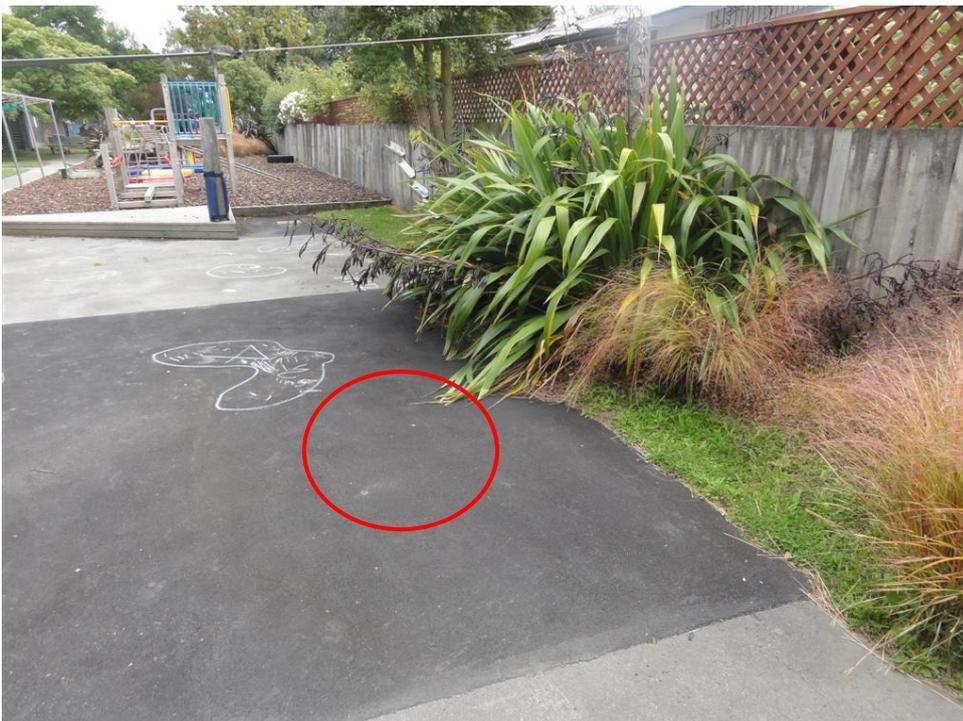
Photo 4: Approximate location of liquefaction on site (0.25m^2), note new asphalt.

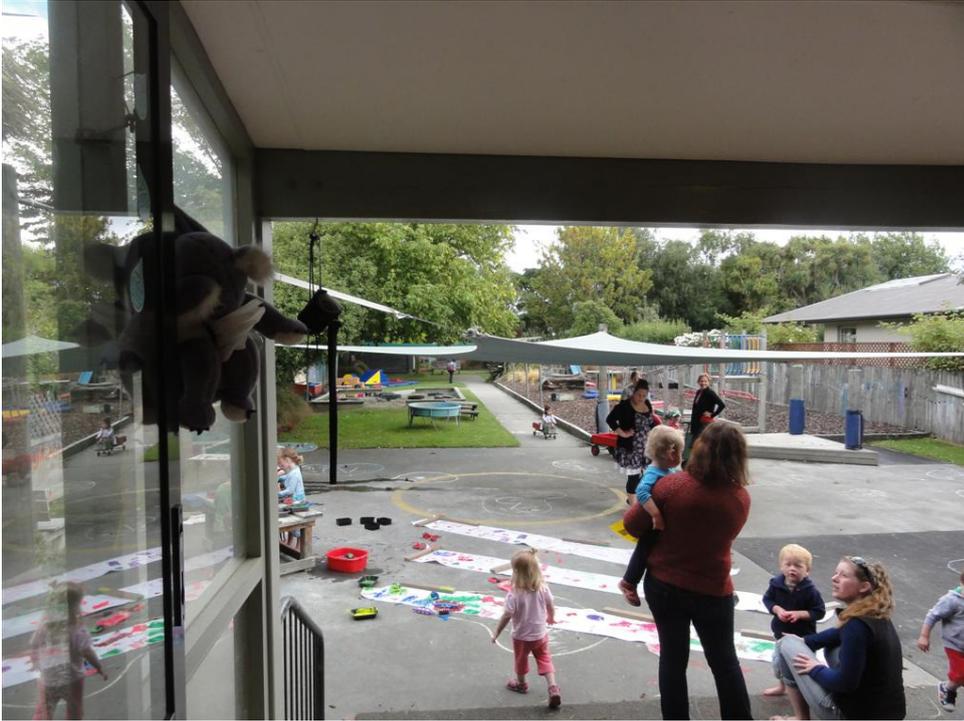
Photo 5: View from rear of building, note uneven asphalt and newly paved areas.

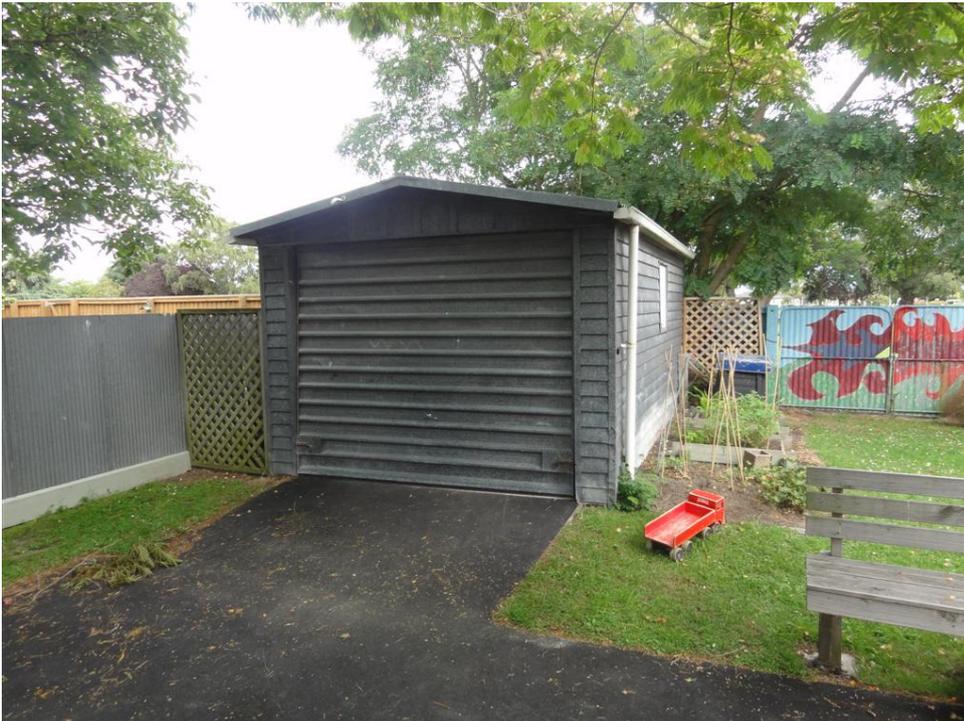
Photo 6: Shed at rear of property.

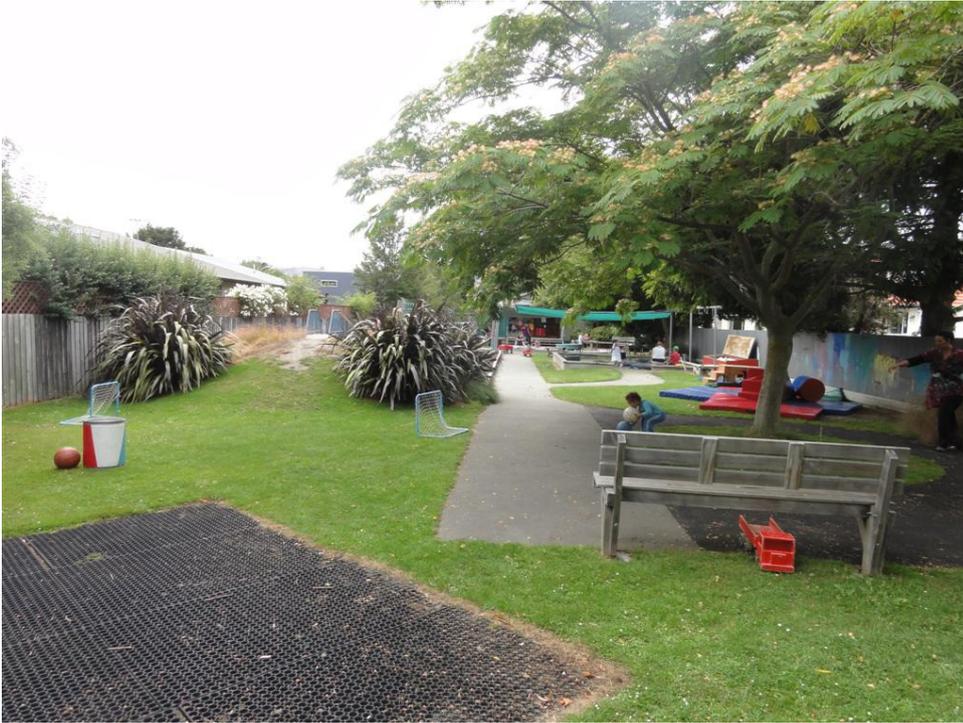
Photo 7: View from rear of property looking south-east.

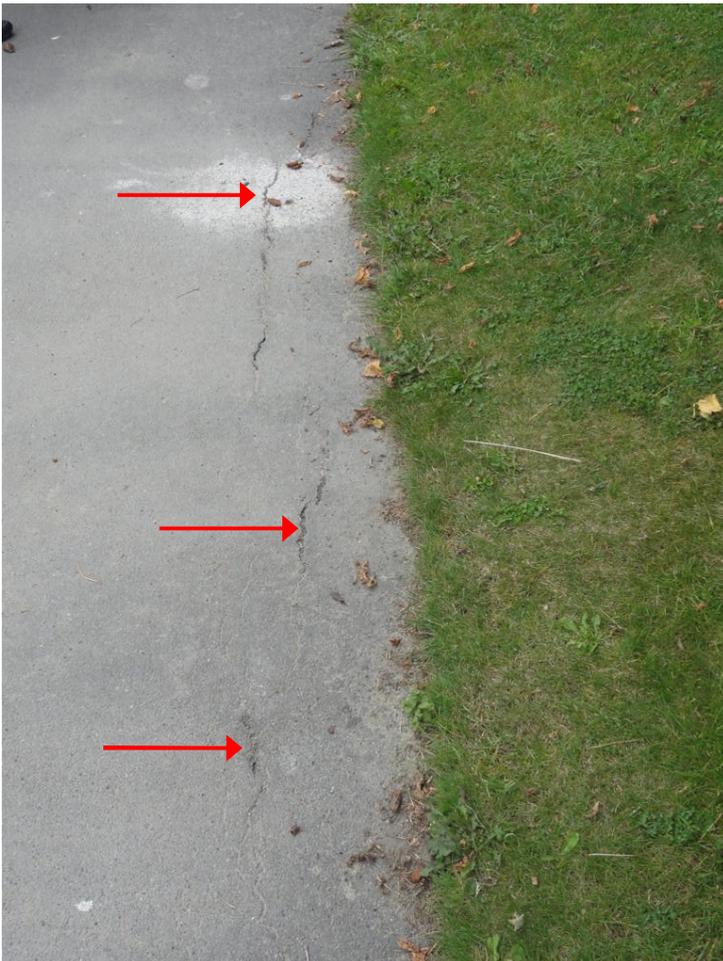
Photo 8: Possible earthquake induced cracks in asphalt.

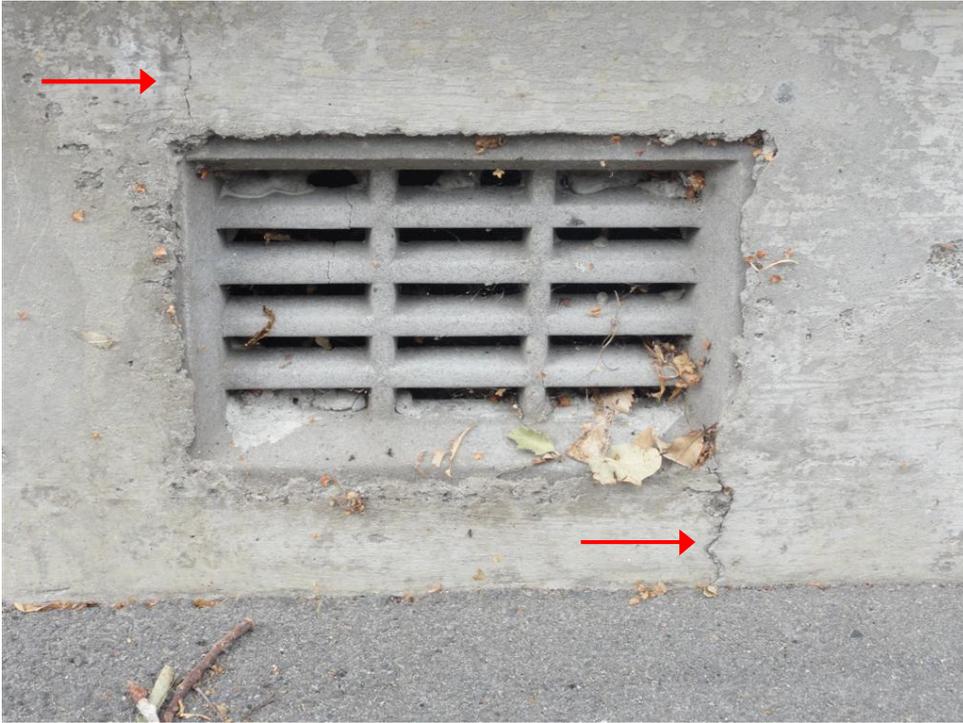
- Based on visual observations of the building, there is no evidence of differential settlement or rotation of the foundations.
- Asphalt paving has been damaged and replaced in several areas due to cracking during the shaking of the 22 February 2011 earthquake. Refer to Photos 2, 4-7 and Site Walkover Plan for location.
- Some paved areas seem slightly uneven, may have been present prior to earthquakes. Refer to Photo 3 and 5.
- An area of approximately 0.25m² located 5m north of the building was affected by surface rupture liquefaction. Refer to Photo 4 and Site Walkover Plan for location.
- Minor cracking to existing asphalt paving, may have been present prior to earthquakes. Refer to Photo 8 and Site Walkover Plan for location.
- Minor cracking was observed around the vents in the perimeter strip footing. Refer to Photo 9 and 10.

Cracks in the reinforced concrete foundation wall appear to be minor, and will not affect the structural integrity of the building or its performance in future earthquakes.

Photo 9: Minor cracking in concrete foundation wall around vent on north-eastern side.

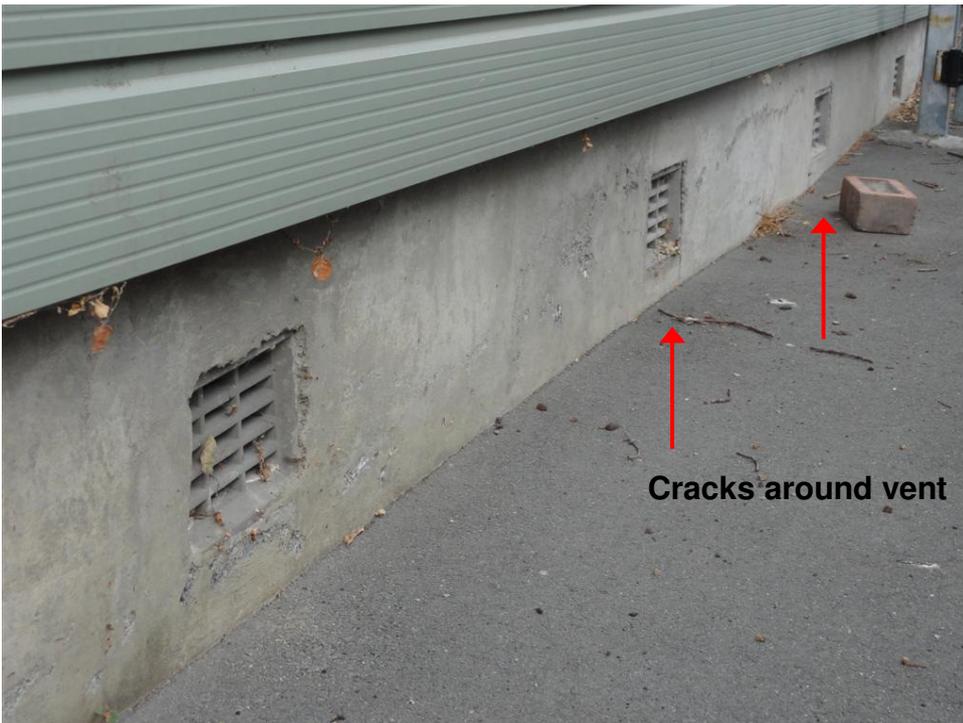
Photo 10: Reinforced concrete foundation wall, north-east side.

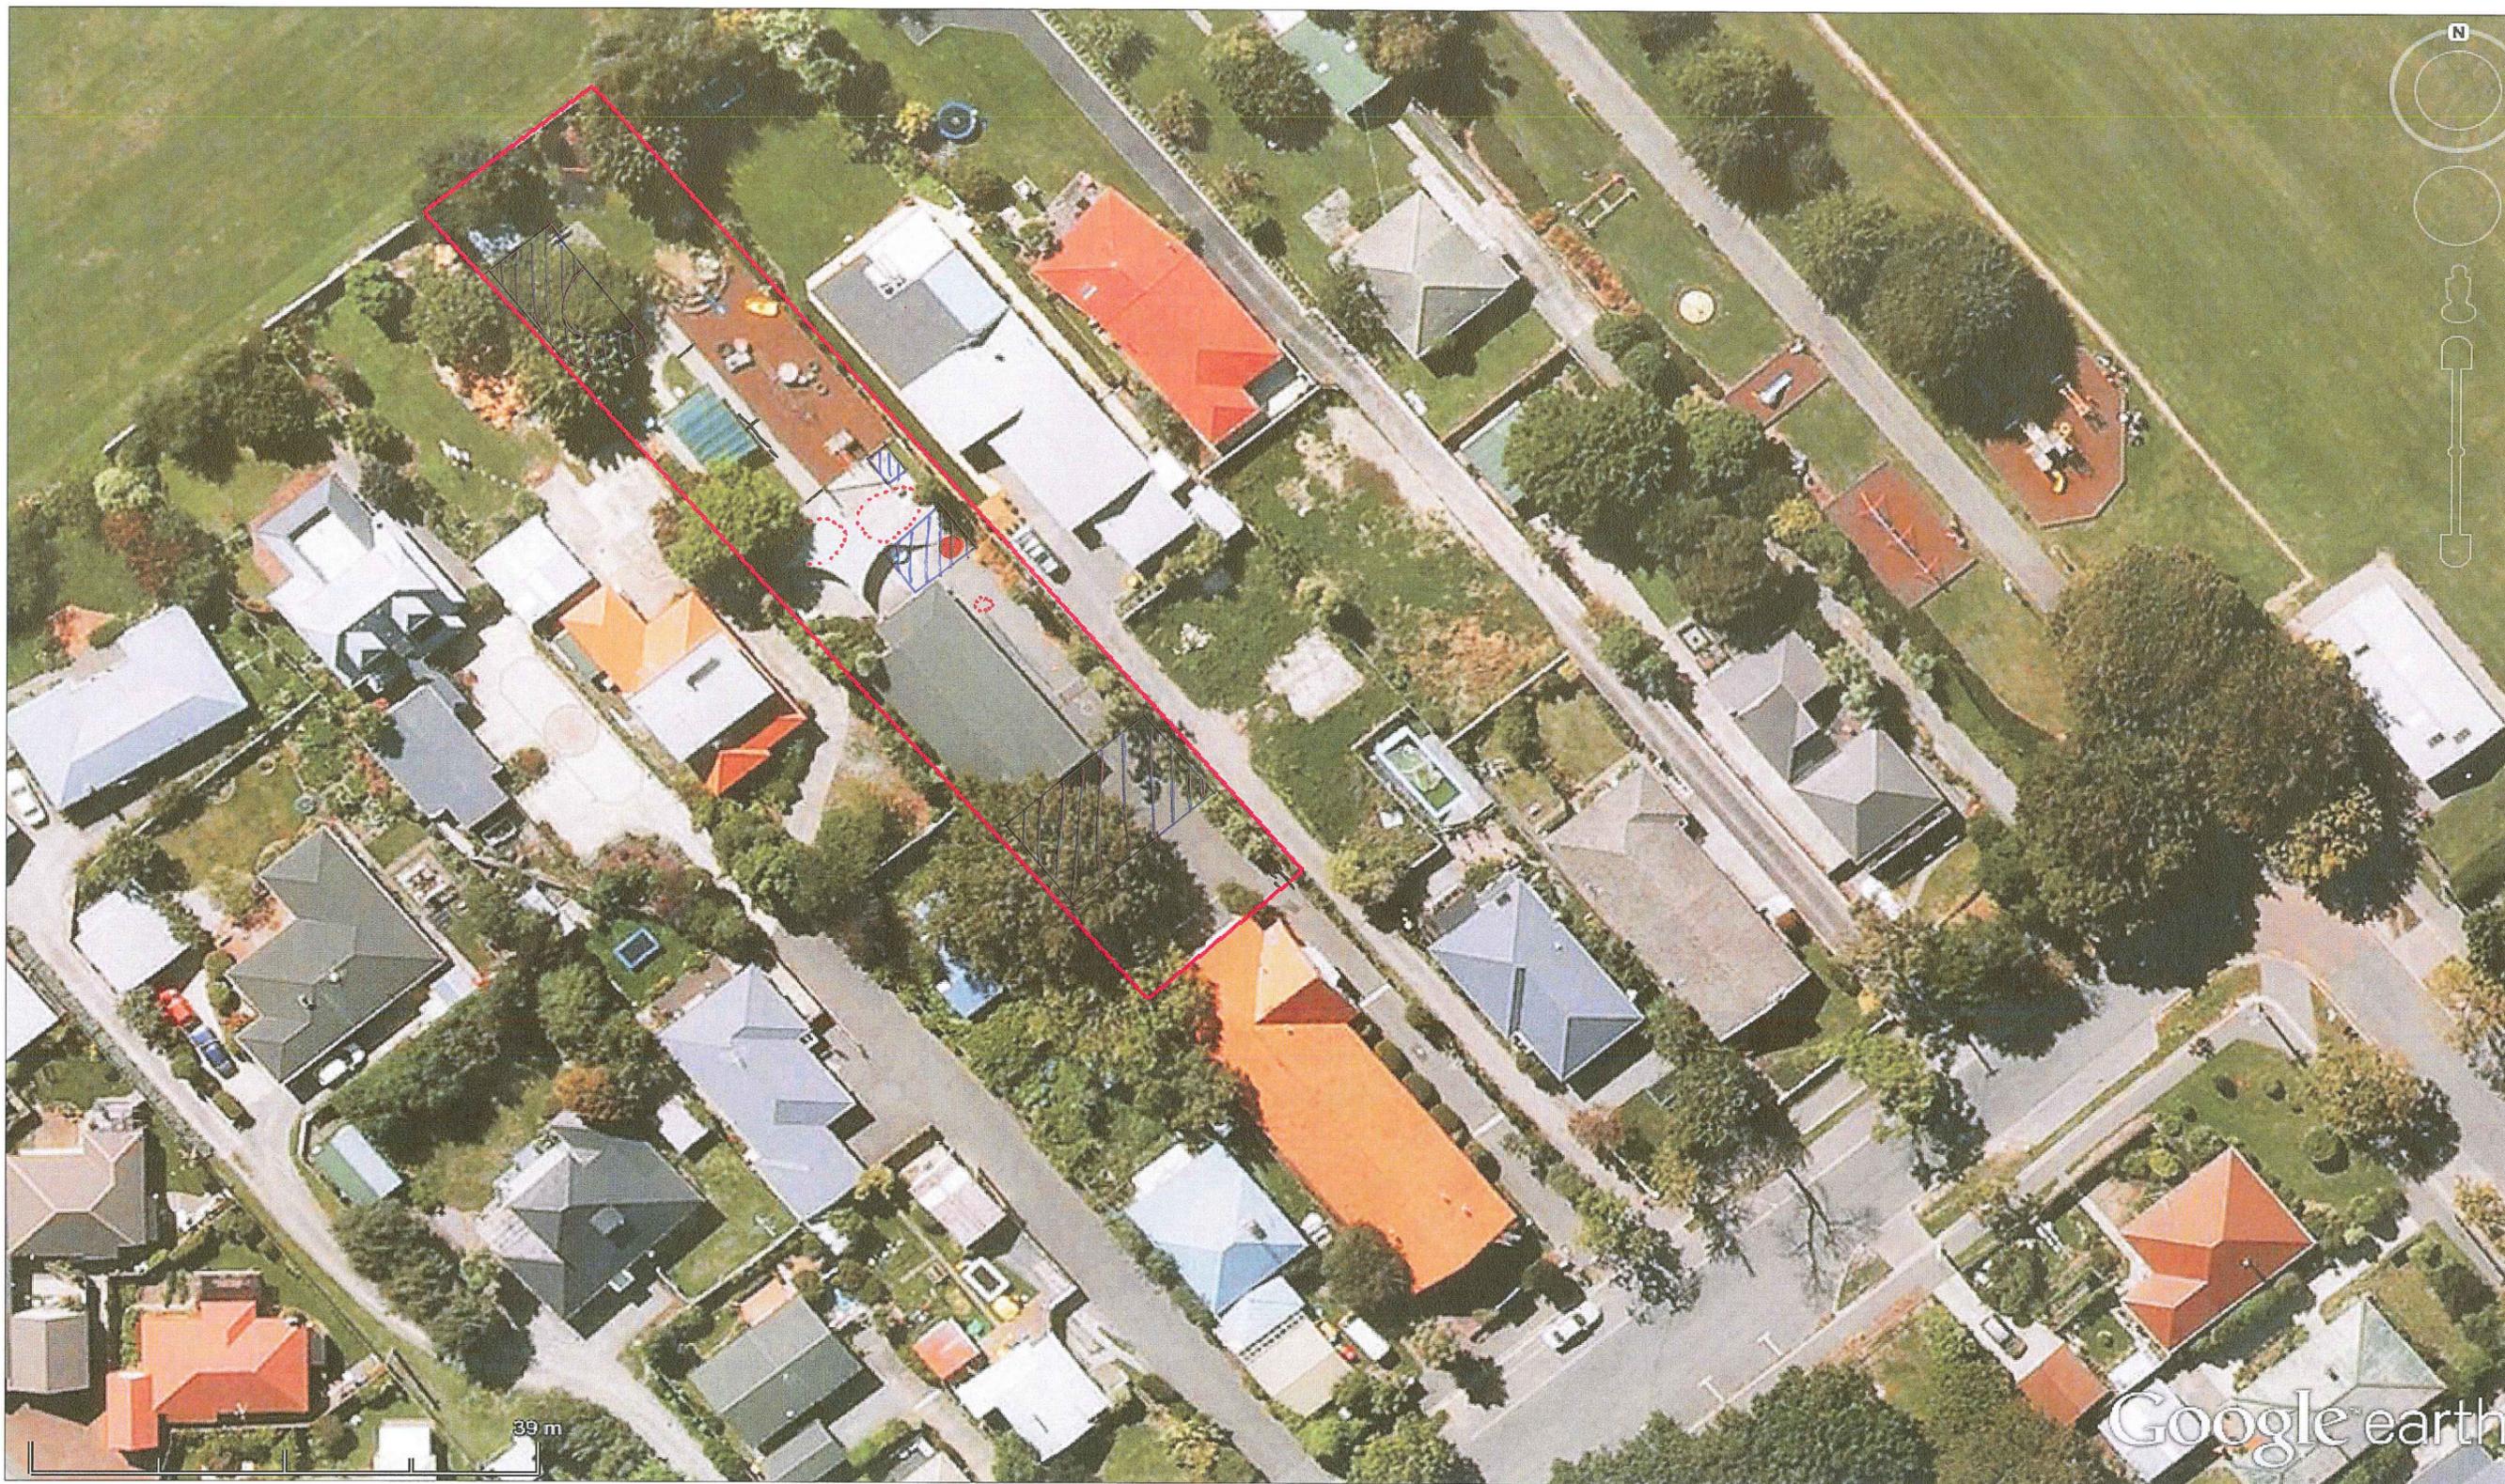
Red line: Playcentre Boundary
 ● Liquefaction
 ▨ Areas of new asphalt

↘ Cracks in asphalt
 ○ Areas of uneven asphalt
