# South Brighton Motor Camp – Camp Building 1

## Detailed Engineering Evaluation

### BU 1359-007 EQ2

### Qualitative Report

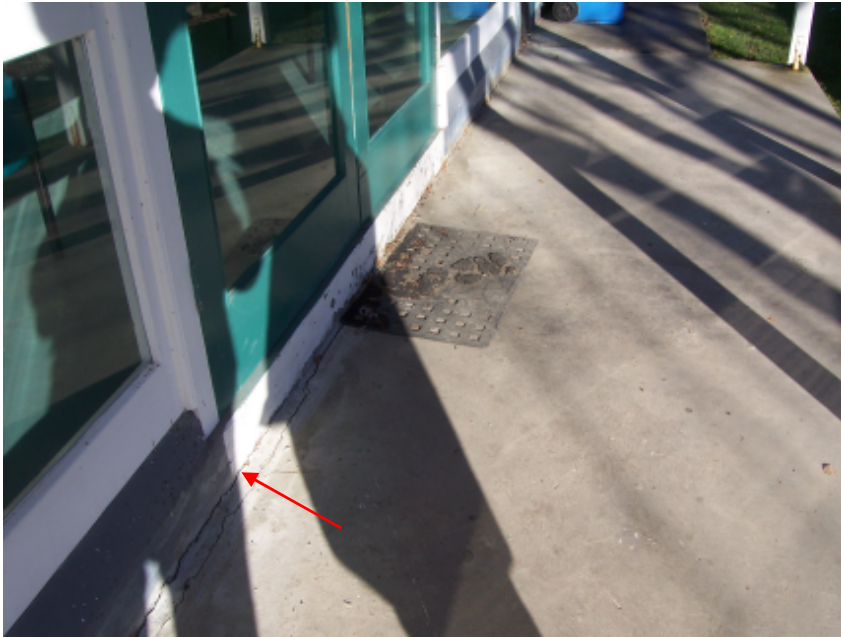
**Photo 1: Typical Cracking and separation between slab edge thickening and external concrete apron**

Damage type	Unknown	Minor	Moderate	Major	Comment
settlement of foundations			✓		Cracking to thickened slab supporting the masonry walls and the damage to main structure indicate there is a moderate settlement of foundation especially at the western end of the building.  The damage to the masonry walls and slab at the western side is worse. This may indicate differential settlement.  Elevation difference using Light Detection and Ranging (LiDAR) from post September 2010 and post December 2011 shows that the earthquakes caused more than 900 mm settlement in this region.
tilt of building		✓			Limited investigation and visual observation indicate the building is on a minor tilt. No verticality survey has been carried out.
liquefaction				✓	The aerial reconnaissance photograph from 24 <sup>th</sup> Feb 2011 indicates extensive liquefaction occurred on this site and in immediate surrounds.
settlement of external ground			✓		The joint opening of the external concrete apron and separation between external concrete apron and slab edge thickening may indicate settlement of external ground.

Damage description: Cracking and separation between slab edge thickening and external concrete apron indicate the building has likely suffered ground movement.

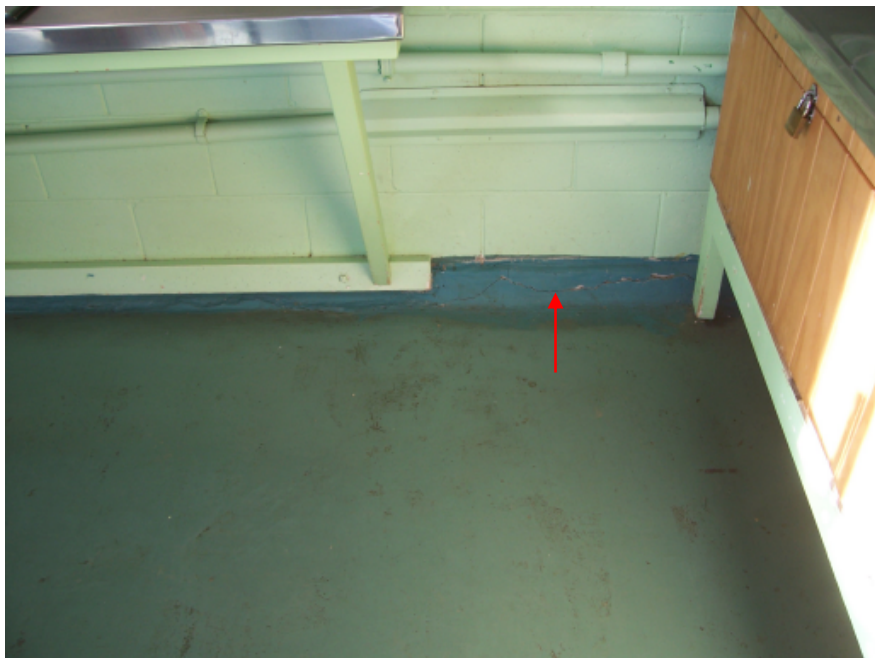
**Photo 2: Typical cracking to thickened slab and separation between internal wall and thickened slab**

Damage description: Widespread cracking and separation between internal wall and thickened slab especially at the western end of the building imply there is differential settlement and lateral spread of ground.

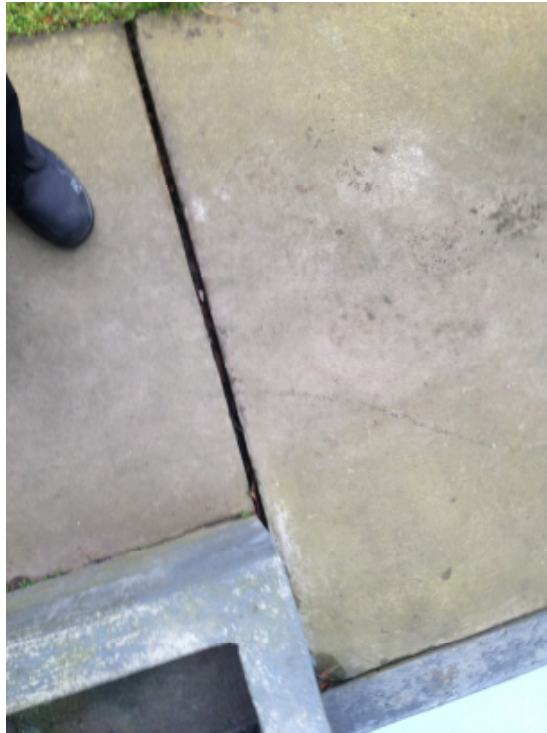
**Photo 3: Widened construction joint of external concrete apron**

Damage description: Widened construction joint of external concrete apron indicate there is external ground settlement.

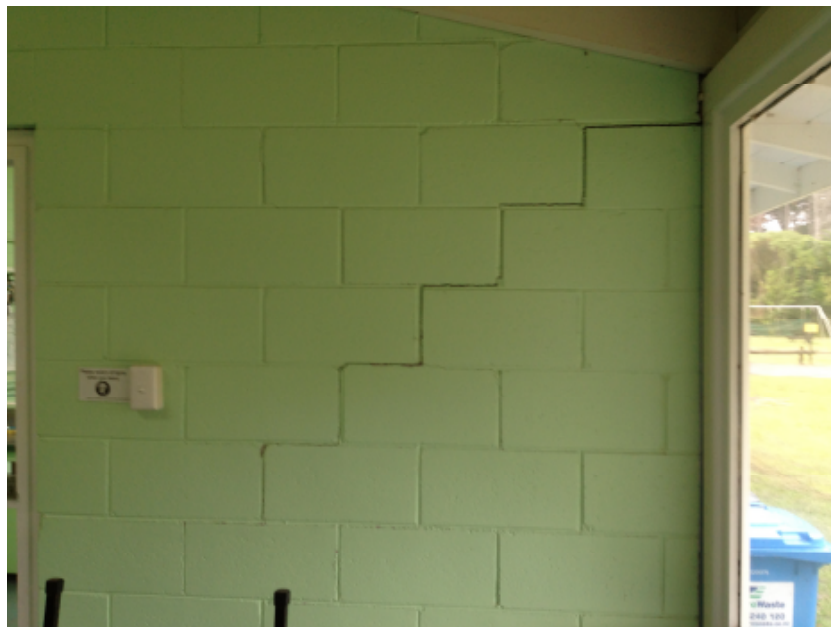
**Photo 4: The widest cracking to masonry block**

Damage description: The significant cracking at the west end of the building with 5mm cracking width indicate the building has suffered significant displacement or differential settlement.

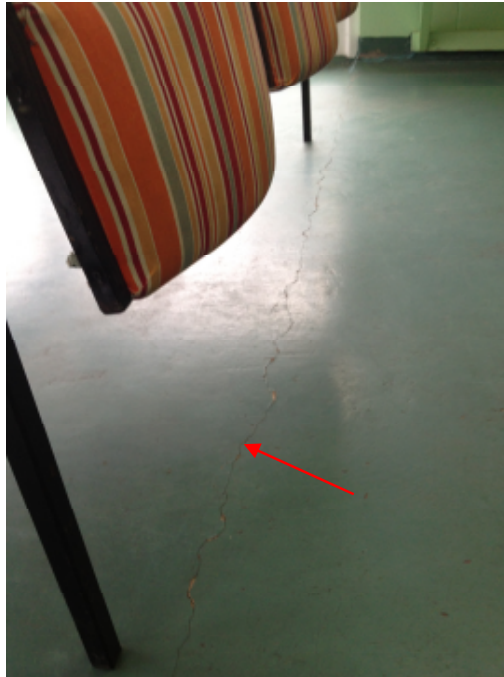
**Photo 5: Typical cracking to concrete slab**

Damage description: The cracking to concrete slab with approximately 0.4mm width observed likely due to settlement caused by earthquake shaking. The cracking to concrete slab was observed predominantly in the west end of the building.

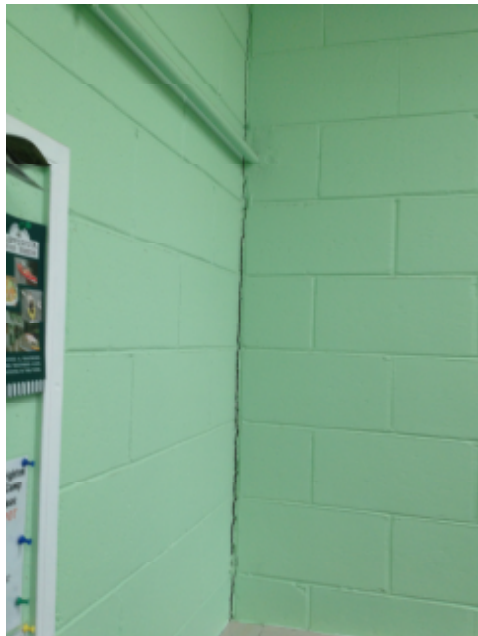
**Photo 6: Typical separation of masonry block joint**

Damage description: Separation between masonry block units at their joints is extensive especially at the western side of the building.

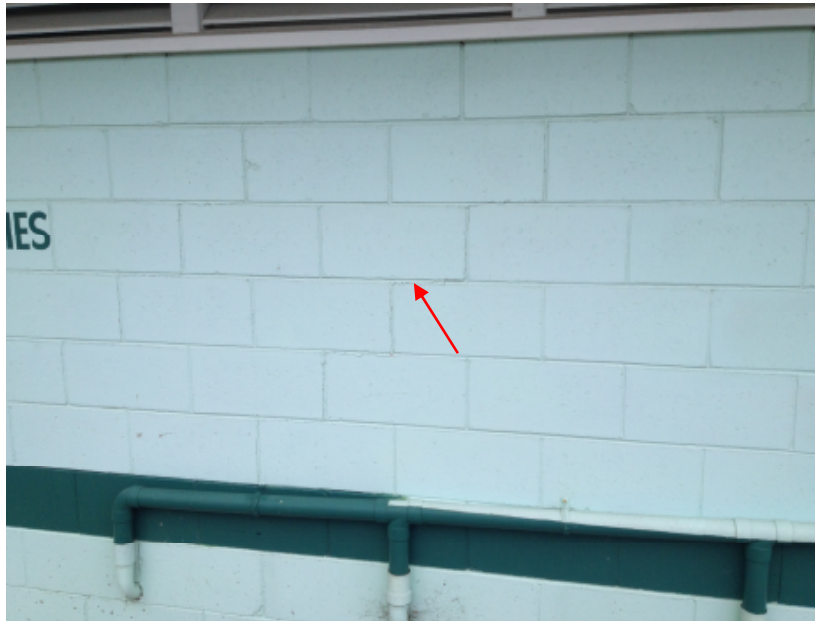
**Photo 7: Typical stepped cracking to masonry wall**

Damage type	Unknown	Minor	Moderate	Major	Comment
precast flooring seating damage					Not applicable
Stairs damage					Not applicable
cladding /envelope damage			✓		Widespread stepped cracking to masonry wall at the perimeter of the building. Separation between timber window framing and masonry block.
internal fit out damage			✓		Widespread cracking to masonry block internal fit out. Separation between masonry block units joint also observed. The internal fit out at western side of the building indicates worse damage than the other part of the building.
building services damage	✓				No inspections of services were carried out.
Other damage		✓			Corrosion to the steel connection between timber column supporting the roof at the west end and the concrete pavement.

Damage description: Widespread stepped cracking to masonry wall are potentially due to differential settlement caused by earthquake shaking.

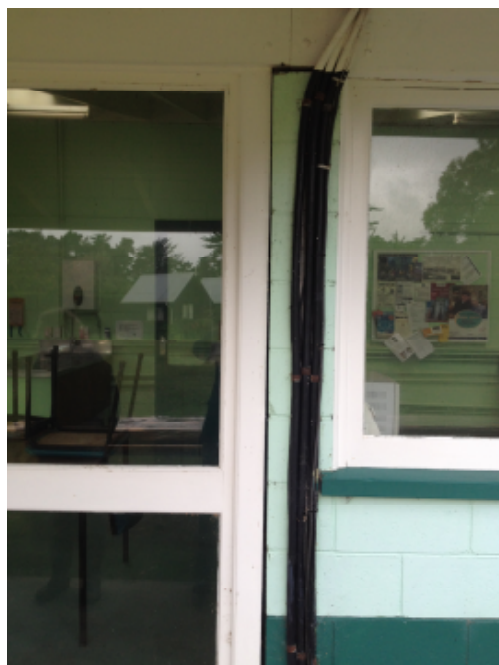
**Photo 8: Separation between timber window framing and masonry block**

Damage description: Separation between timber window framing and masonry block at the northwest of the building indicate the building has suffered ground settlement. This damage is consistent with other damage which also implies the ground movement at the western side of the building.
