**Christchurch South Library**

*Detailed Engineering Evaluation*

**Quantitative Assessment Report**

**66 Colombo Street, Christchurch**

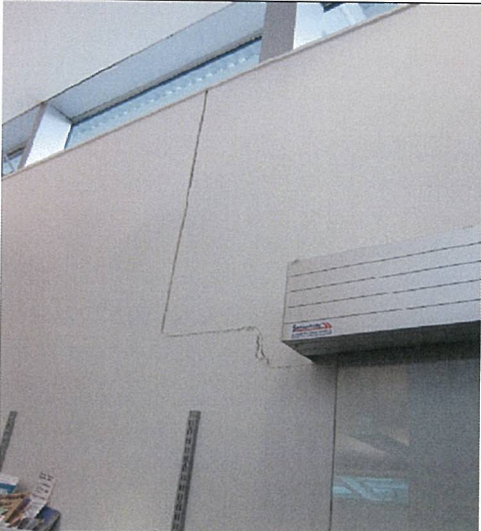
8.	Cracking in the gib board

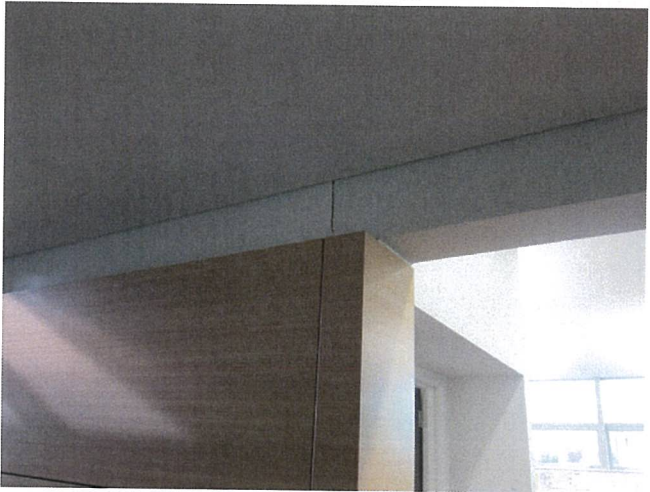
9.	Cracking in the gib board

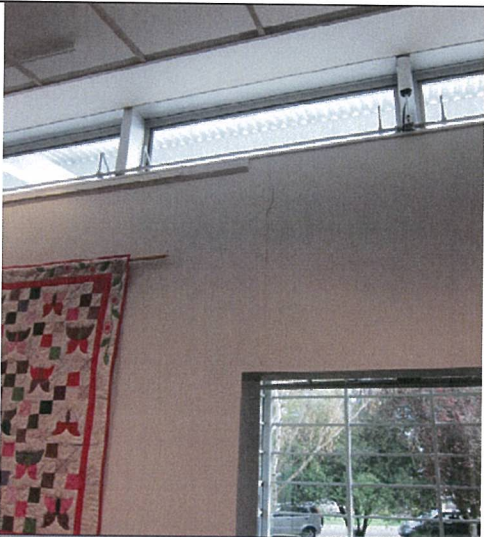
10.	Cracking in the gib board

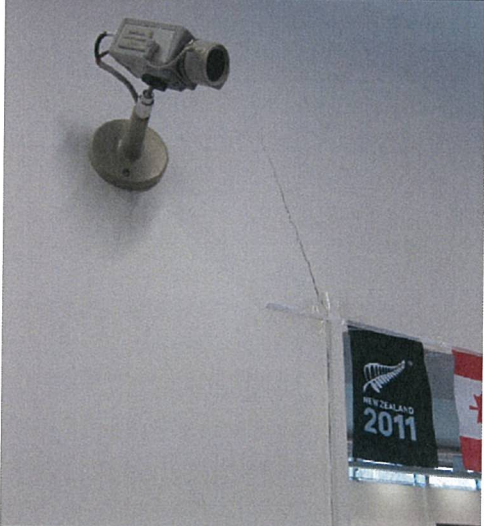
11.	Cracking in the gib board

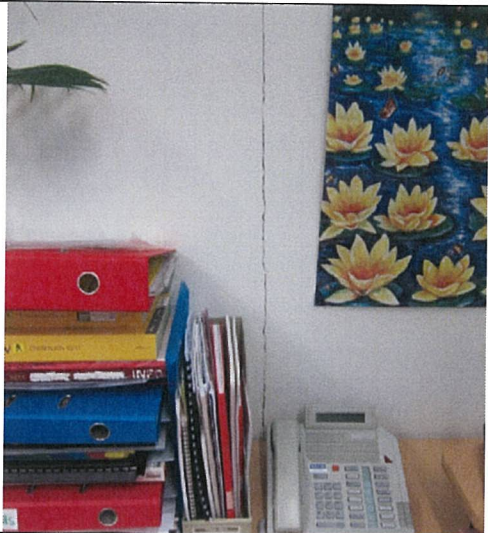
12.	Cracking in the gib board

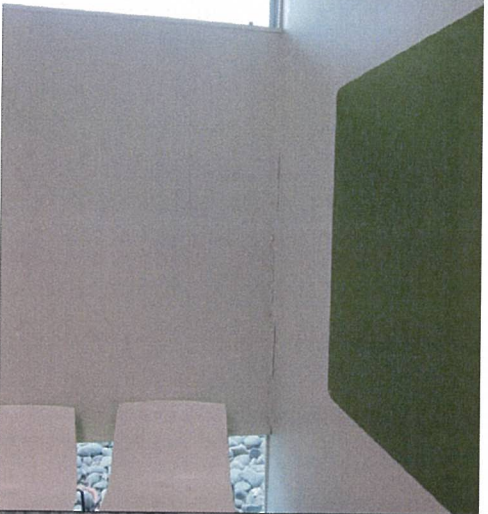
13.	Cracking in the gib board

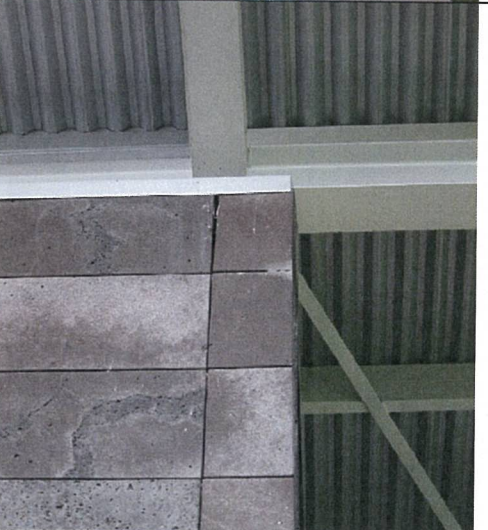
- i) It is understood that several façade panels became loose during the 22 February 2011 earthquake.
- j) Significant differential settlement throughout the entire building. The overall differential settlement is in the order of 90mm, while the maximum differential settlement over a 6m length is in the order of 45mm. This settlement exceeds the maximum allowable differential settlement of 25mm over 6m as specified in Clause B1 of the New Zealand Building Code at Serviceability Limit State.

14.	Dislodged stone façade piece on the west face

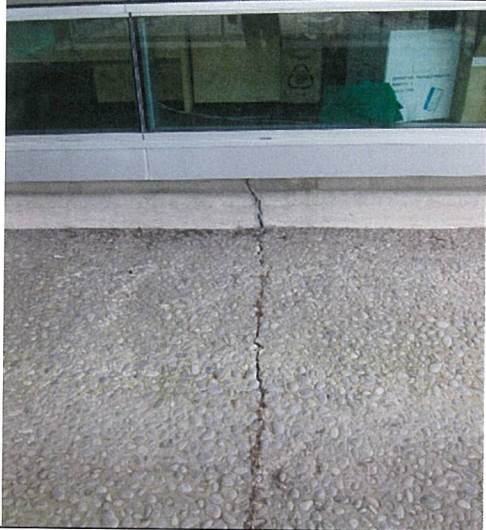
- e) Slumping in the ground within children's playground area.
- f) Lateral spreading induced cracks to external moat/pond slab in several locations.

15.	Cracking in the moat and perimeter ground beam

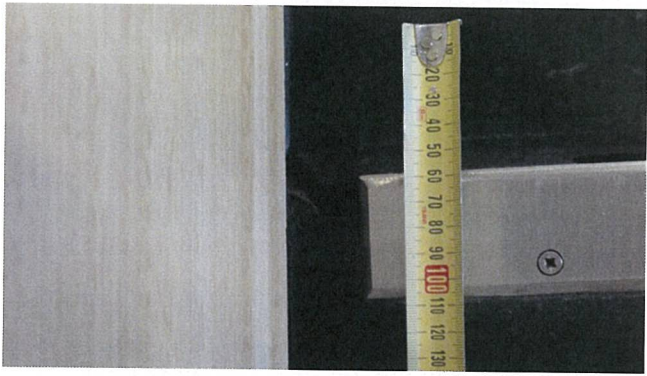
- c) Displaced/movement of ground floor slab by the Children's Area.
- d) Three significant cracks in the concrete slab, ranging from 10 to 40mm wide, underneath carpet and tile areas in the western and central areas of the building. The effect of this crack on the water-tightness of the building needs to be quantified. Only isolated areas of the slab have been checked for cracking and it is recommended that the entire slab be investigated.

16.	Cracking in the ground floor slab due to ground movement

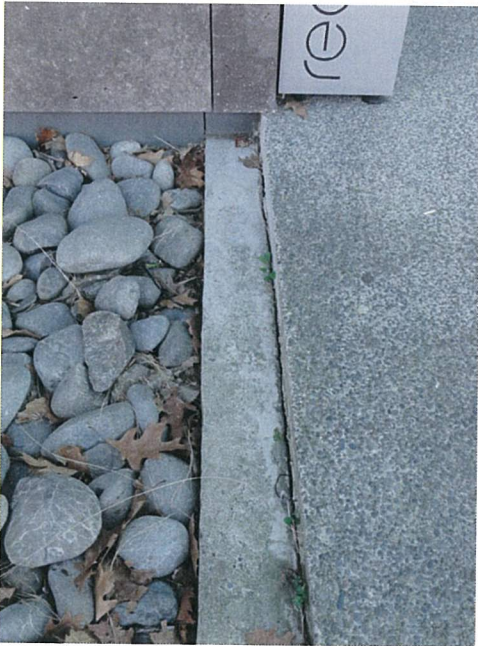
17.	Differential settlement of the exterior paving at the library entrance

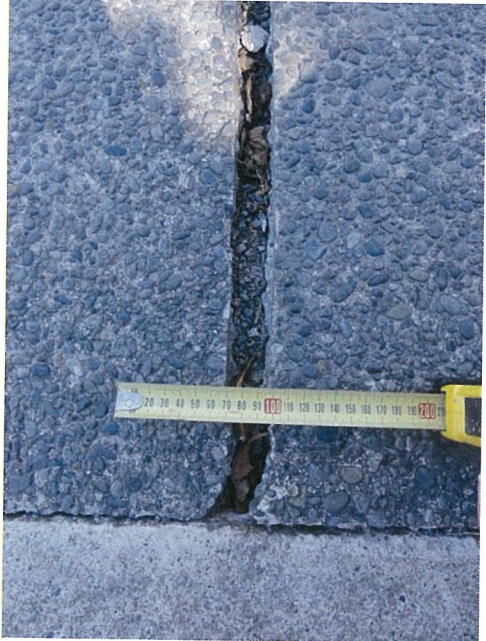
<p><b>18.</b></p>	<p>Separation of the paving along the exterior walkway due to ground movement</p>

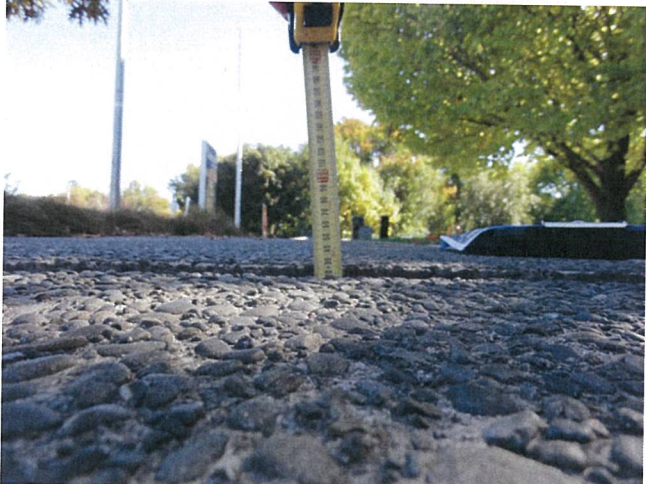
<p><b>19.</b></p>	<p>Differential settlement in the paving along the exterior walkway due to ground movement</p>

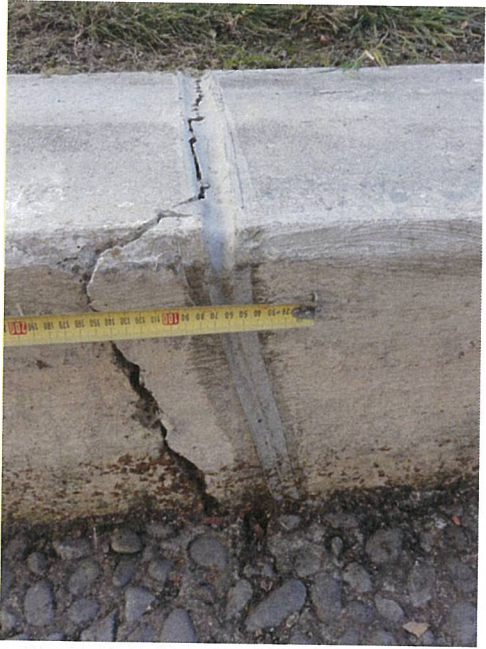
- g) Opening of existing cracks in the vertical faces of ground beams along the northern sides of the building wings. No longitudinal reinforcement was visible in these cracks, which were up to 15mm wide.

20.	Cracking in the ground beam along the perimeter moat

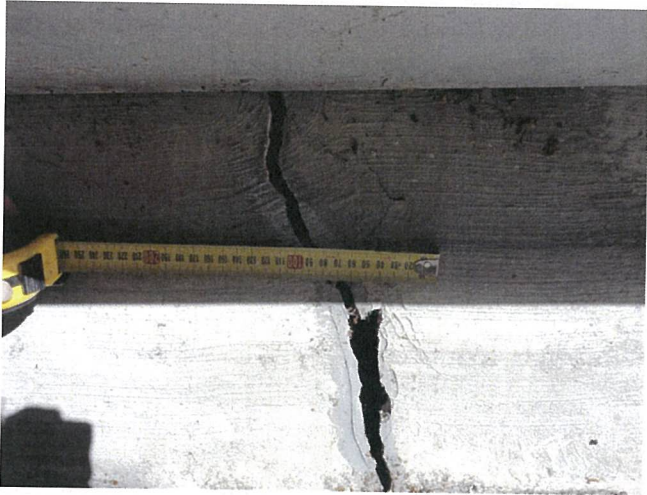
A photograph showing a vertical crack in a concrete ground beam. A yellow measuring tape is placed horizontally across the crack to indicate its width. The crack is located along the perimeter of a moat, with gravel and vegetation visible in the background.
21.	Cracking in the perimeter ground beam

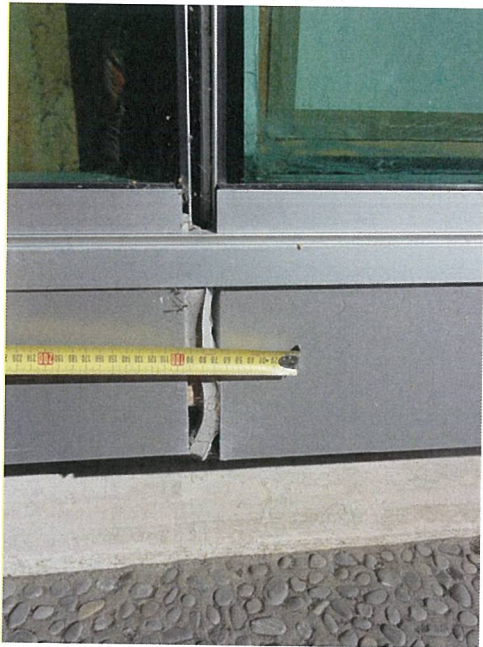
22.	Separation of the façade pieces due to ground movement

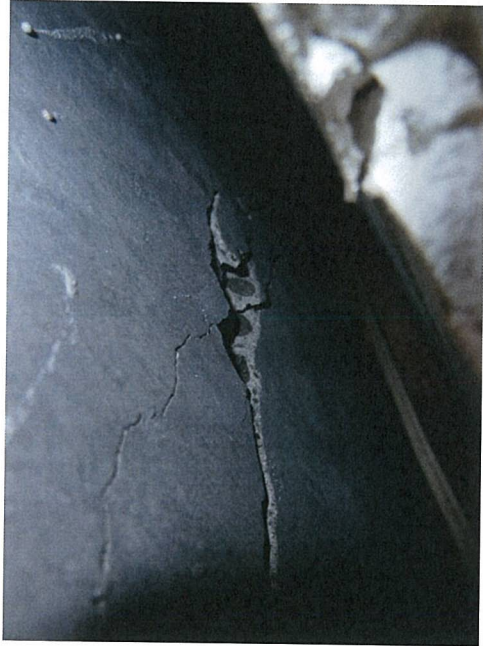
- a) Cracks to wall gib board linings and ceilings throughout the building. Several cracks through the wall linings are up to 10mm in width.
- b) A significant 4mm wide crack was identified at the eastern end of the southern face of precast panel H.1 following intrusive investigations. A number of other cracks greater than 0.5mm width were also identified in this location. Intrusive investigation of all precast panels along this line is recommended so that all damage to the precast walls can be identified.

- e) Significant cracks, one of which is 4mm wide, have been identified in precast panel H.1.
- f) Intrusive investigations to the short stub columns and the internal precast concrete walls should be undertaken.
- g) The geotechnical investigation has not yet been completed. This report will be updated once the interpretation of the CPT ground investigation results is completed.

23.	Cracking to precast panel H.1
