South New Brighton Park – North Toilets
PRK 1944 BLDG 008
Detailed Engineering Evaluation
Qualitative Report
Version FINAL

74 Beatty Street, New Brighton

Christchurch City Council

Date
9 July 2013

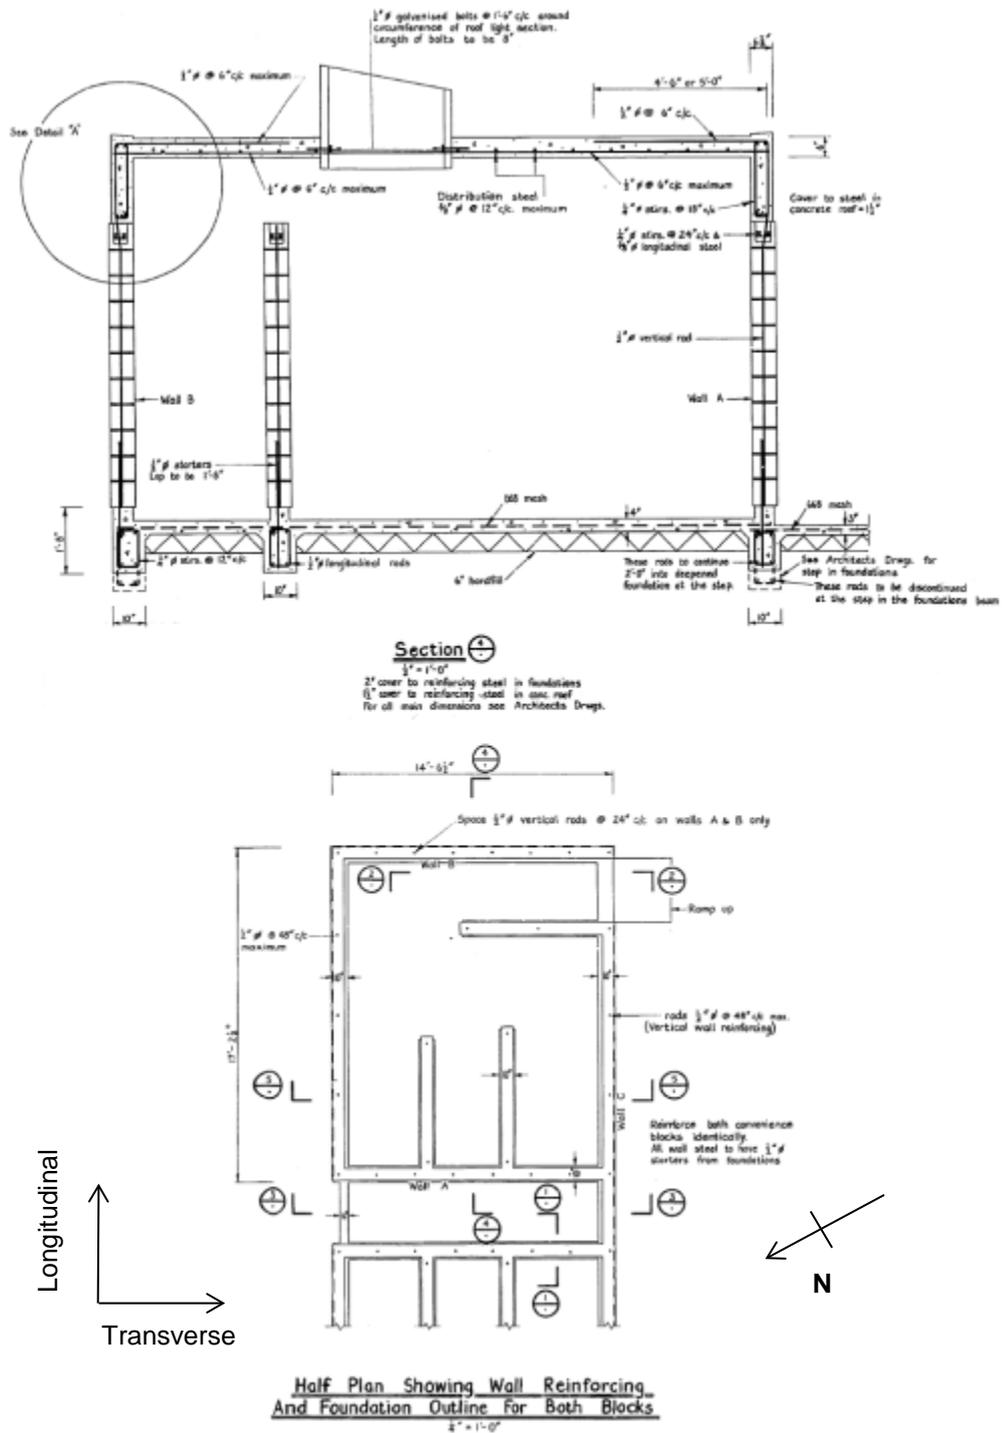
Figure 2 Excerpt from Drawings Showing Key Structural Elements

For an earthquake occurring in the longitudinal direction of the building, there is no obvious load path in the structure to transfer seismic loads from the reinforced concrete roof slab to the lateral load resisting concrete masonry walls in the plane of loading.

In the longitudinal direction of the building, there is minimal connection between the reinforced concrete roof slab and the concrete masonry walls in the plane of loading. There is no reliable load path in the structure to transfer seismic loads from the reinforced concrete roof slab to the lateral load resisting concrete masonry walls. The seismic loads are likely to be resisted by out-of-plane action of the transverse concrete masonry walls supporting the roof slabs.

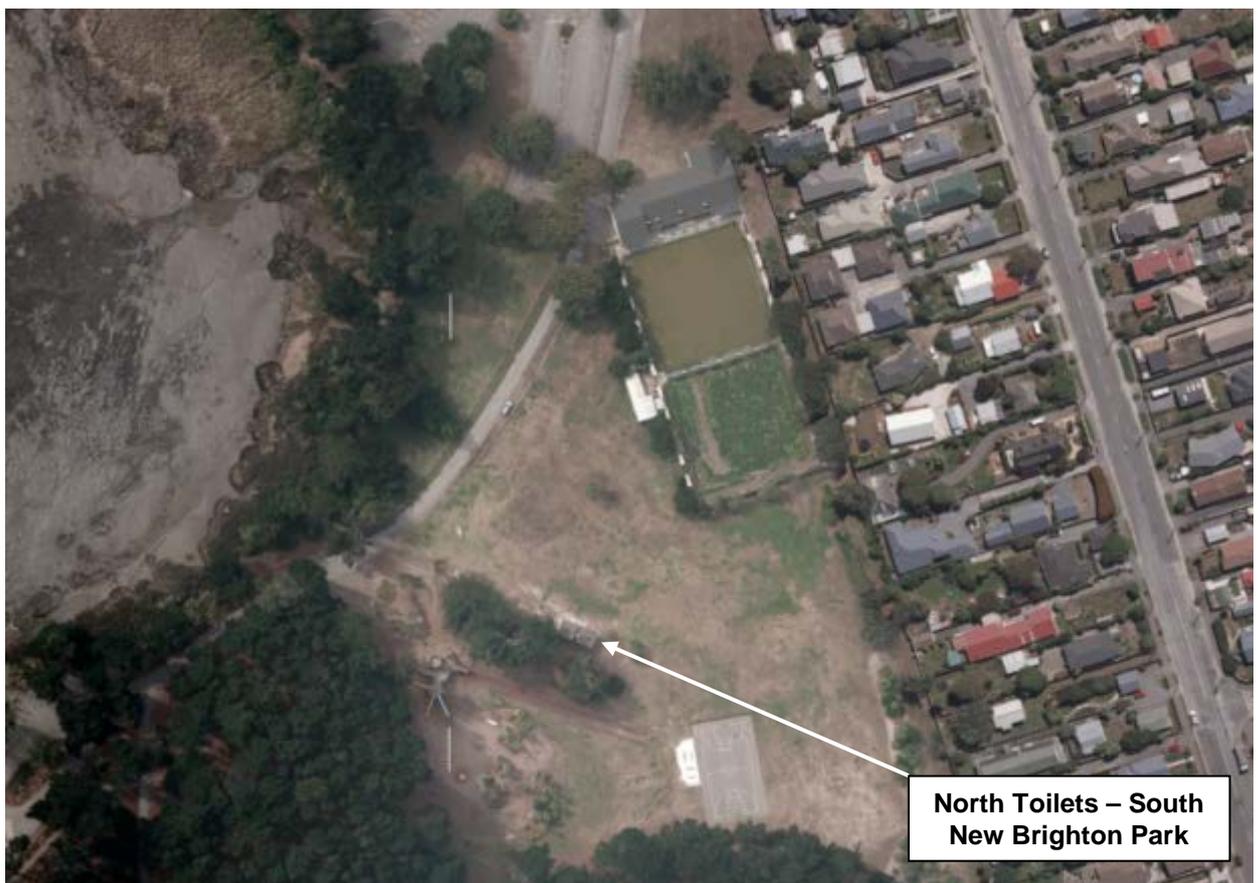
Figure 3 Post February 2011 Earthquake Aerial Photography³

Aerial photography taken following the 22 February 2011 earthquake shows signs of minor liquefaction outside the building footprint, as shown in Figure 3.

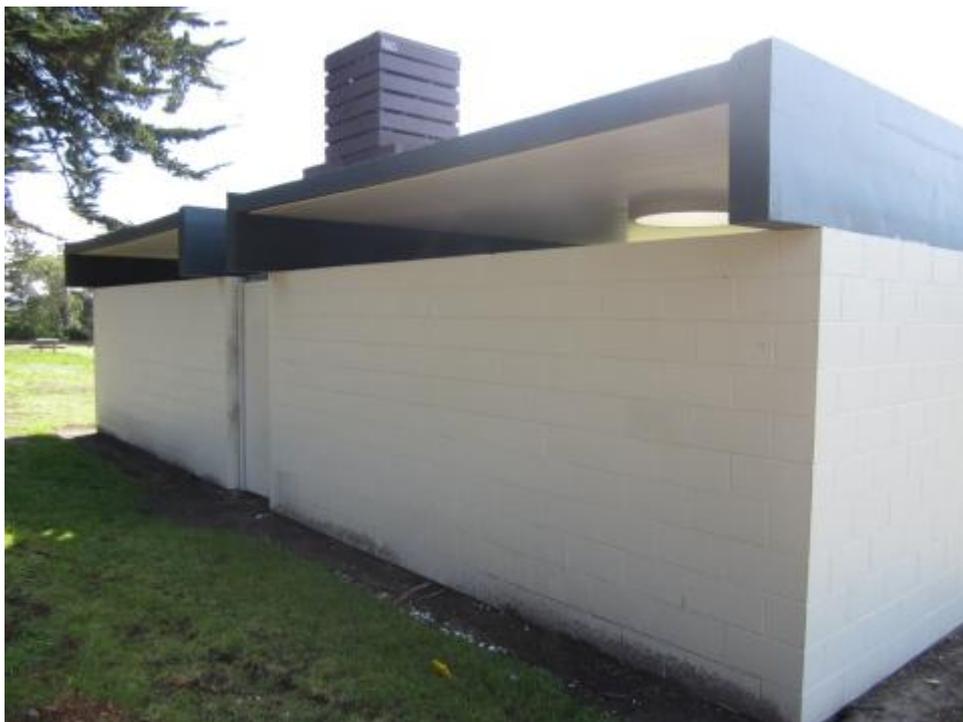
Photograph 2 View of concrete masonry wall and reinforced concrete roof slab

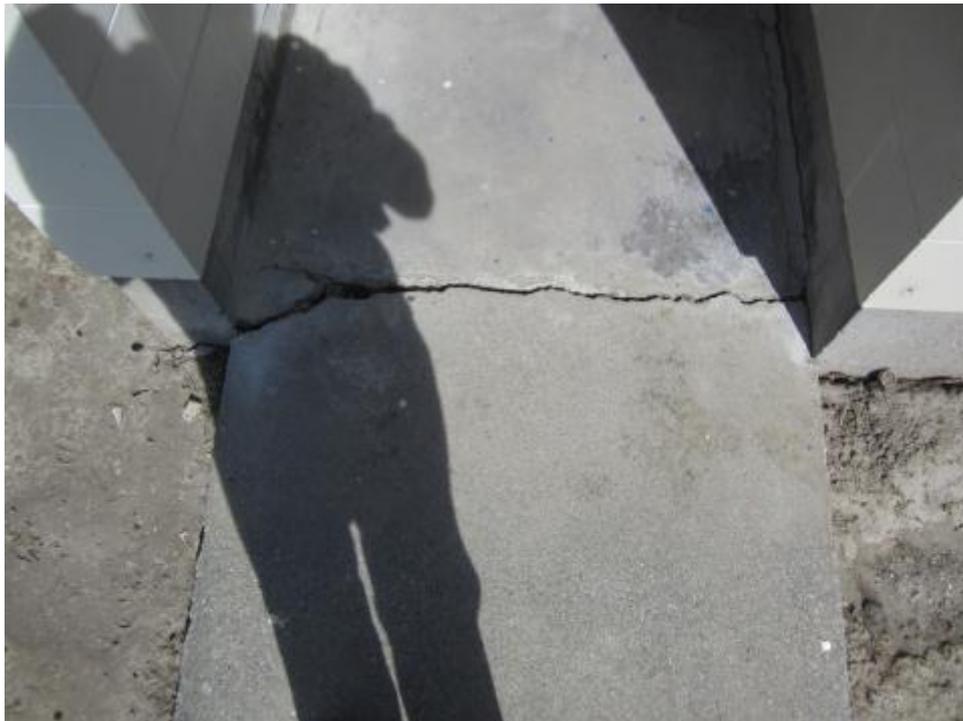
No residual displacements of the structure were observed during inspection of the building. Some cracking in the concrete floor slab was observed at the eastern entrance to the building as can be seen in Photograph 4. It is unclear if this damage was caused by seismic activity.

Photograph 4 Cracking in concrete floor slab at the eastern corner of the building

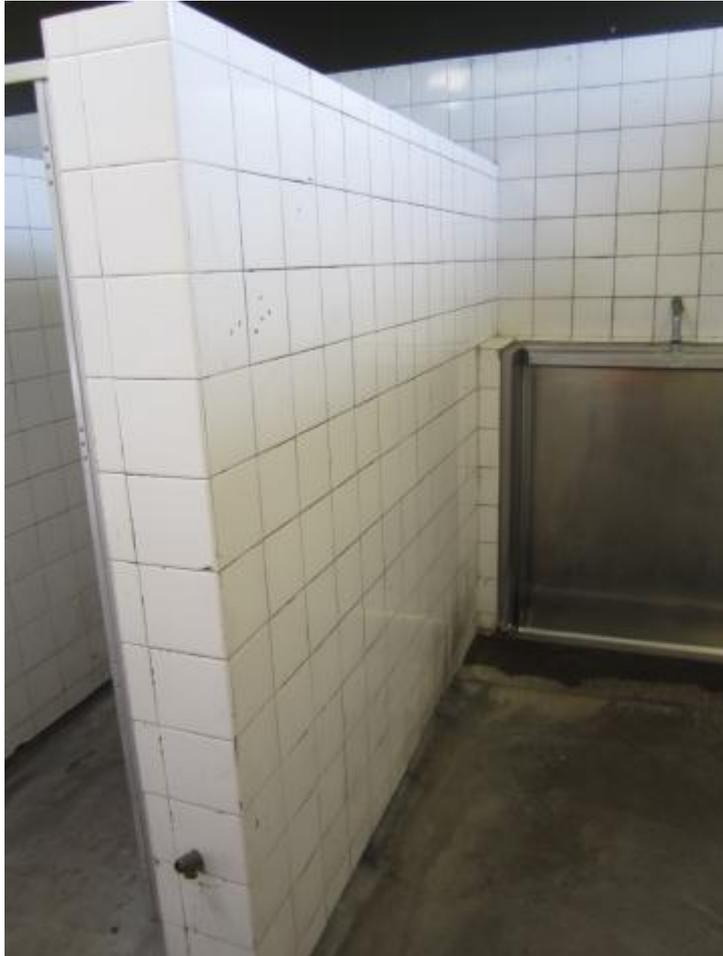
The 190mm thick concrete masonry partition walls are unrestrained along the top edge (see Photograph 5). These unrestrained masonry walls may be susceptible to collapse from out-of-plane seismic actions. The unrestrained concrete masonry panels are not expected to have an adverse effect on overall structural performance; however, they do have implications for possible threat to life if they collapse.

Photograph 5 Internal concrete masonry partition walls clad with ceramic tiles

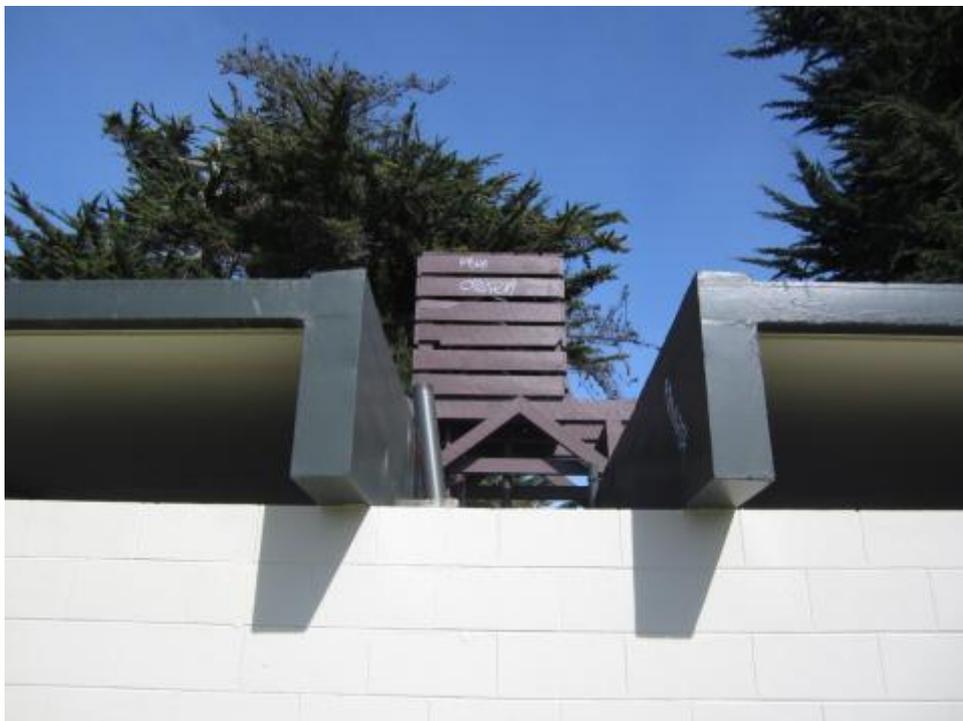
Photograph 6 Reinforced concrete legs supporting the reinforced concrete roof slab
