Spencer Park – Amenity
Block/Laundry

Qualitative Engineering Evaluation

Functional Location ID: PRO_0157_B006

Date: 16 October 2013

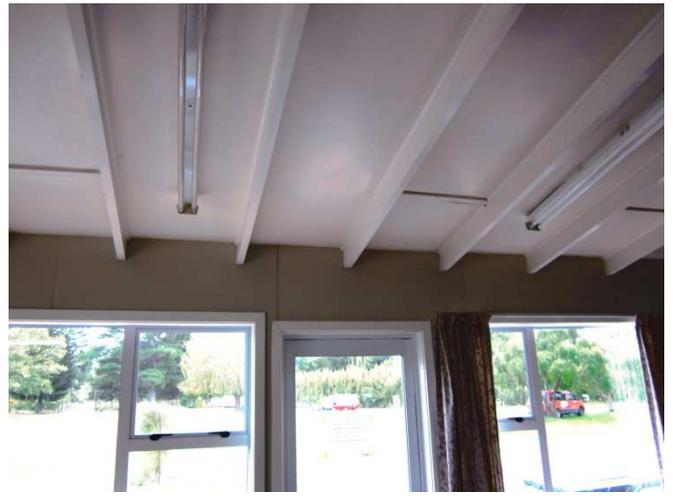
- Severe step cracking in the mortar joints by the laundry room
- Separation of the concrete masonry wall from the concrete pilaster by the laundry room
- Cracking in the brittle hardboard cladding above the kitchen
- Cracking in the mortar joints around the kitchen windows

The level of damage observed on the Spencer Park – Amenity Block/Laundry was wide ranging. The excessive step cracking in the mortar joints in the laundry room was a clear indication of the inadequate shear and flexural strength of the concrete masonry wall. The level of damage observed in this instant was very severe. On the other end of the spectrum, the cracking of the hardboard cladding above the kitchen was minor.

Step cracking and remedial work undertaken to restrain the wall from falling out of plane in the North Western corner of the building.

It is noted that some restraining work has been undertaken to prevent the concrete masonry wall in the laundry area from falling out of plane.

However, there remains a degree of uncertainty surrounding the robustness of the concrete masonry walls. As such, it is strongly recommended that **an intrusive investigation and Level 5 Quantitative Detailed Engineering Investigation be undertaken**.

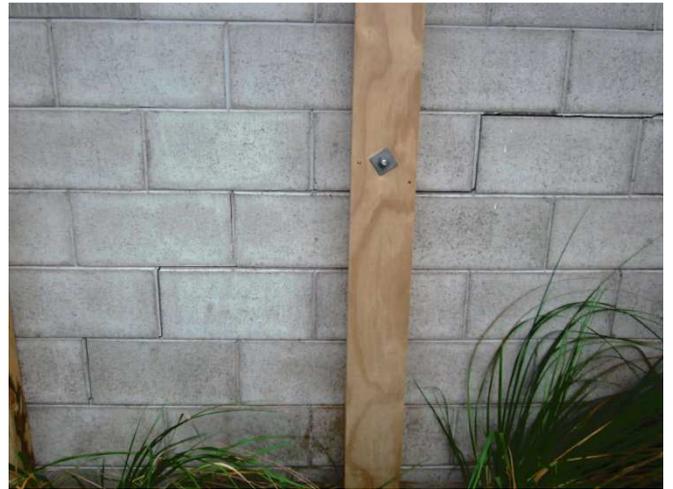
Step cracking and remedial work undertaken to restrain the wall from falling out of plane in the North Western corner of the building.

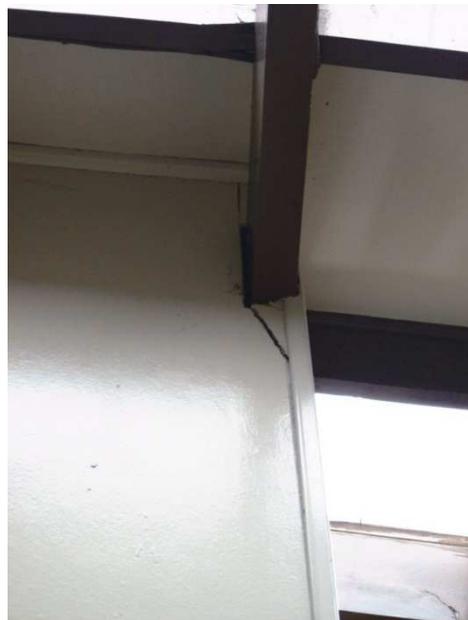
Cracking beneath the window sill on the exterior of the kitchen.

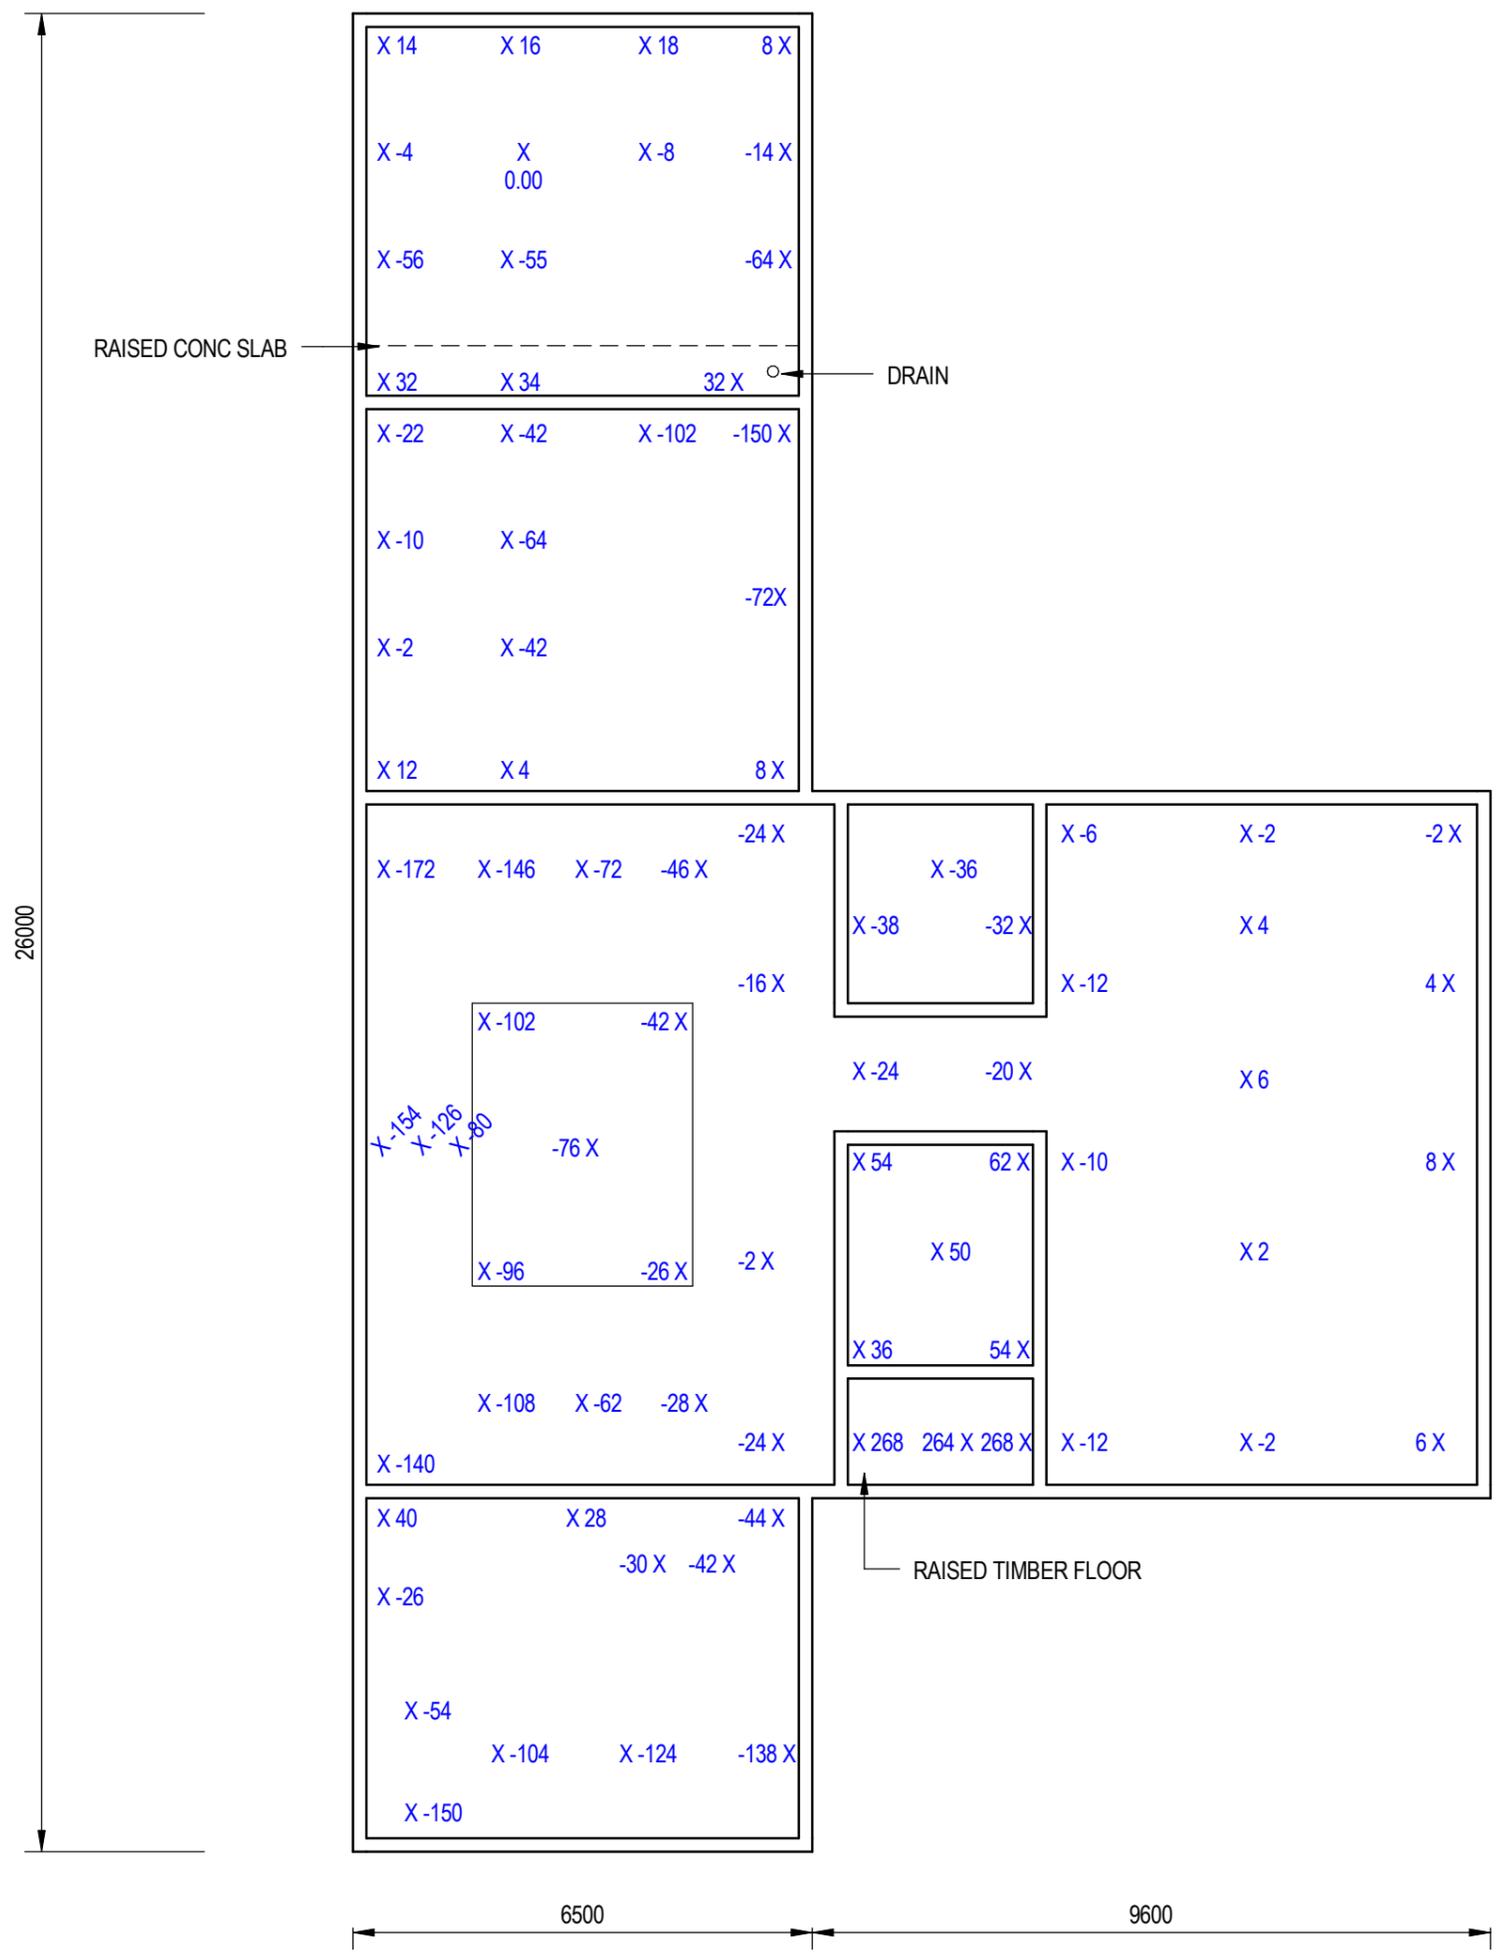
TITLE
LEVEL SURVEY

Levels Survey Results	Y	The floor slopes are within the DBH's Guidelines with falls of less than 1:200 or 0.5%.			
Building %NBS From Analysis	Approx. 36%	Based on out of plane unreinforced masonry performance. "Medium risk" category according to NZSEE guidelines refer Figure C1 in Appendix C.			
Qualitative L4 Report Recommendations					
Geotechnical Survey Required	N	A geotechnical survey is not required.			
Proceed to L5 Quantitative DEE	Y	Intrusive investigation and further analysis required to confirm the stability of the unreinforced concrete masonry walls.			
Approval					
Author Signature

A levels survey was undertaken on the floor coverings of the building to quantify the level of any unevenness. The levels survey results were within the 1 in 200 or 0.5% slope threshold set by the Department of Building and Housing’s November 2011 Guidelines. Therefore no further action in the form of re-levelling is considered necessary.
