Spencer Park Garage
Qualitative Engineering Evaluation

Reference: 228892

Prepared for:
Christchurch City
Council

Date: 2 July 2013

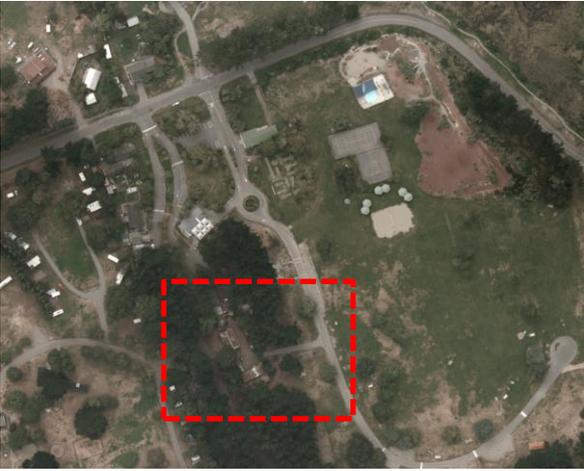
<p>General view of the spencer park site.</p>

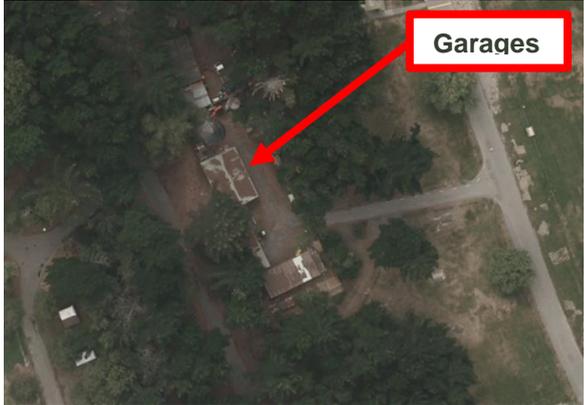
<p>Location of the Spencer Park Garage.</p>

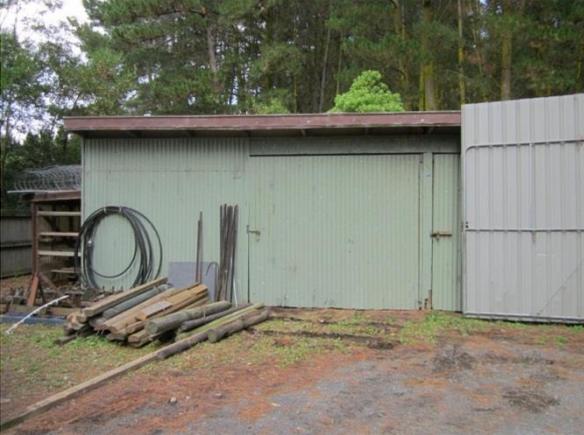
<p>Building northern elevation.</p>

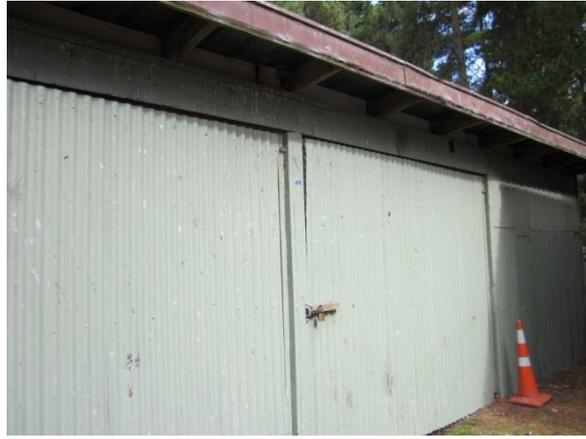
Building northern elevation.

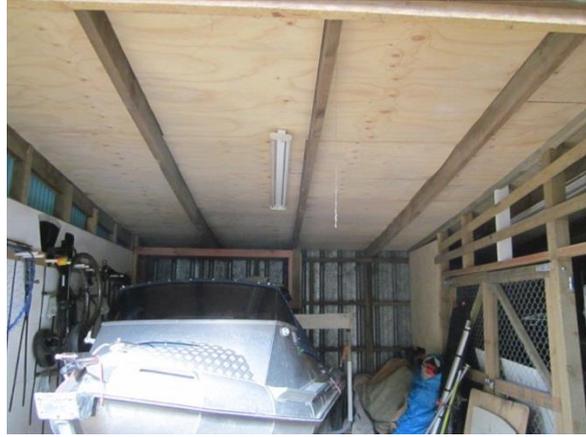
Building internal view.
