Spencer Park Camping Ground
Office Block
Qualitative Engineering Evaluation

Reference: 228608
Prepared for:
Christchurch City Council

Functional Location ID: BU 0157 007 EQ2

Address: 100 Heyders Road, Spencerville

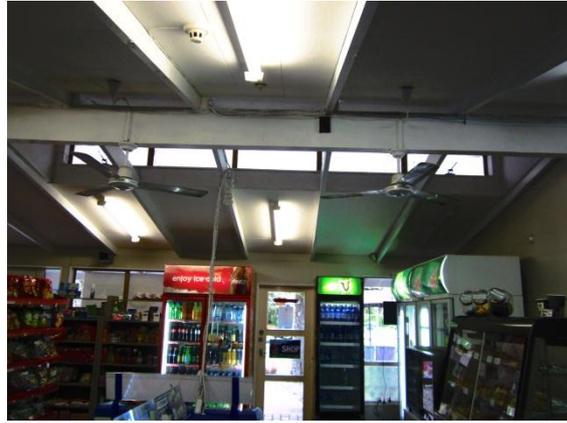
View beneath the pop up roof showing the lightweight timber beams, columns as well as timber framed walls.

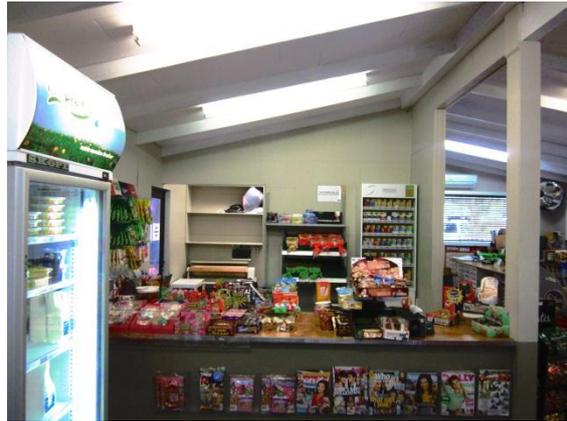
View inside the café showing a typical post which supports up the sail roof.

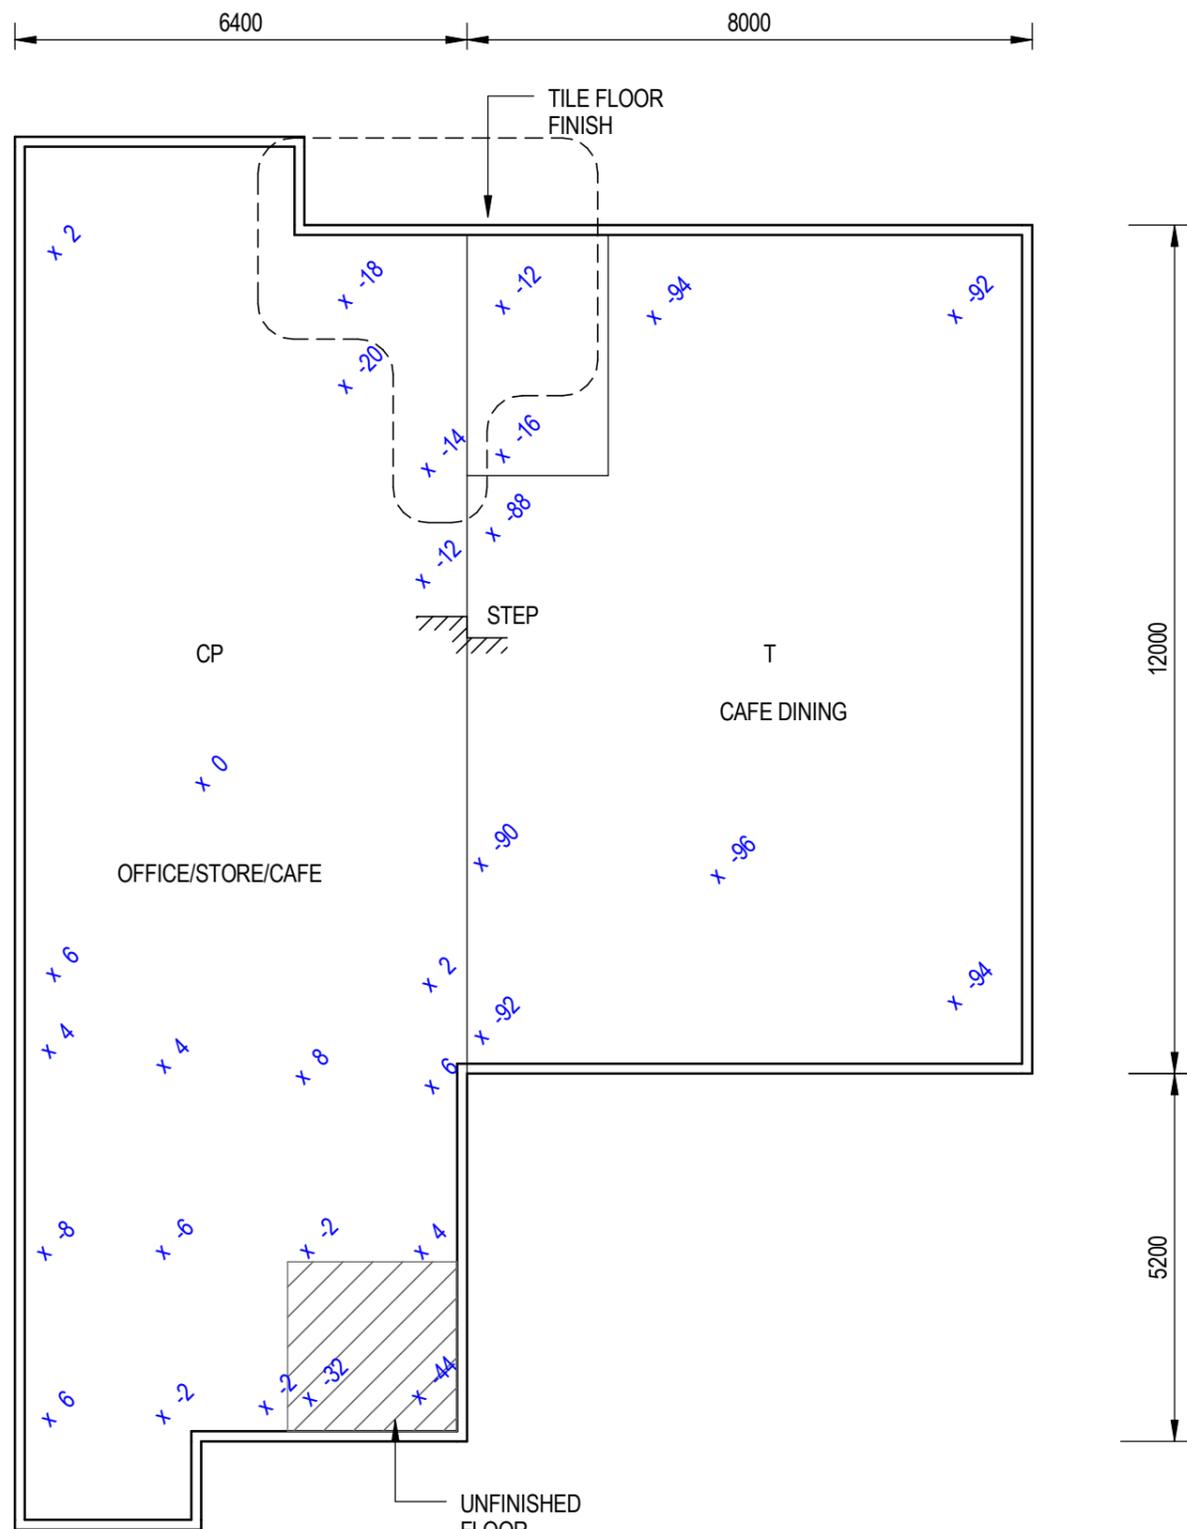
MAXIMUM VARIATION ACROSS GROUND LEVEL = 8mm
