Spencer Park Picnic Shelters
Qualitative Engineering Evaluation

Prepared for:
Christchurch City
Council

Address: Spencer Park, 100 Heyders Road

Date: 2 October 2012

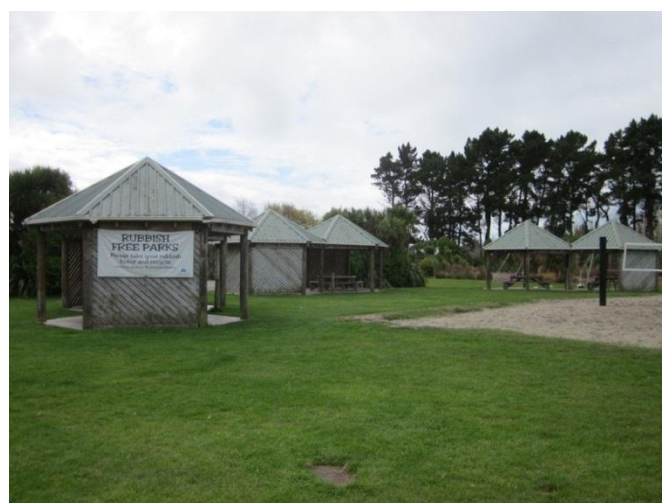
General view of the Picnic Shelters

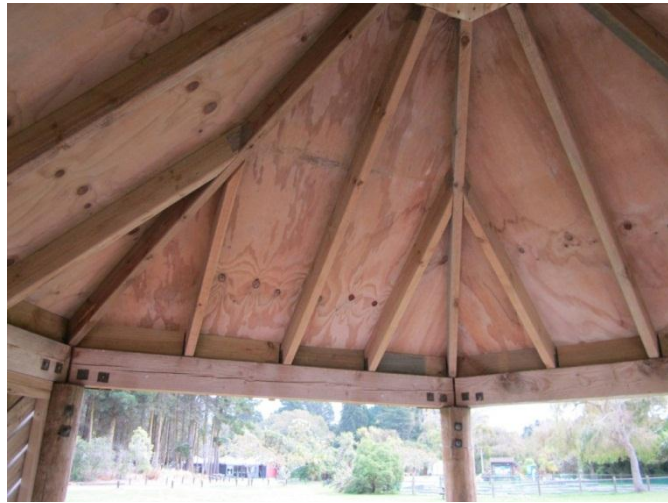
Internal view of the Picnic Shelters

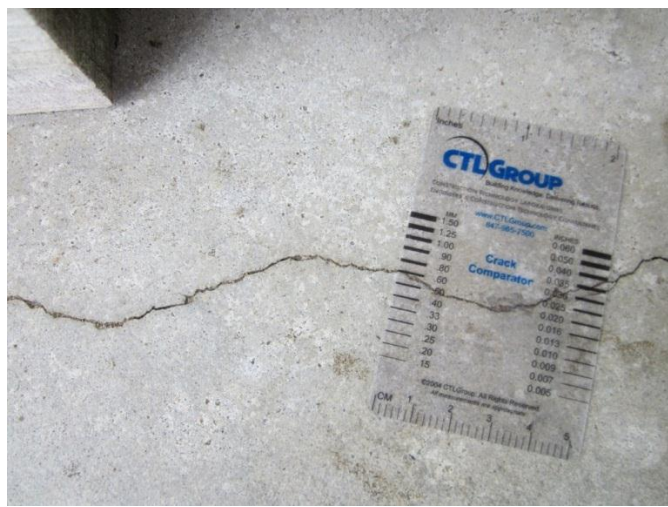
The Spencer Park Picnic Shelters have performed well and no damage was noted to the main structure. There was however some minor cracking of the floor slabs which is potentially earthquake related.

Minor cracking to slab
