Spencer Park Surf Club Toilets
Quantitative Engineering
Evaluation

Functional Location ID: PRK 2971 BLDG 002

Address: 100 Heyders Road, Bottle Lake

Date: 1 July 2013

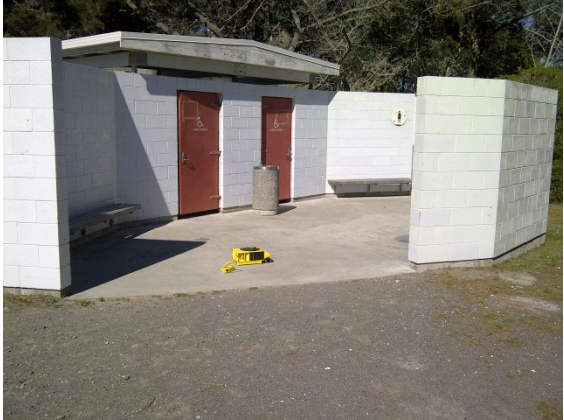
The cracks in the slab on grade do not seem to be related to seismic loads. The widest one (+/- 5mm) starts at the shower drain and ends at the drinking fountain (see photographs ref.6 in Appendix A). It separates the northern and outside slab on grade portion in two halves. These openings are the weakest points of the slab on grade. If concrete shrinkage or slight movement occurs, this weakest link will act as an expansion joint between the two halves of the building. Furthermore, the slab on grade is quite large and most likely lightly reinforced between these two parts (a mesh is assumed). From good practice, control joints in new buildings are recommended every 40 m², which is half of the actual slab on grade area. Nevertheless, this type of damage is not a critical issue and is very unlikely to create further damage.

Other smaller cracks were observed and are most likely also the result of shrinkage. Considering the proximity of TC3 lands, liquefaction and differential settlement might be other possible causes. Since the level of damage is very low and the results from the level survey are within the acceptable tolerances, no geotechnical survey is recommended.

6	Oblique view of the Spencer Park Surf Club Toilets and slab on grade cracking.

The slab on grade cracking can be repaired with epoxy grout injection in order to increase its longevity and prevent water infiltration.

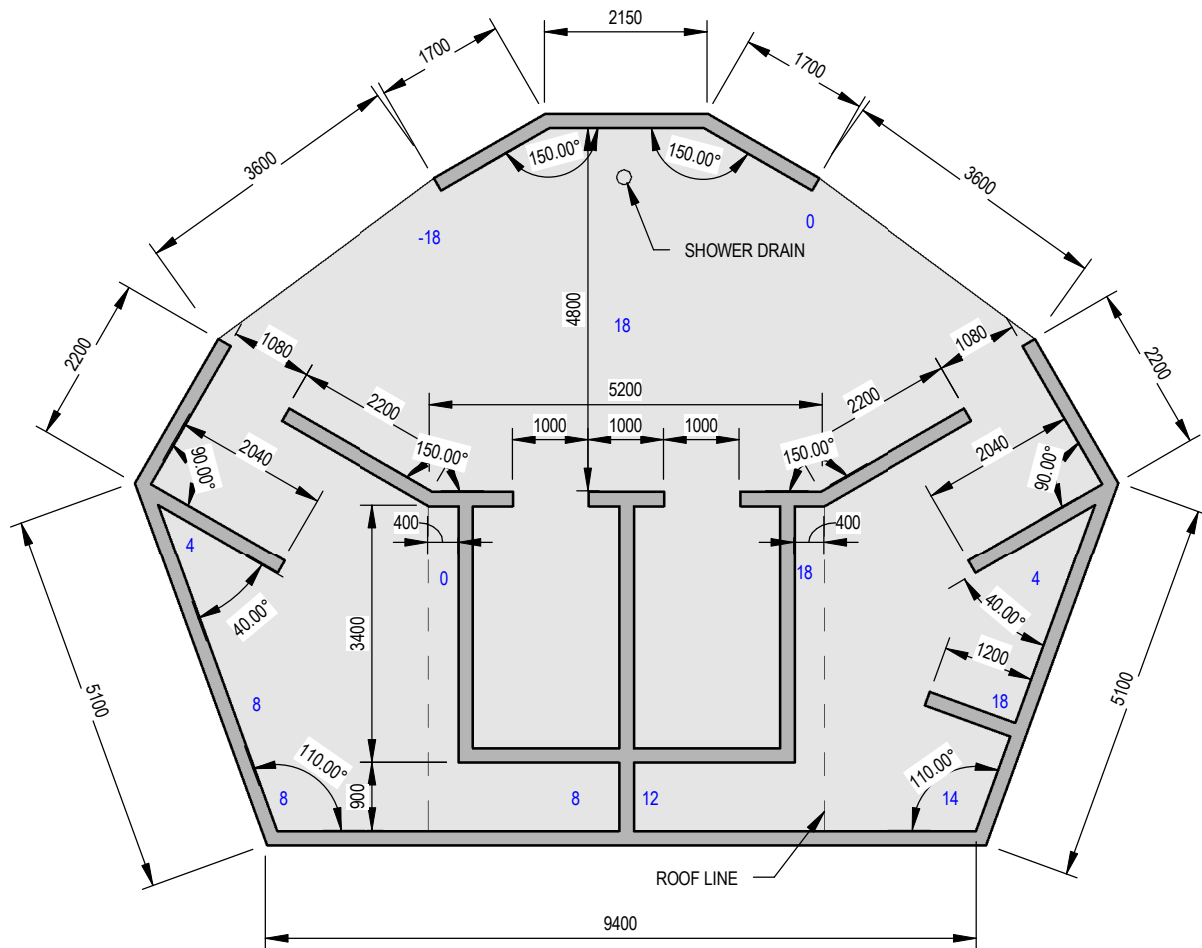
FLOOR LEVEL SURVEY

A floor level survey was undertaken to establish the level of unevenness across the floors. The results of the survey are presented on the attached sketch in Appendix A.

The floor levels for the Spencer Park Surf Club Toilets are considered to be acceptable despite the fact that some cracks were observed on the slab on grade. Furthermore, the toilet floors have an in-built fall for drainage. The slope from the shower is obviously over tolerances of standard floors, but it has been neglected during the overall evaluation because of its utility.
