Spencer Park Camping Ground  
Tourist Flats  
Qualitative Engineering Evaluation

Functional Location ID: BU 0157 008 EQ2

Address: 100 Heyders Road, Spencerville

**Reference:** 228610

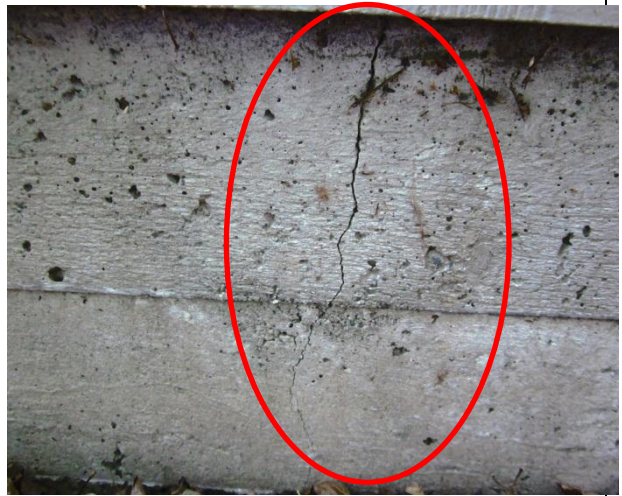
The cracking in the concrete slab on grade could be partially attributed to shrinkage and creep due to the size of the slab. However, when viewed from the exposed side, the differential widths of the cracks seen are wider at the top; thus implying bowing/hogging in the slab due to comparatively greater levels of settlement on the ends of the concrete slab on grade. Nevertheless, the levels survey has shown that the floor levels are within acceptable limits and no further action in the form of re-levelling is considered necessary.

Another instance of cracking in the concrete foundation pad.

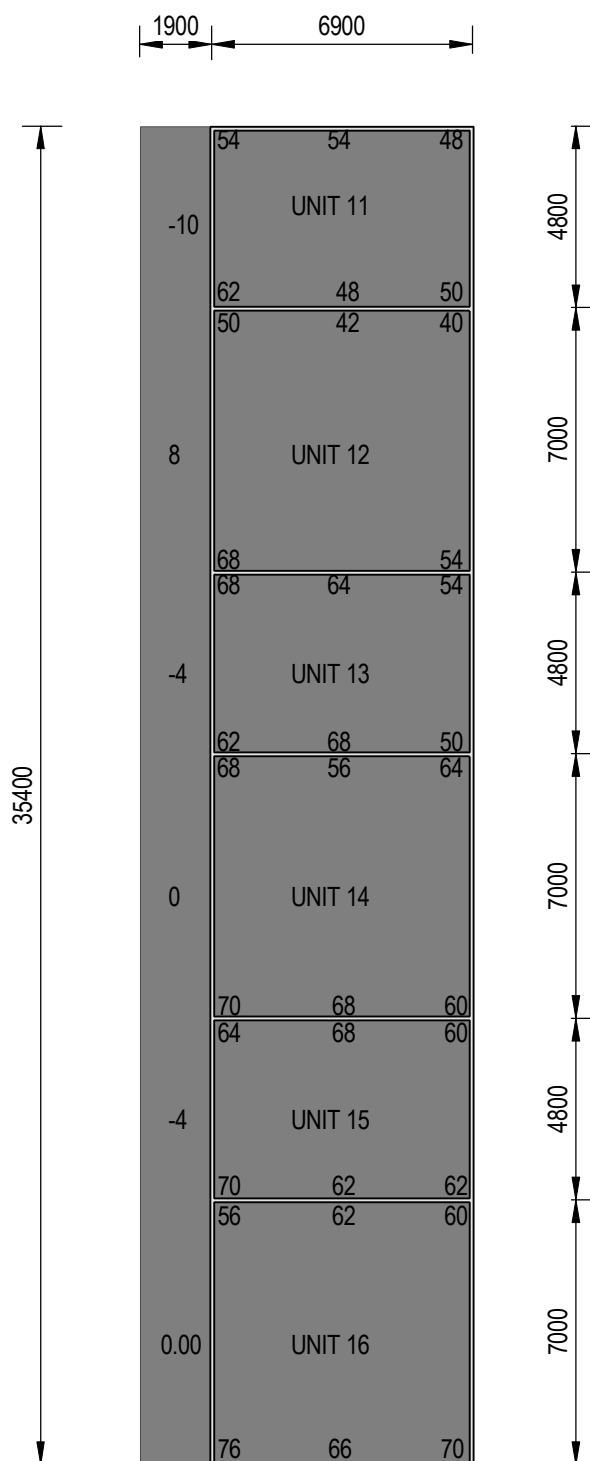
PROJECT  
TOURIST FLATS F BLOCK (BLUE DOORS)  
CHRISTCHURCH  
TITLE  
FLOOR LEVELS  
PLAN

A levels survey was undertaken on the floor coverings of the building to quantify the level of unevenness. The levels survey results were within the 1 in 200 or 0.5% slope threshold set by the Department of Building and Housing's November 2011 Guidelines. Therefore no further action in the form of re-levelling is considered necessary.
