Spreydon Library  
Qualitative Engineering Evaluation

**Reference:** 227256

**Prepared for:**  
Christchurch City Council

**Address:** 266 Barrington Street

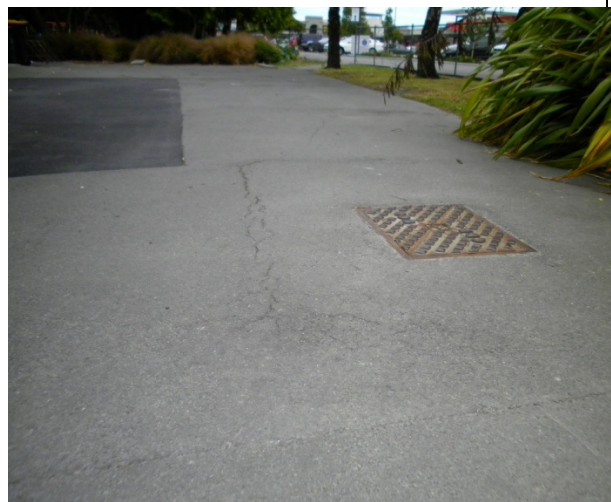
Repair work in adjacent car park due to liquefaction damage.

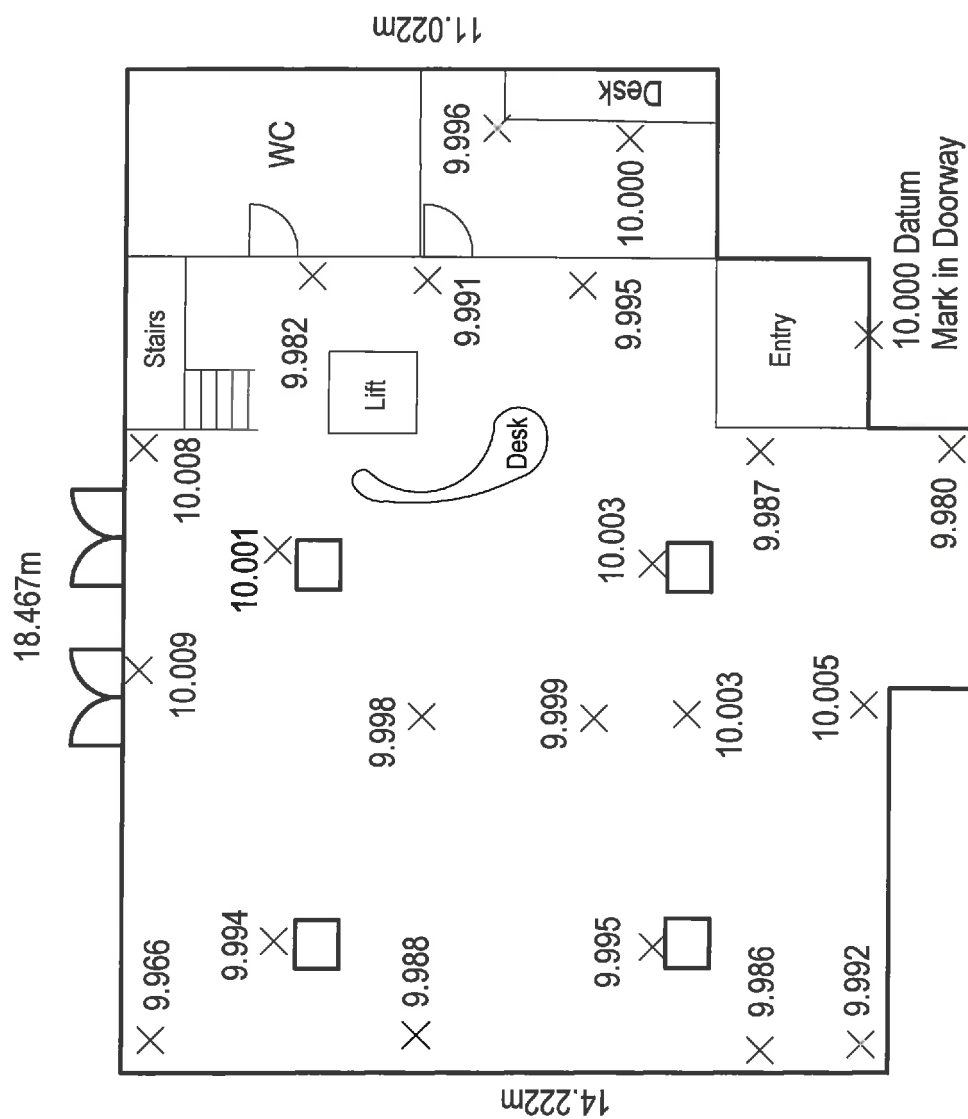
The floor levels for the Spreydon Library were found to be within the recommended tolerances excluding the north-west corner of the building which has a slope of near 1%. No damage to the slab or wall was observed, nor any slant in the window frames. It is our belief that this slope is a defect from construction and not earthquake related.
