St James Park Toilet
Qualitative Engineering Evaluation

Reference: 229181

Prepared for:
Christchurch City
Council

Address: 64 St James Avenue

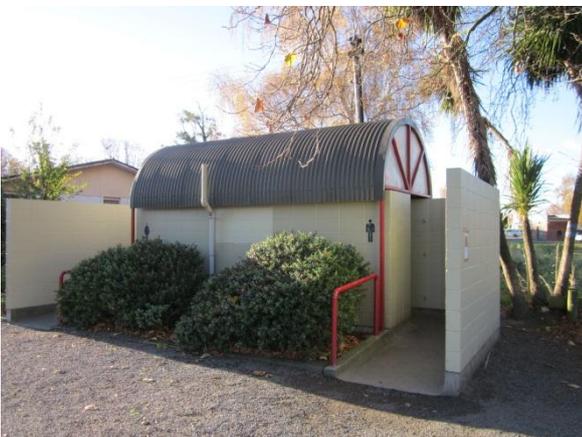
<p>Building south-west elevation.</p>

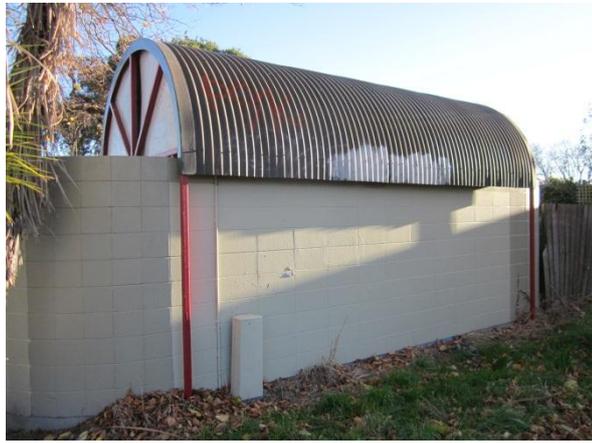
Building north-east elevation.

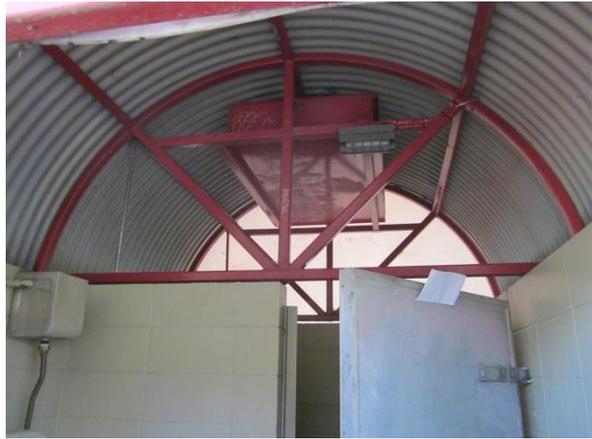
Interior view of steel trusses.

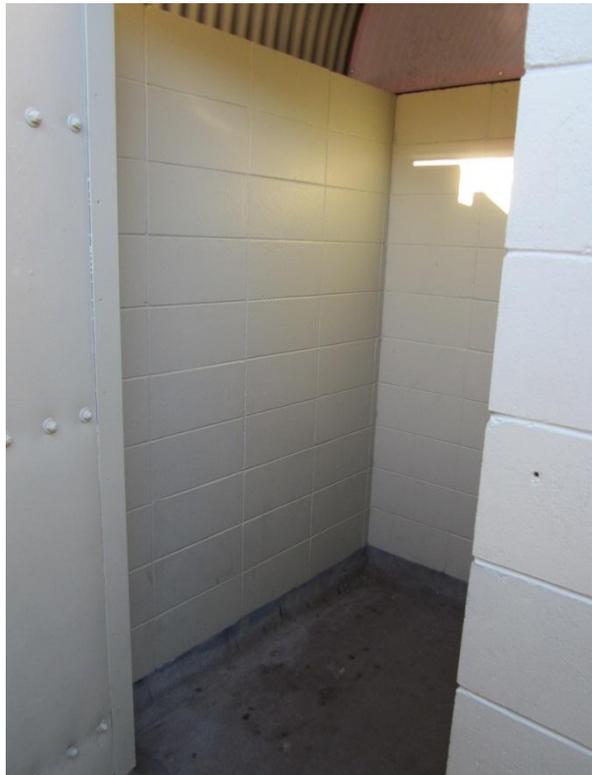
Interior view of reinforced concrete block walls.
