Christchurch City Council
PRK_3555_BLDG_009 EQ2
Toilet – Stoddart Point Reserve
1 J Waipapa Avenue

QUALITATIVE ASSESSMENT REPORT

FINAL

- Rev B
- 23 May 2013

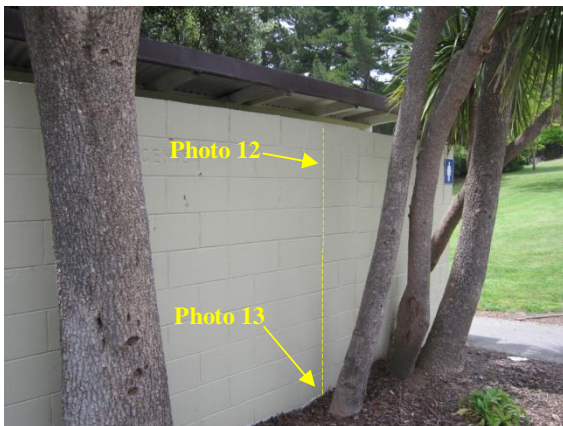
- 0.2mm vertical crack running entire height of masonry wall (photo 11 & 12)
- 1mm crack at foundation (photo 13)

Photo 11: View of front face of toilets, with line indicating the approximate location of vertical crack through masonry

Recommendations		Level of repair/strengthening required: minor non-structural		Describe: crack injection into wall	
		Building Consent required: no		Describe:	
		Interim occupancy recommendations: full occupancy		Describe:	
Along		Assessed %NBS before: 70%		If IEP not used, please detail assessment methodology:	
		Assessed %NBS after: 70%		Qualitative Assessment carried out, this includes the NZSEE IEP - refer to SKM report	
Across		Assessed %NBS before: 70%			
		Assessed %NBS after: 70%

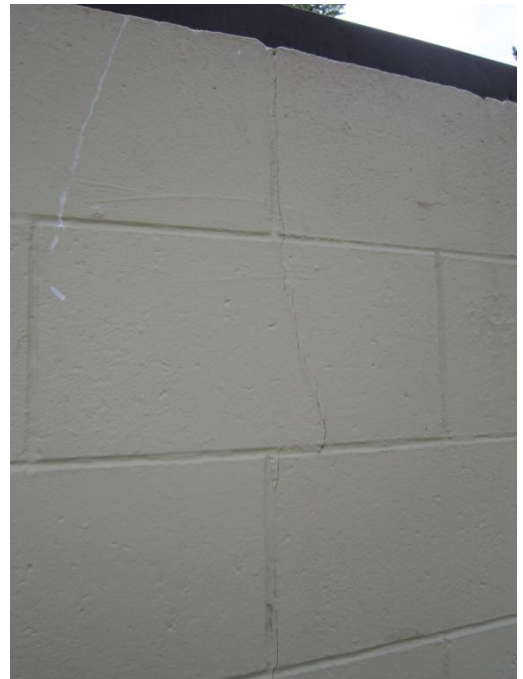
Photo 12: close up view from photo 11 showing 0.2mm cracks through masonry

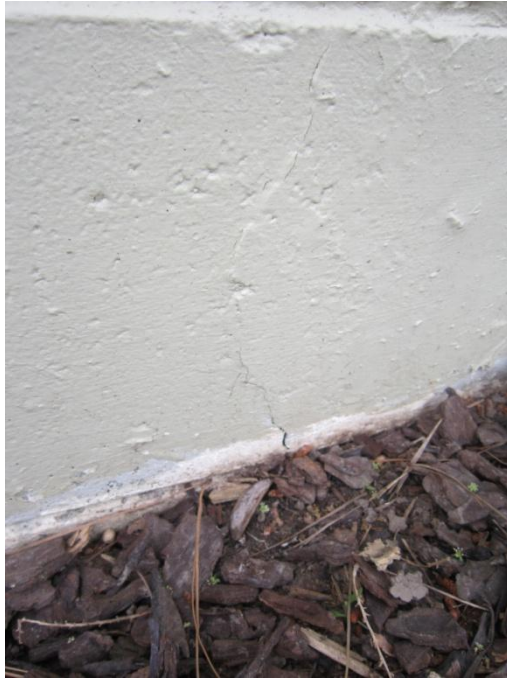
Photo 13: close up view from photo 11 showing
1mm cracks at foundation
