Styx Mill Reserve Park Toilet
PRK 0340-BLDG-002 EQ2
Detailed Engineering Evaluation
Qualitative Report
Version FINAL

130 Hussey Road, Harewood

Christchurch City Council

Date
6/11/12

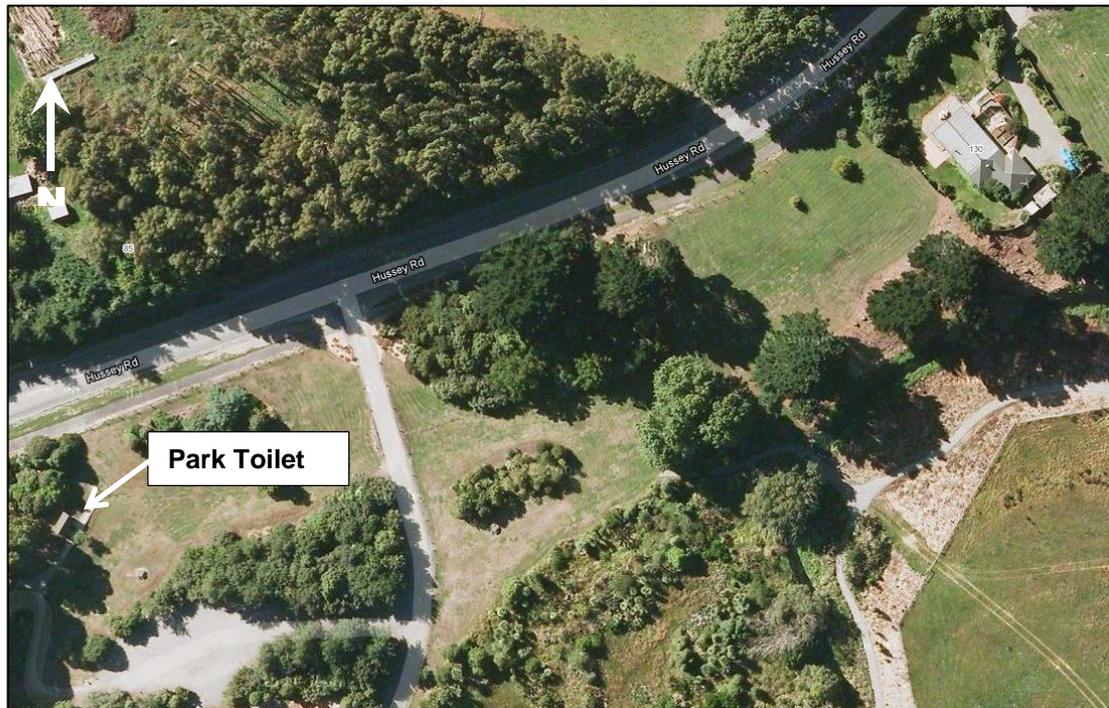
Figure 4 Post February 2011 Earthquake Aerial Photography ²

Aerial photography taken following the 22 February 2011 earthquake doesn't show the clear signs of liquefaction, as shown in Figure 4.

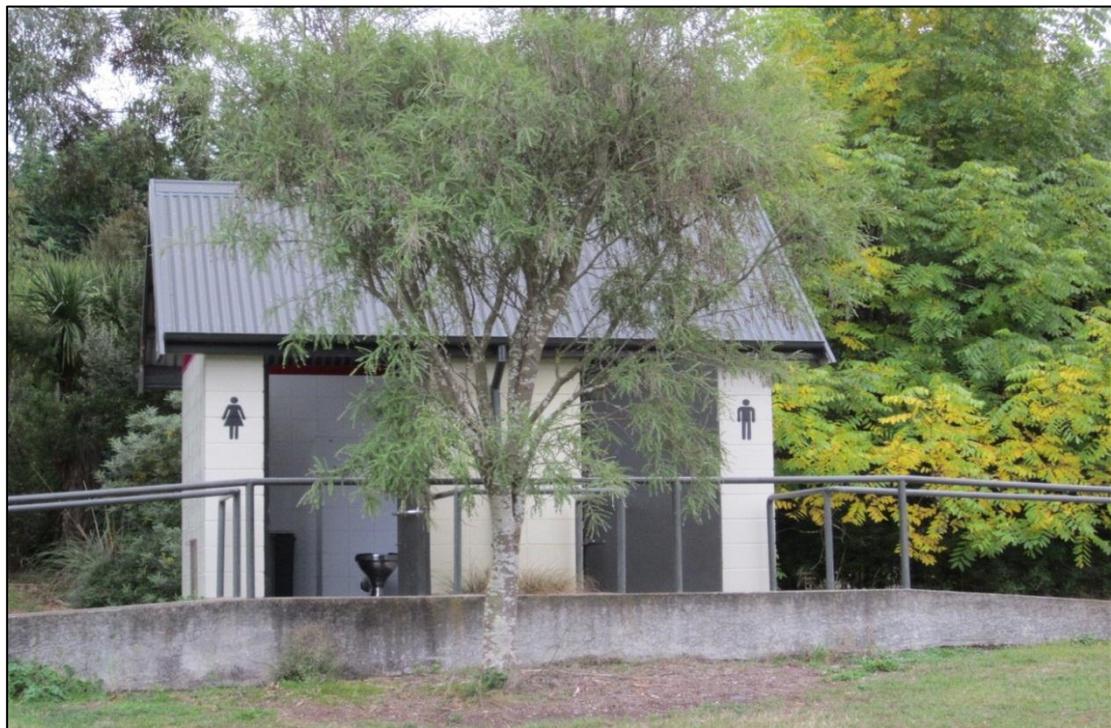
Photo 2 Park Toilet (Front, photo is taken facing northwest).

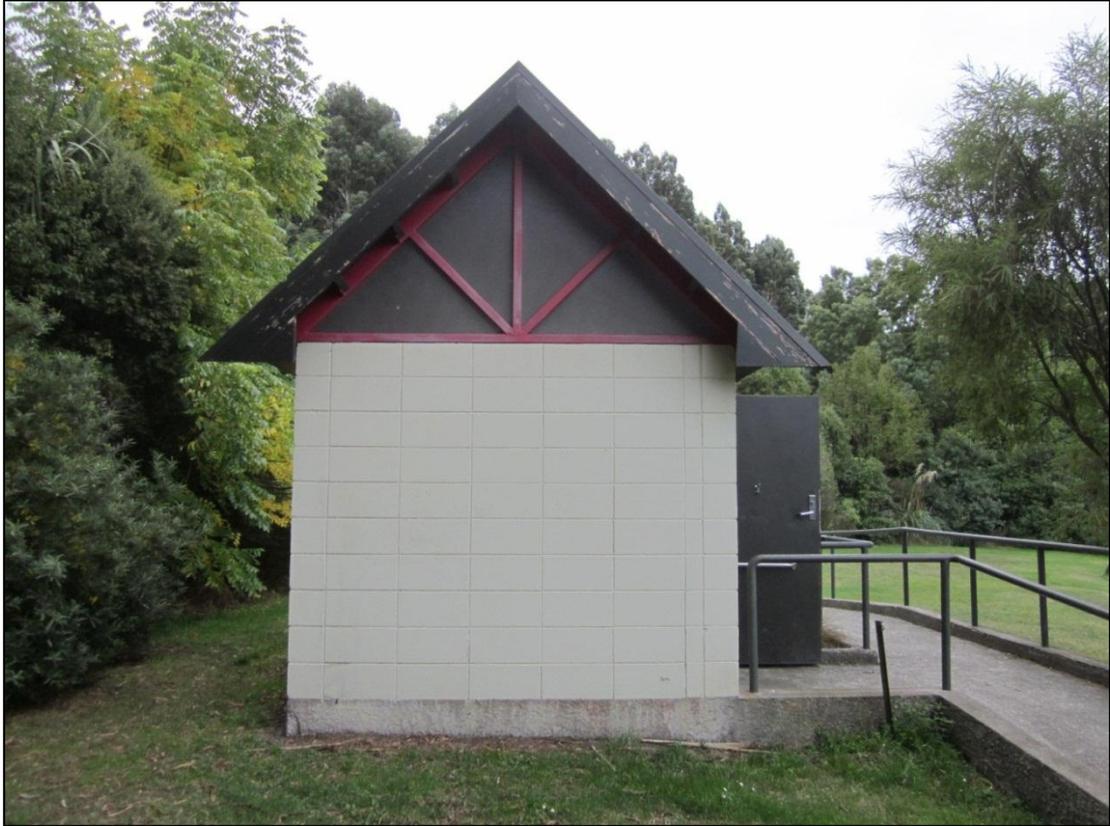
Photo 3 Park Toilet (Sideways, photo is taken facing northeast).

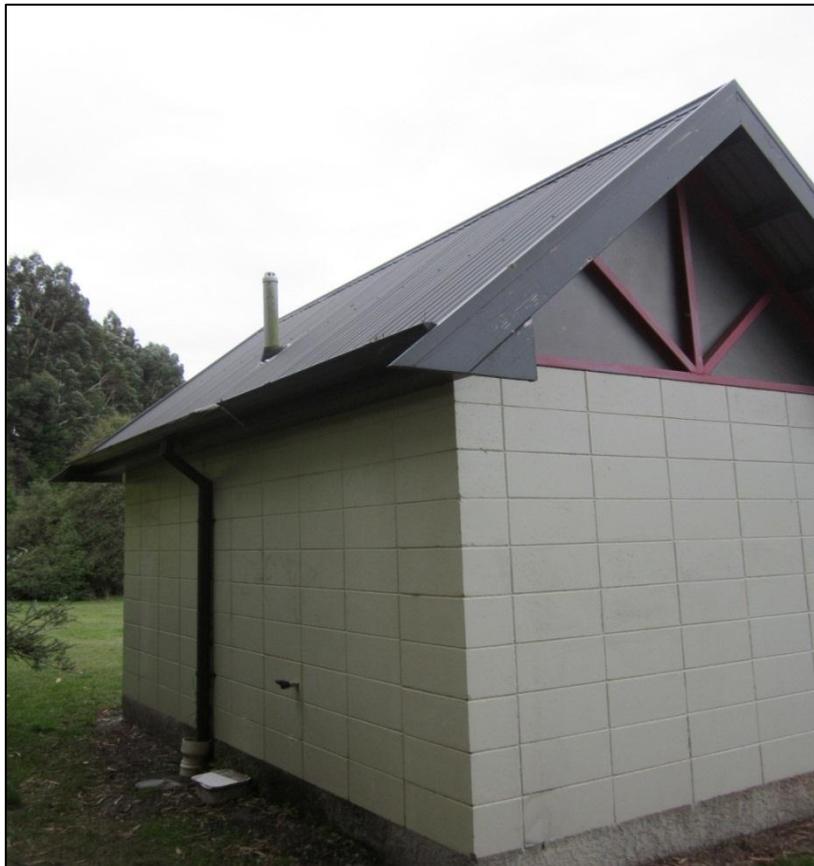
Photo 4 Park Toilet (Rear, photo is taken facing northeast).

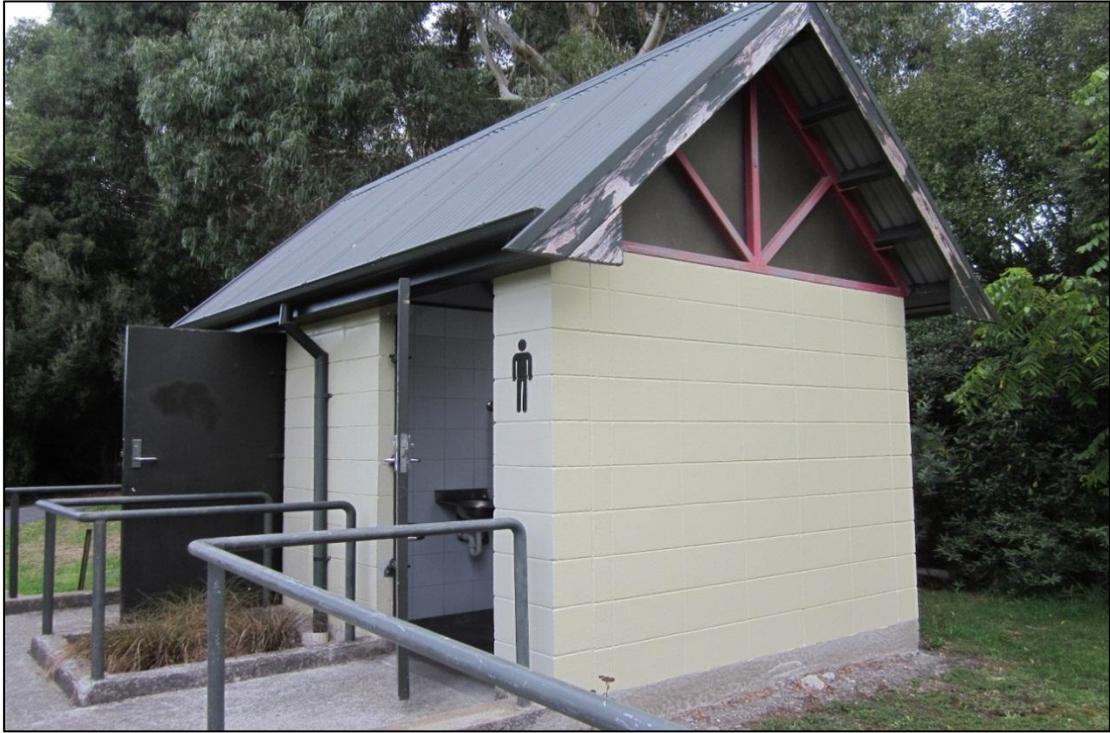
Photo 5 Park Toilet (Sideways, photo is taken facing southwest).

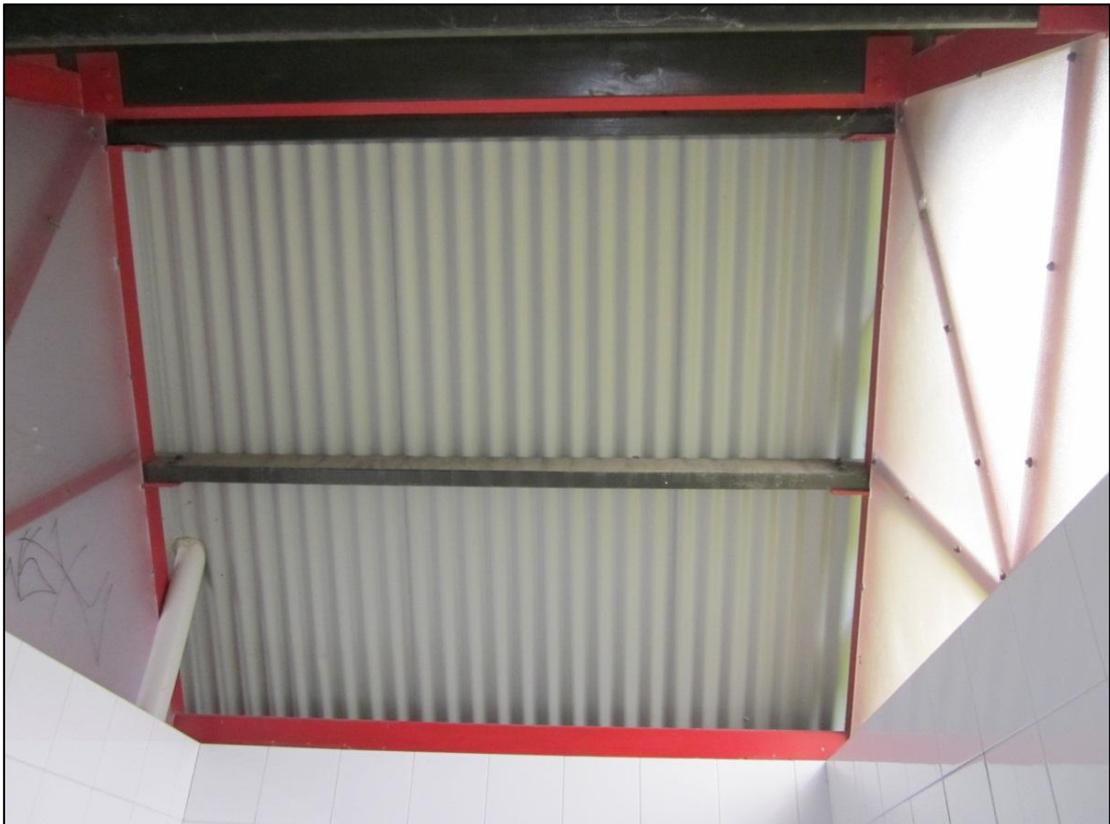
A lack of roof bracing was observed but was not regarded as a Critical Structural Weakness in this case due to the close spacing of the roof trusses and masonry walls and corrugated metal cladding.

Photo 6 View of the roof structure.

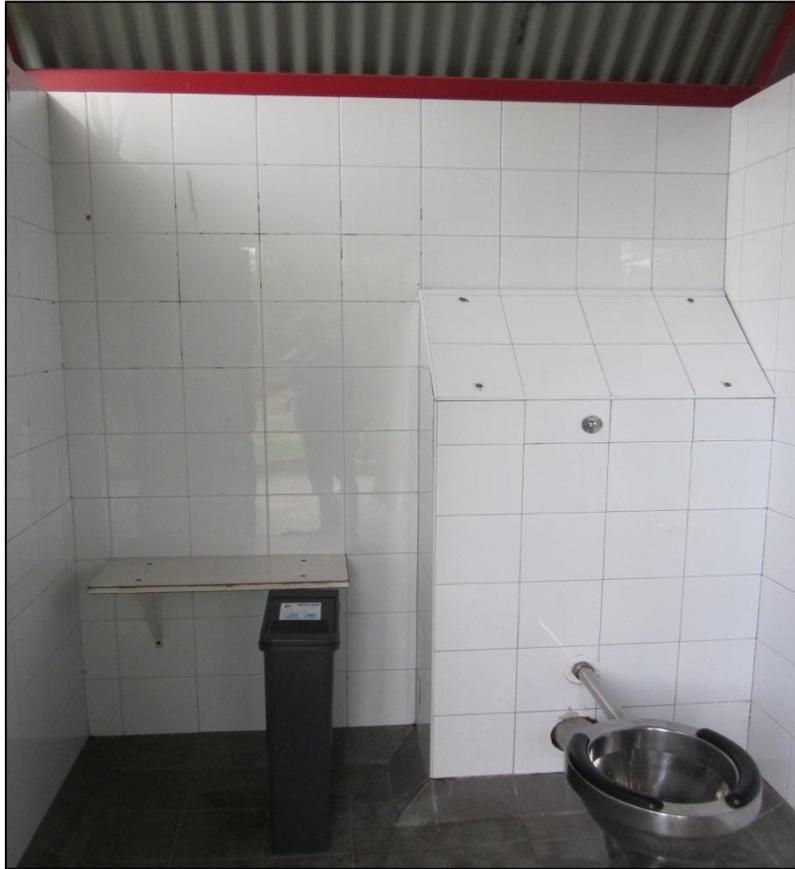
Photo 7 View of ceramic tiles cladding the perimeter and partition walls.
