**Barn - Styx River Reserve #2**  
**PRK 2546 BLDG 005-EQ2**  
Detailed Engineering Evaluation  
Qualitative Report  
Version Final

Styx River Reserve, 303 Radcliffe Road,  
Belfast, Christchurch

Christchurch City Council

**Date**  
06/03/13

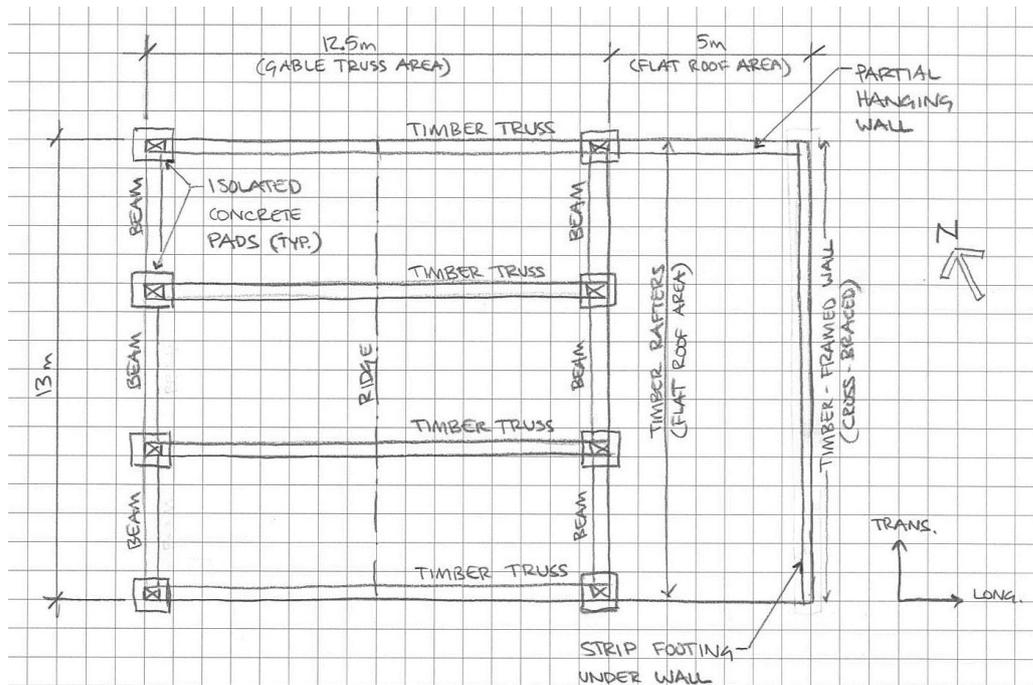
**Figure 2 Plan Sketch Showing Key Structural Elements**

The building shape in plan is a simple rectangle. The stiff eastern wall is balanced by knee braced portal connections along the western edge and the internal line of posts. However, the lack of bracing in the roof structure necessitates a significant critical structural weakness in the form of plan irregularity, as noted above.

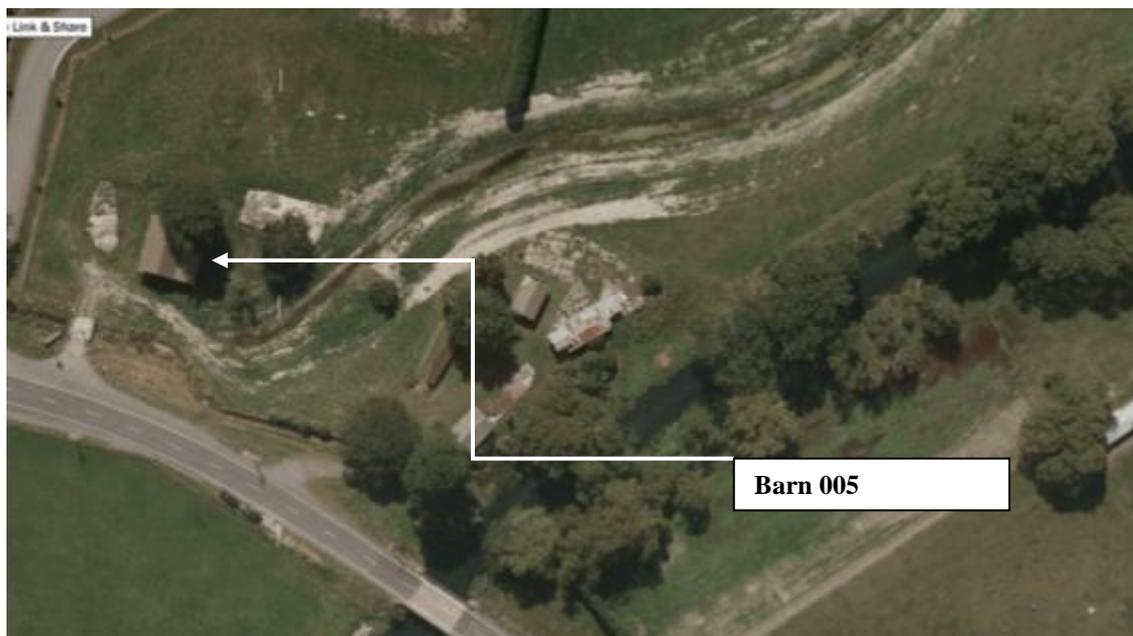
**Figure 3 Post February 2011 Earthquake Aerial Photography**<sup>2</sup>

Aerial photography taken following the 22 February 2011 earthquake shows a large amount of material on site (and properties adjacent) that maybe liquefaction as shown in Figure 3, although this material could also be evident on the surface due to a dry summer. However, lateral spreading is visible to the south along the Styx River. Material in the base of the drainage channel appears to be sand ejected from liquefaction.

Further investigation is recommended to better determine subsoil conditions. An intrusive investigation comprising one piezocone CPT test to 20m bgl is recommended to allow a more comprehensive liquefaction assessment to be undertaken.

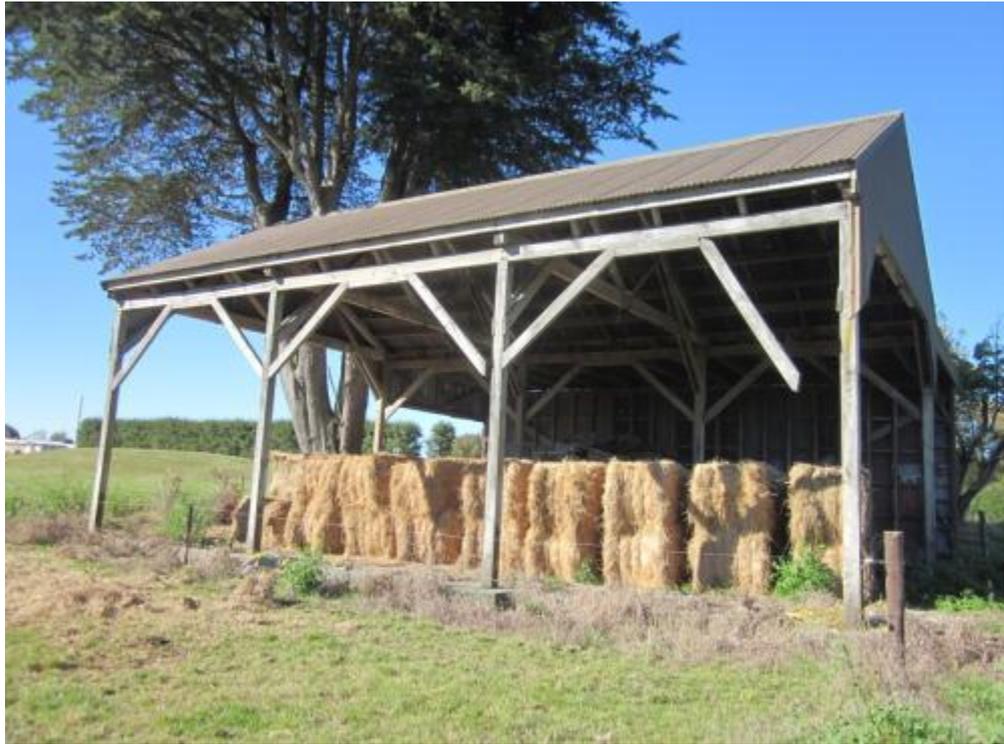
The barn displayed residual displacements in the knee-braced connections along the western edge of the building. Three of the knee-braced connections were disconnected from the posts and left hanging from the roof structure. These displacements appeared to be due to a lack of maintenance and not due to seismic damage.

**Photograph 1: West elevation.**

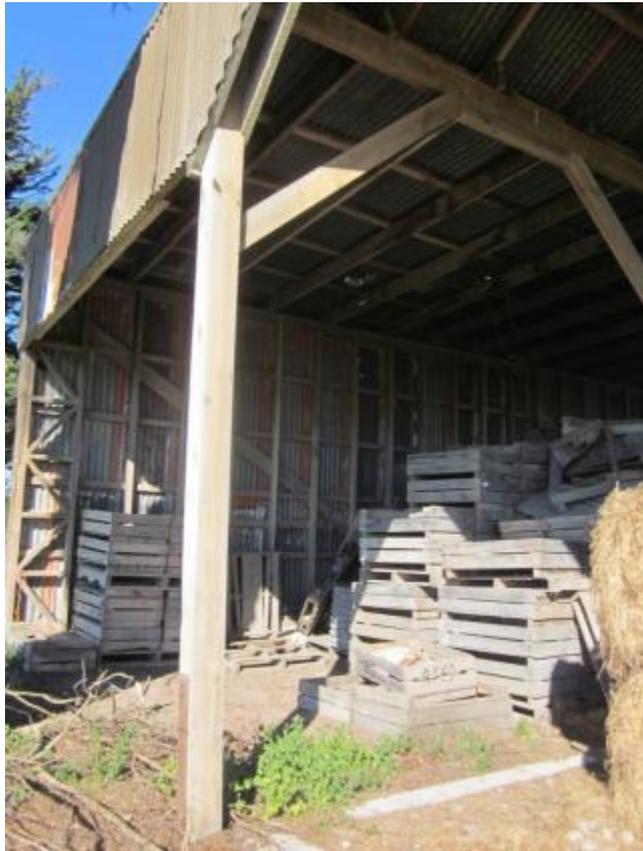
**Photograph 4: View of interior at north end. Note braced eastern wall.**

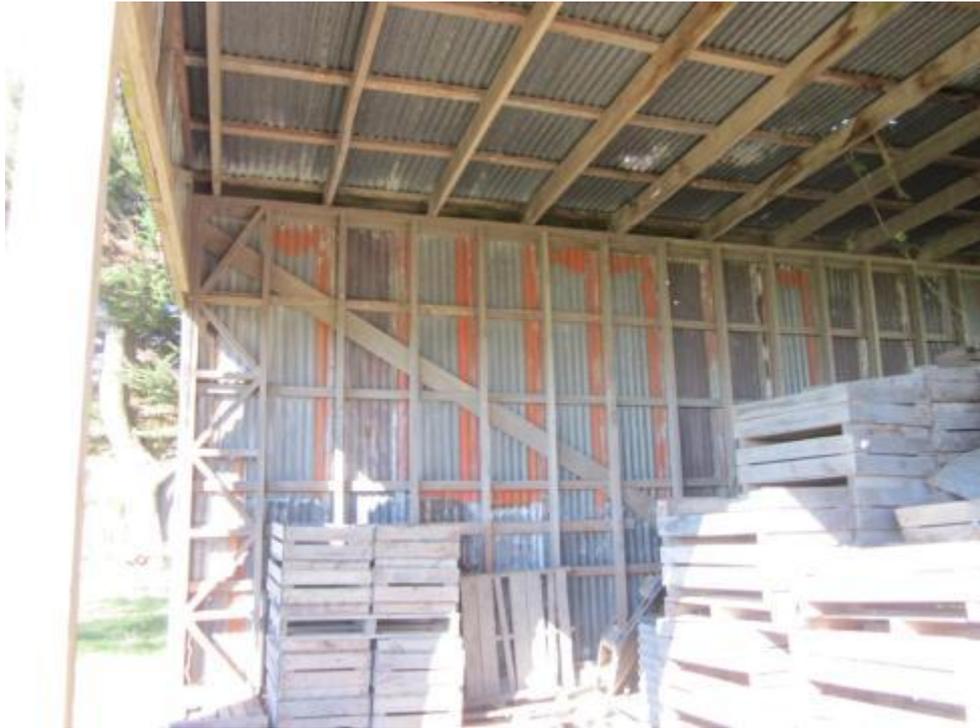
**Photograph 5: Interior view of cross-braced east wall and timber roof members.**

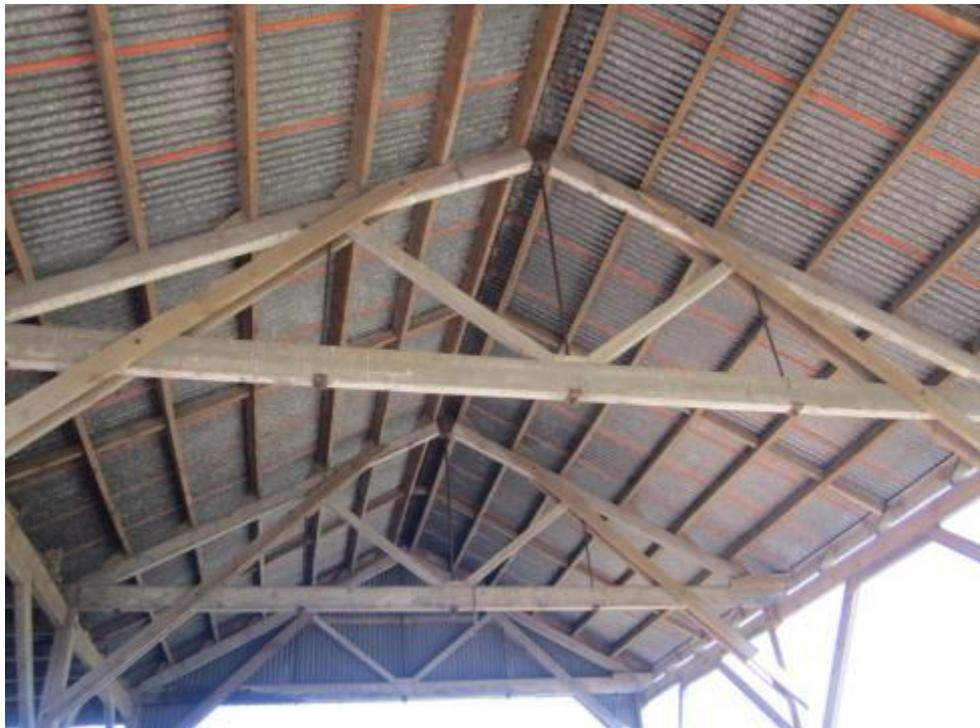
**Photograph 6: Interior view of knee-braced timber and steel rod trusses.**

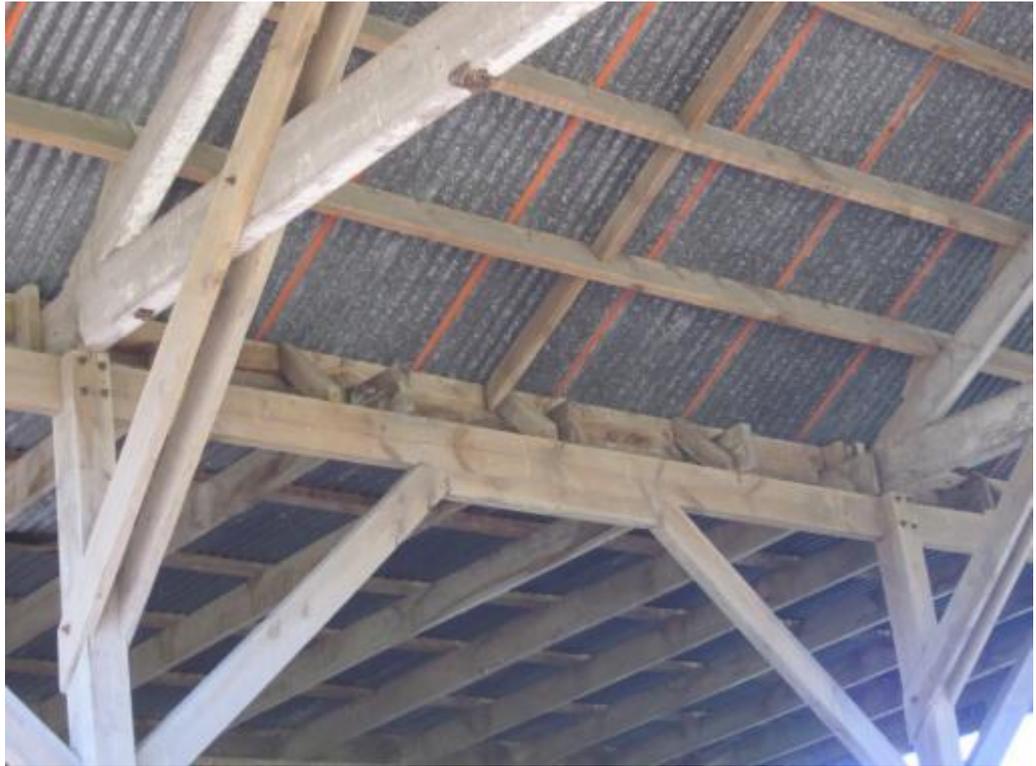
The duo-pitch roof structure features timber trusses with deep purlins running continuously atop the trusses, clad in corrugated steel. The mono-pitch roof structure features timber rafters and timber purlins, clad in corrugated steel. Neither of the two roof sections contain any cross-bracing. It is expected that very limited diaphragm action can be expected from the roof structure, though not enough to eliminate the presence of a critical structural weakness. A significant critical structural weakness has been noted as plan irregularity in the IEP assessment.

**Photograph 7: Interior view of junction between flat and trussed roof sections.**

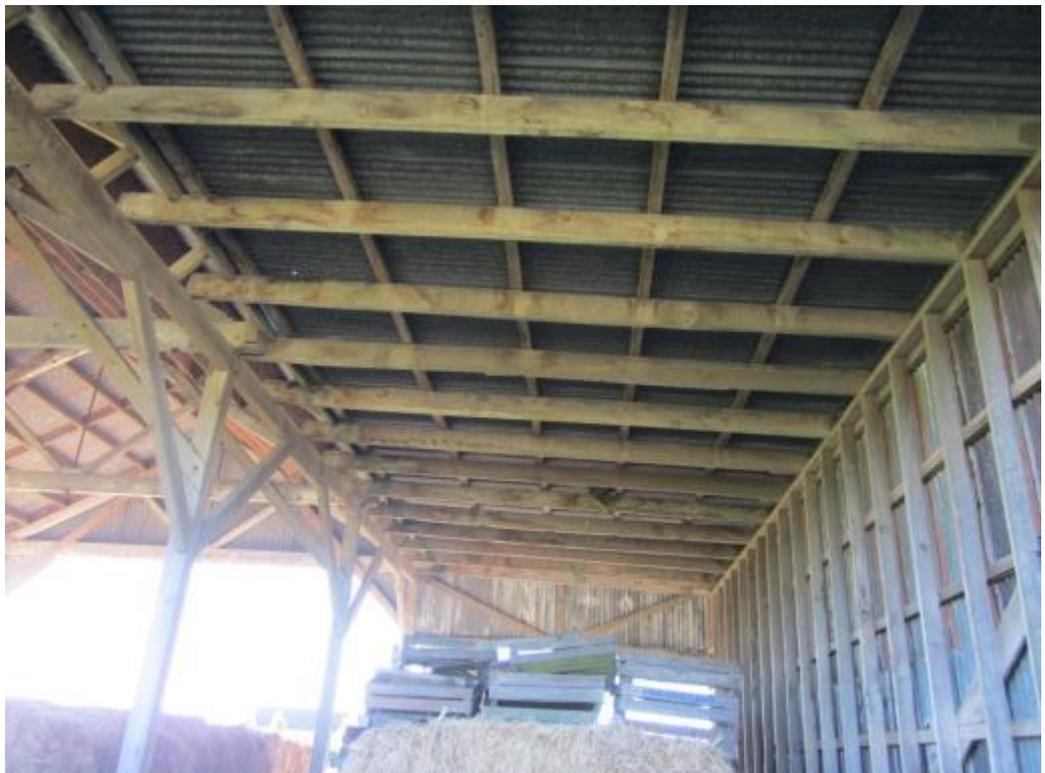
**Photograph 8: Interior view of flat roof section.**

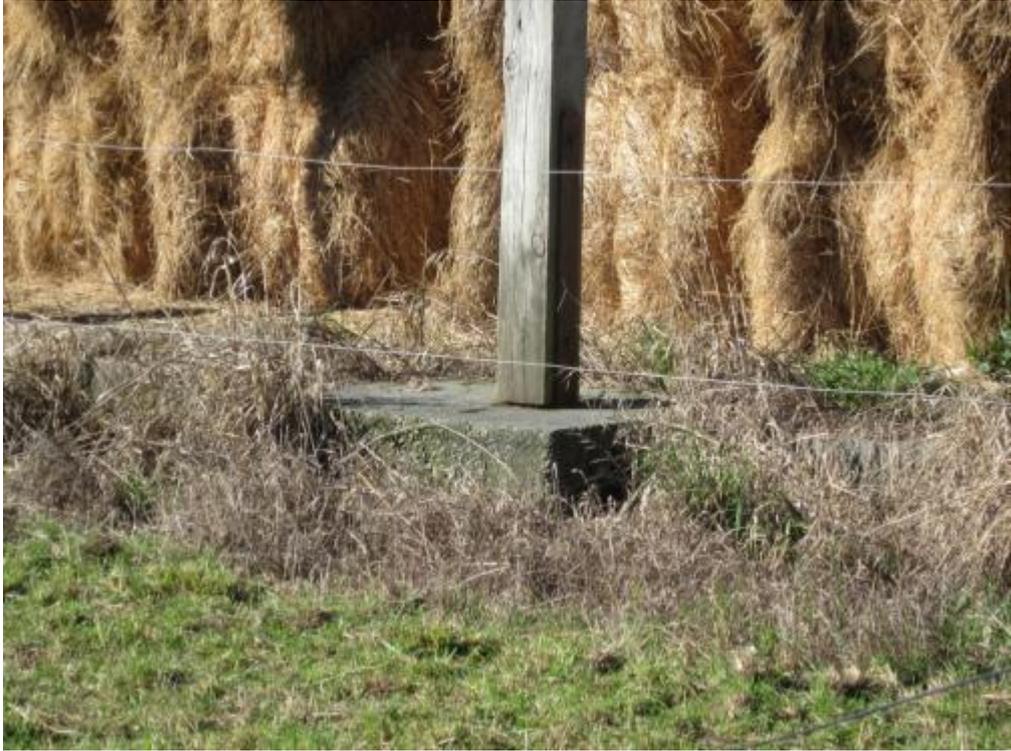
**Photograph 9: Typical post and concrete pad.**

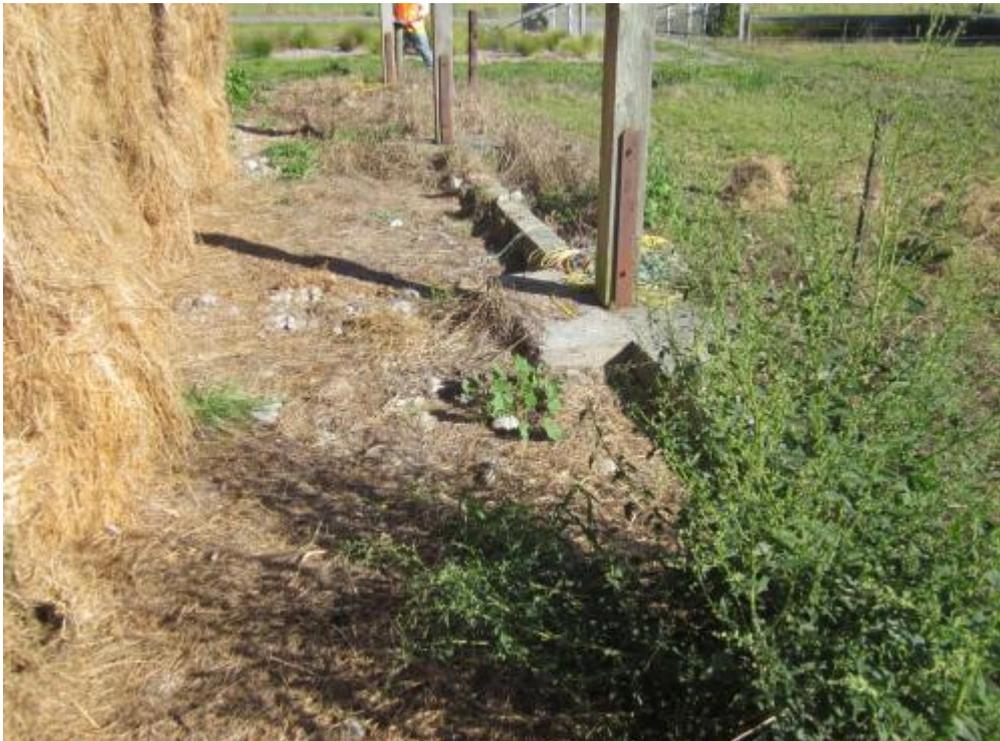
**Photograph 10: Timber posts and pad foundations at western edge.**
