**Plywood Clad Barn**  
**PRK 2635 BLDG 006 EQ2**  
Detailed Engineering Evaluation  
Qualitative Report  
Version FINAL

51 Lower Styx Road, Styx River Reserve

Christchurch City Council

**Date**  
12th December 2013

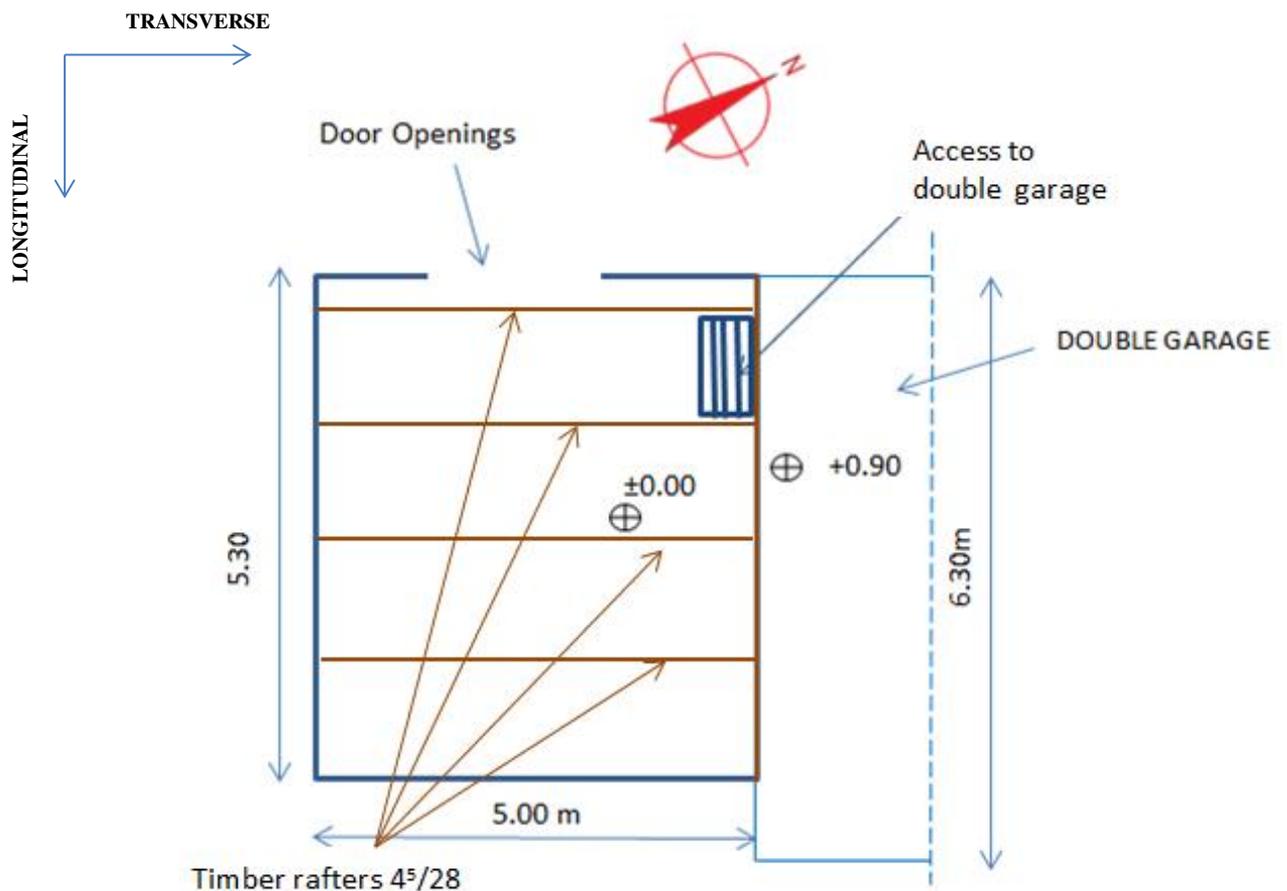
**Figure 2 Plan Sketch Showing Key Structural Elements**

- ▶ The building has a mono pitch corrugated steel roof supported on timber rafters without purlins which span in the transverse direction (no cross bracing is evident in the roof structure). The rafters are supported directly by the ply cladding and not timber framing.
- ▶ Walls are ply cladding with timber studs
- ▶ Floor is unreinforced concrete slab on grade with no apparent perimeter thickening

The building dimensions are 5.3m in length, 5m in width and 2.50m in height. The plan area of the building is approximately 26m<sup>2</sup>.

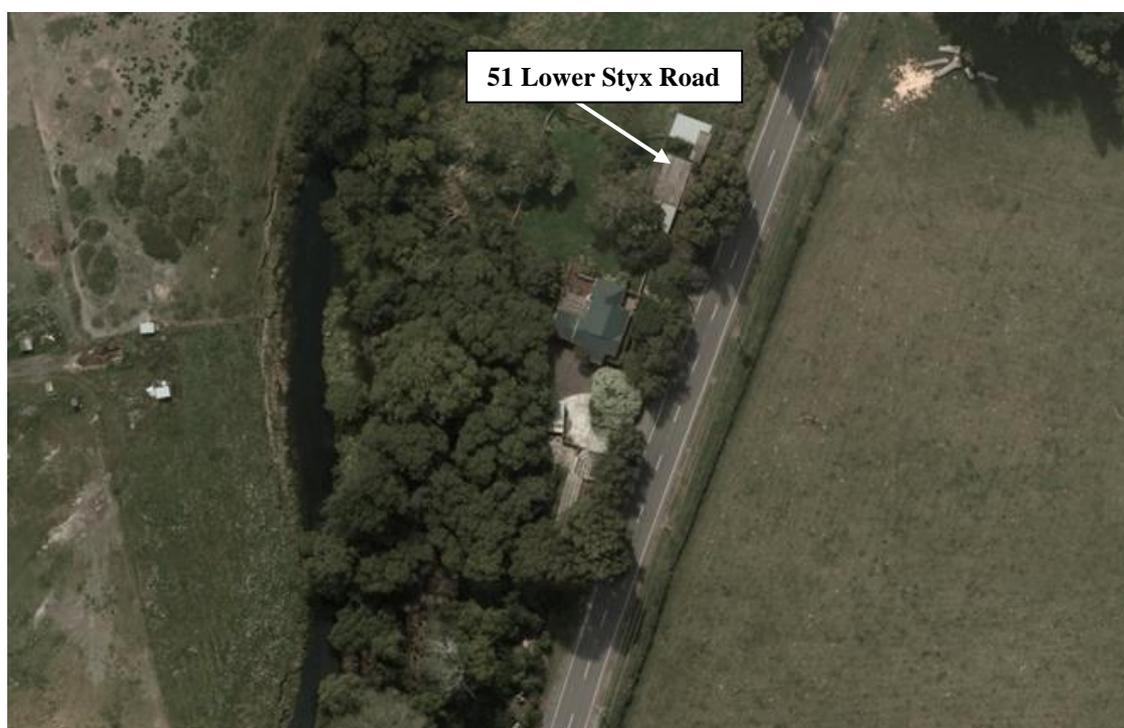
**Figure 3 Post February 2011 Earthquake Aerial Photography** <sup>2</sup>

Aerial photography taken following the 22 February 2011 earthquake shows no signs of liquefaction visible within the property boundary as shown in Figure 3. However, liquefaction in the form of sand boils and lateral spreading is evident on the western side of the Styx River (subject property is to the east).

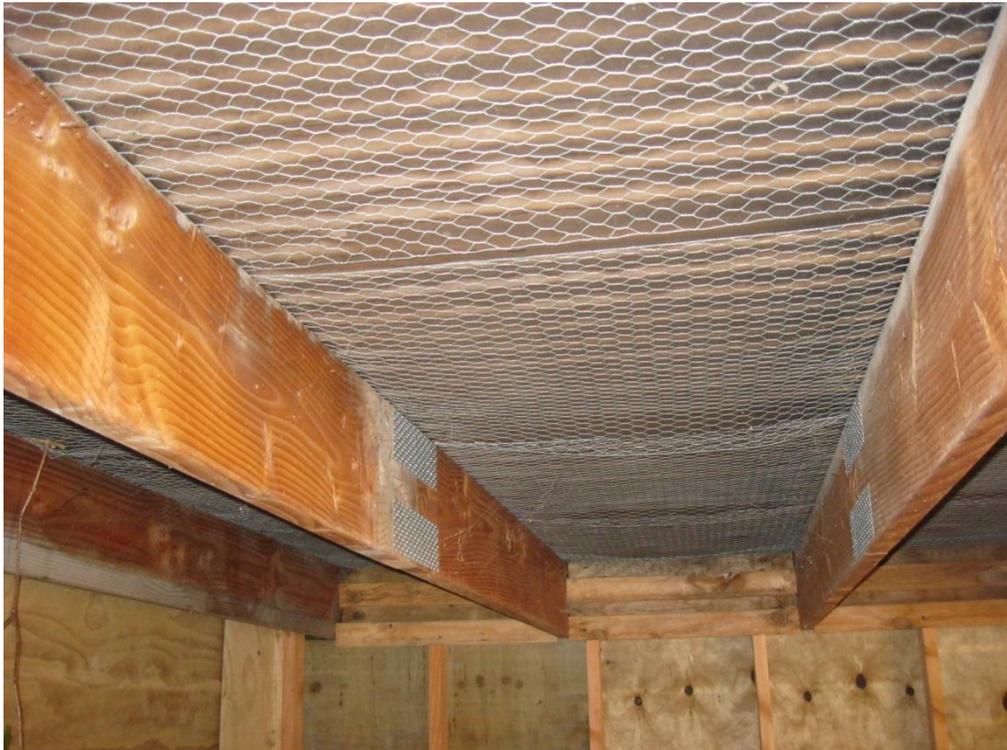
**Photograph 4 Internal view of the building showing roof construction and connection of the rafters to the cladding.**

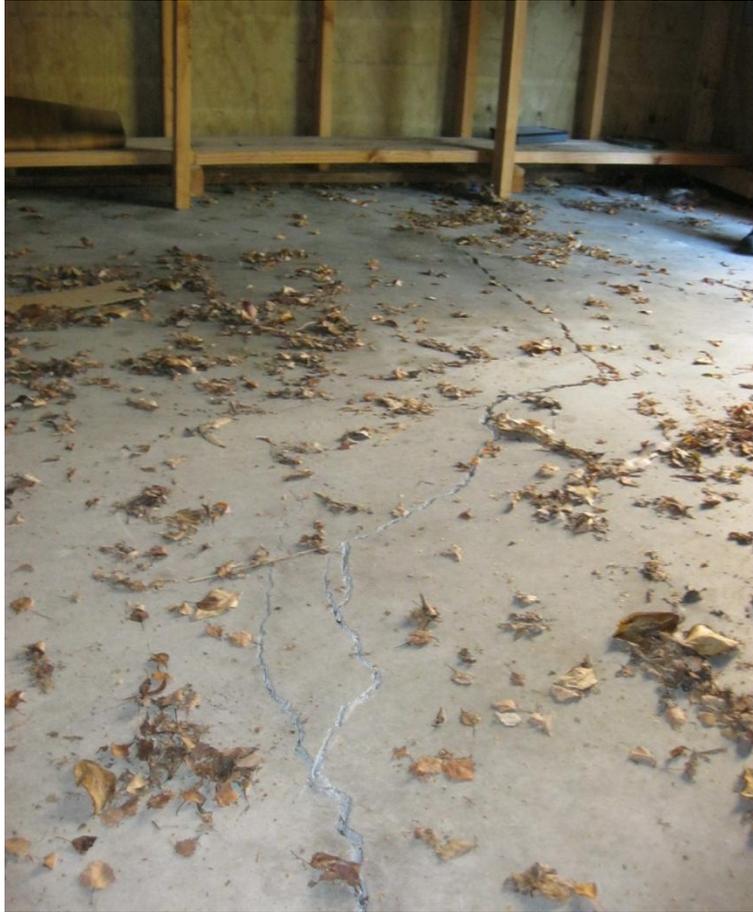
- ▶ Uneven floor surface with significant cracking of the slab

During the site inspection significant cracking of the slab was noted (see the photograph 5 and 6).

**Photograph 5 Internal view of the building showing cracking of the concrete floor.**

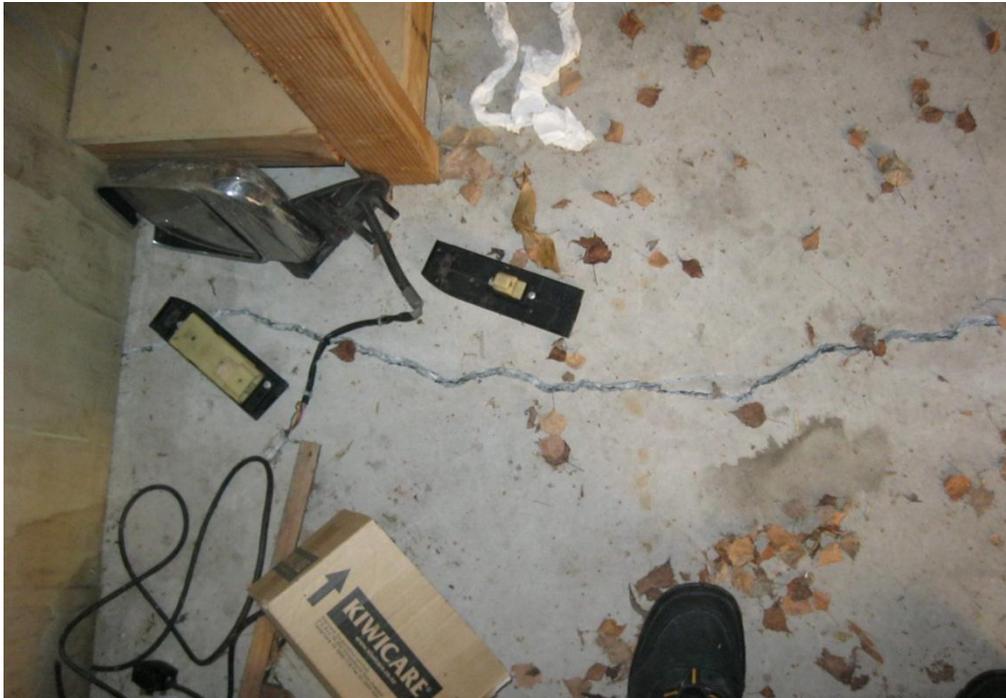
**Photograph 6 Significant cracking of the concrete floor, cracks ~ 3cm**
