Shed - 001
Styx River Reserve #2
PRK 2546 BLDG 001

Detailed Engineering Evaluation
Qualitative Report
FINAL Version

Styx River Reserve, 303 Radcliffe Road,
Belfast, Christchurch

Date
24/05/2013

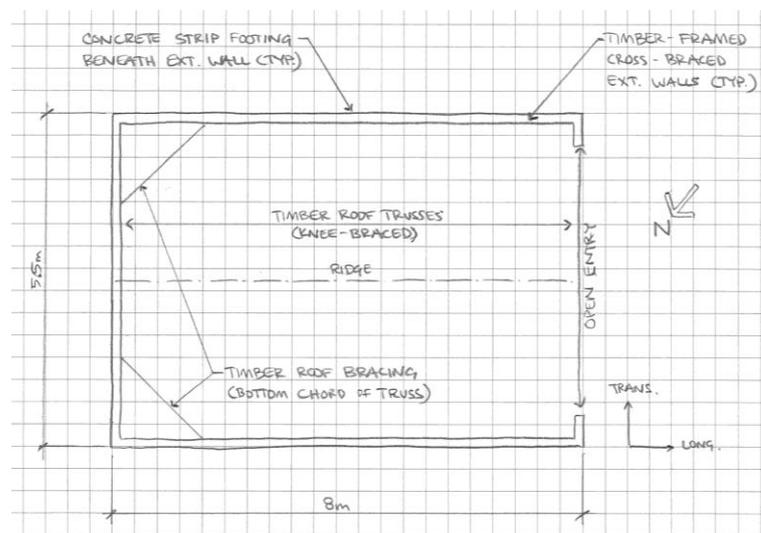
Figure 2 Plan Sketch Showing Key Structural Elements

The general structure is a 3-sided rectangular timber shed with a duo-pitch roof. The roof consists of corrugated steel cladding atop timber sarking which is attached to timber purlins. The purlins run in the longitudinal direction of the building and are supported by shallow timber trusses oriented in the transverse direction of the building. Roughly half of the timber trusses feature knee bracing between the trusses and vertical timber studs of the external walls. Timber cross-bracing members span across the two rear corners of the roof, in plane with and attached to the underside of the bottom chords of the trusses. The load-bearing exterior walls are timber-framed and cross-braced with timber, and clad on the exterior with corrugated steel. There appears to have been a window opening in the original design of the north transverse wall that has since been framed in and clad on the exterior with the same corrugated steel that is used on the rest of the exterior walls. There are no internal walls. The front of the building (to the south) is an open entry to the barn, with a regular timber truss spanning the opening. There is no floor to the barn, only soil on-grade. The three external walls sit atop short concrete foundation walls which are supported by concrete strip footings. The dimensions of the building are approximately 11.4m long by 6.2m wide and 2.6m in height.

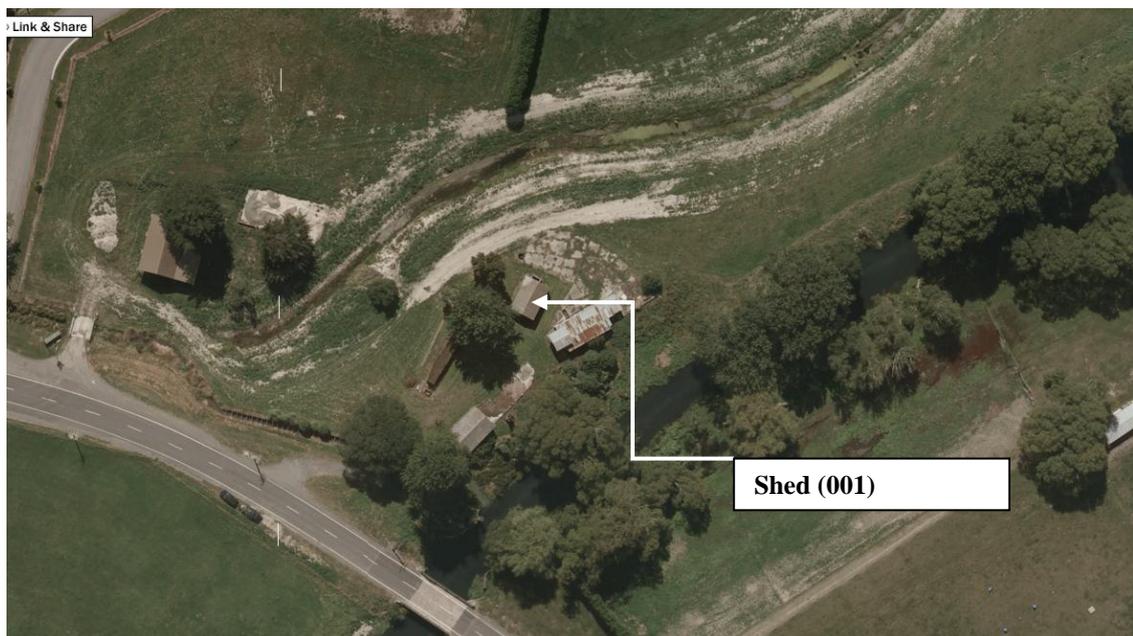
Figure 3 Post February 2011 Earthquake Aerial Photography²

Aerial photography taken following the 22 February 2011 earthquake shows a large amount of material on site (and properties adjacent) that maybe liquefaction as shown in Figure 3, although this material could also be evident on the surface due to a dry summer. However, lateral spreading is visible to the south along the Styx River. Material in the base of the drainage channel appears to be sand ejected from liquefaction.

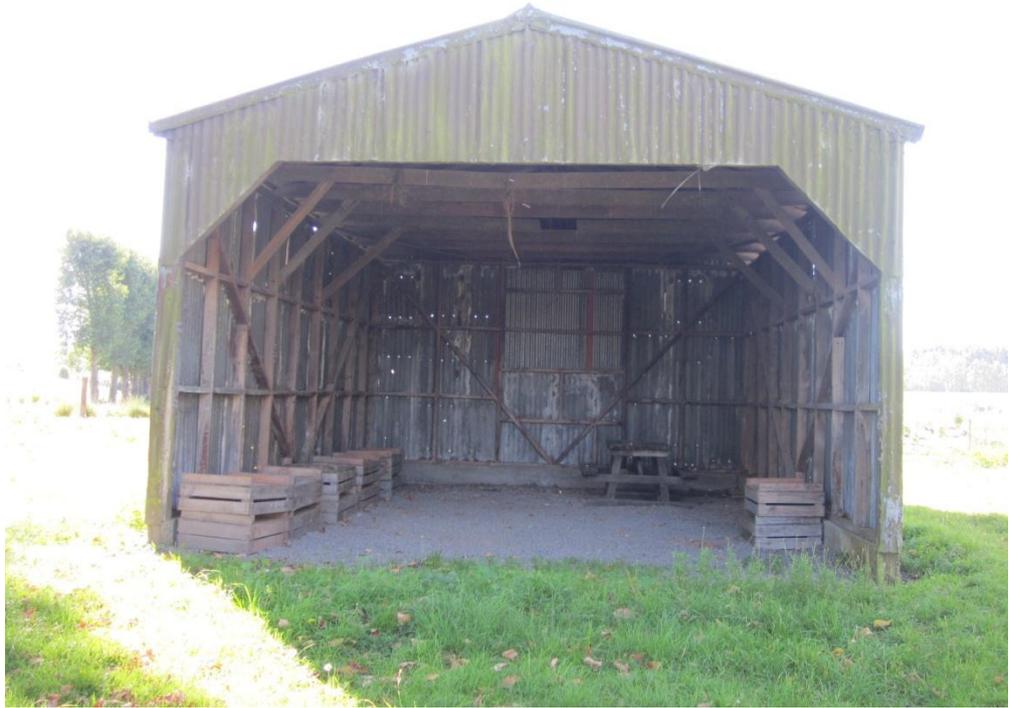
Photograph 1: South elevation.

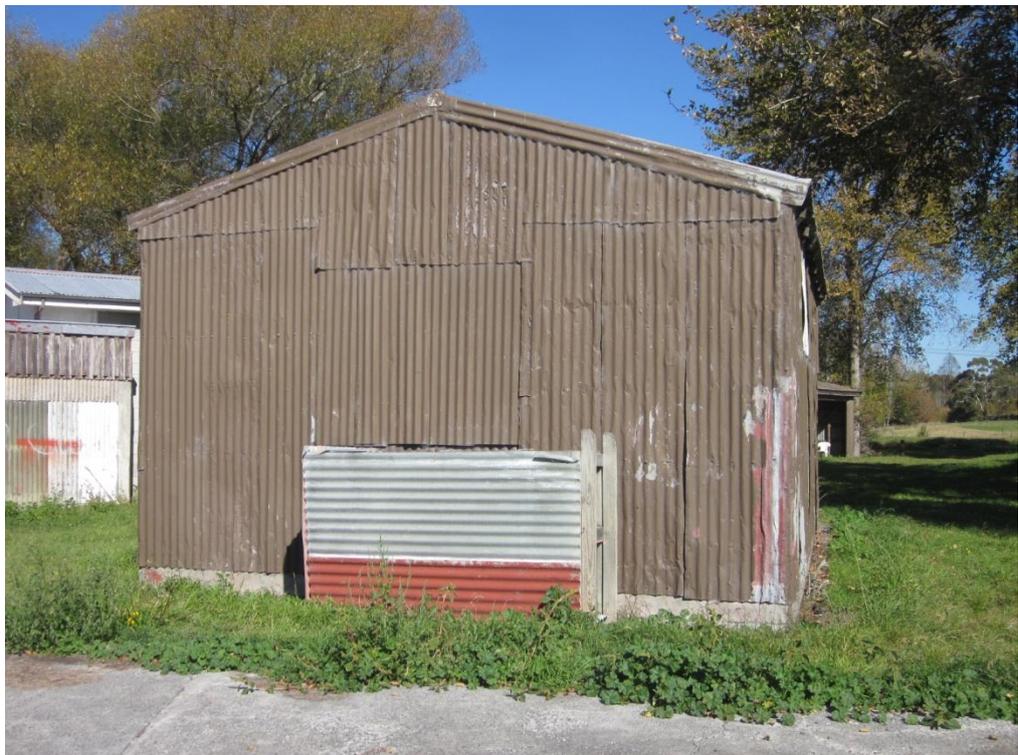
Photograph 2: North Elevation.

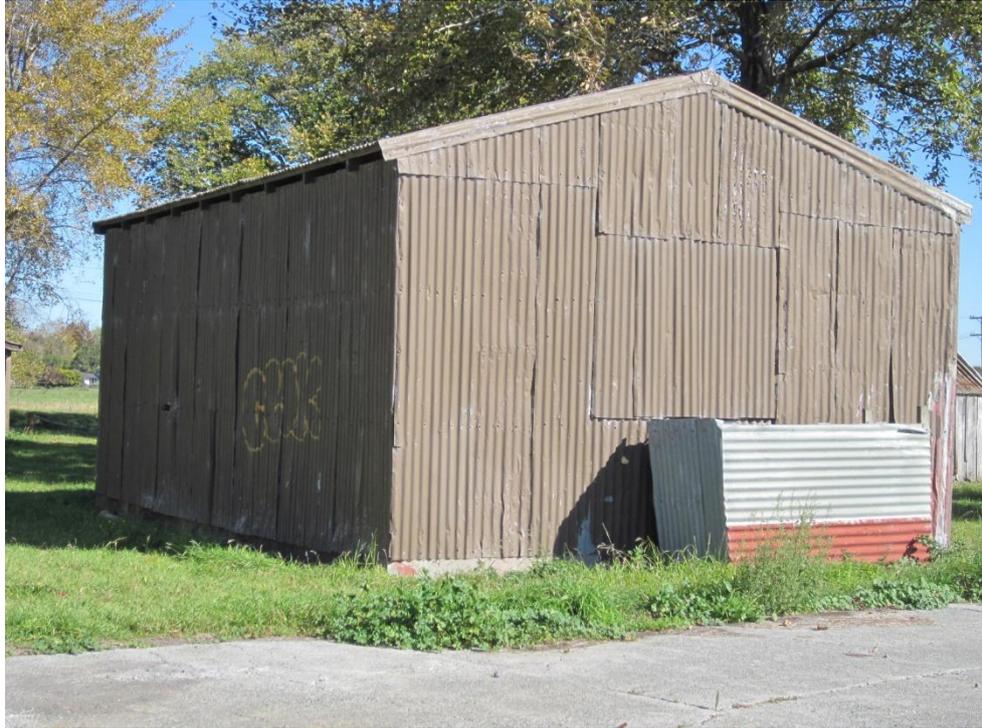
Photograph 3: Northwest corner elevation.

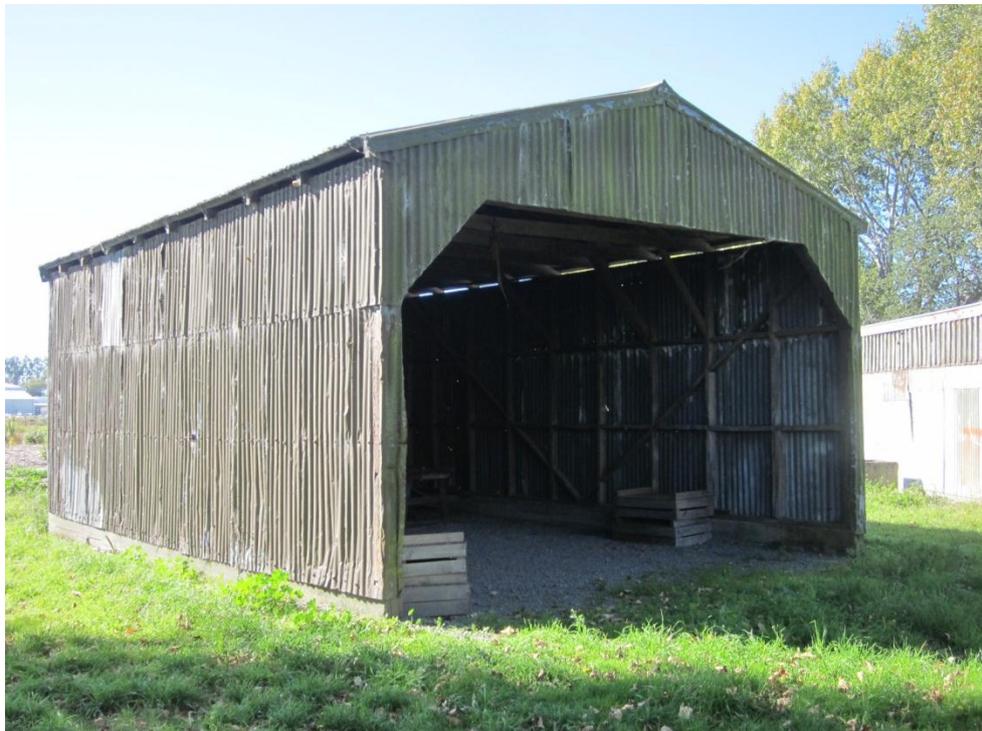
Photograph 4: Southwest corner elevation.

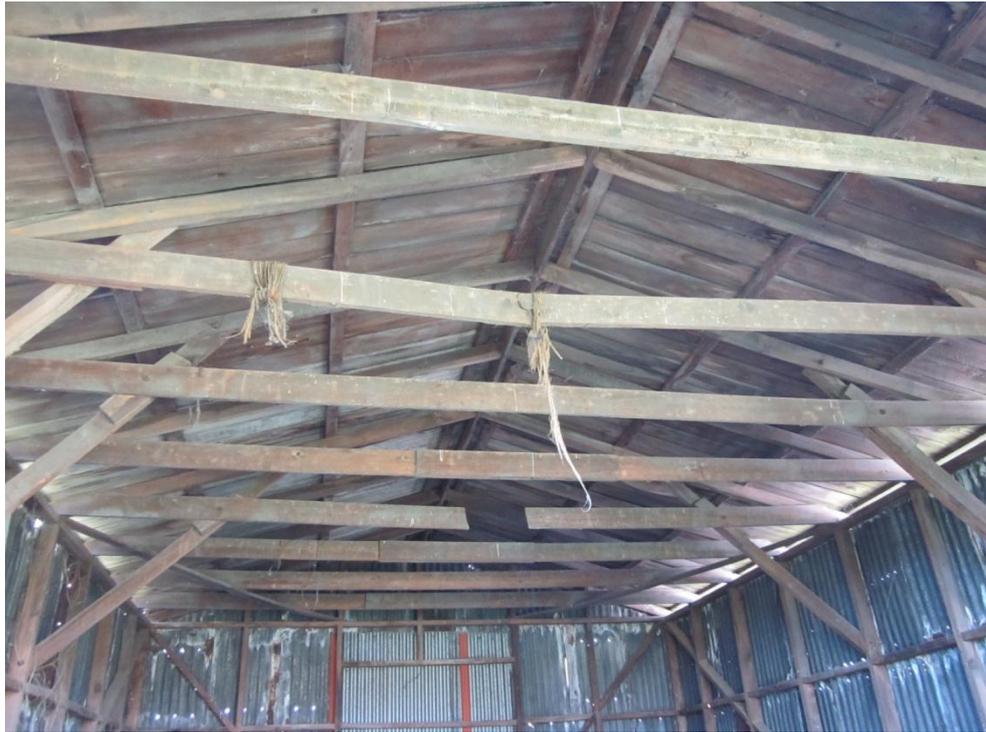
Photograph 5: Interior view of cross-braced and knee braced timber roof and cross-braced timber wall structures.

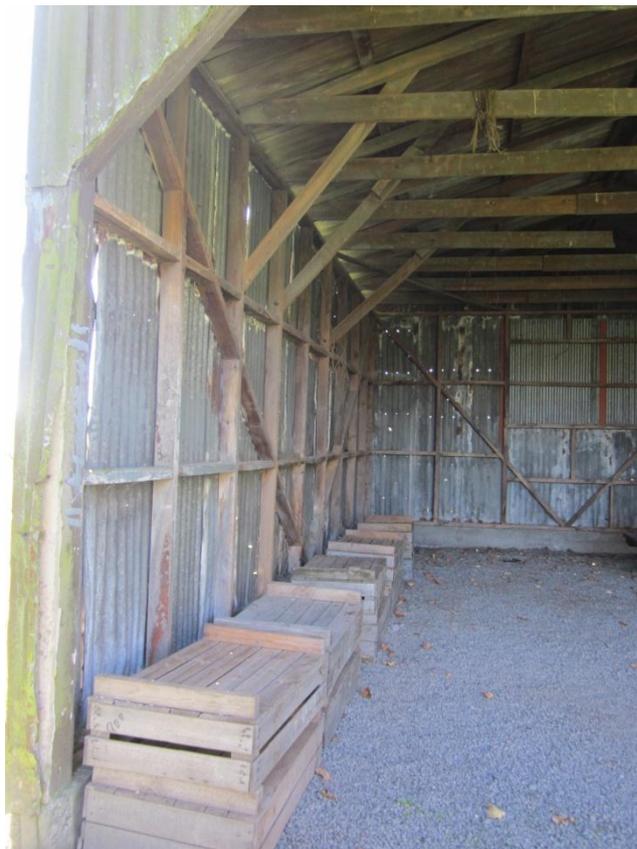
Photograph 6: Interior view of cross-braced external walls.

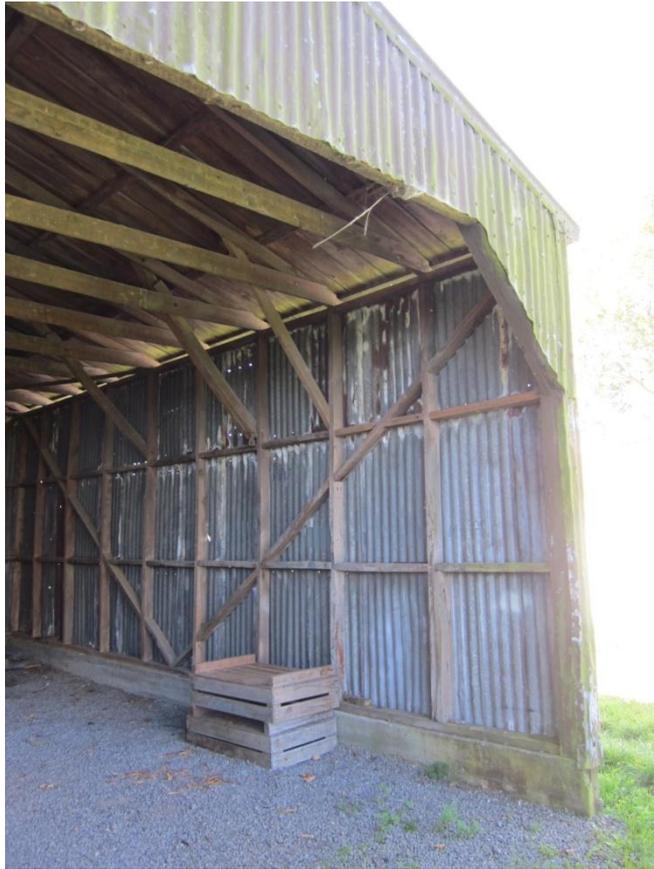
Photograph 7: Interior view of wall and roof structures and short concrete foundation wall.

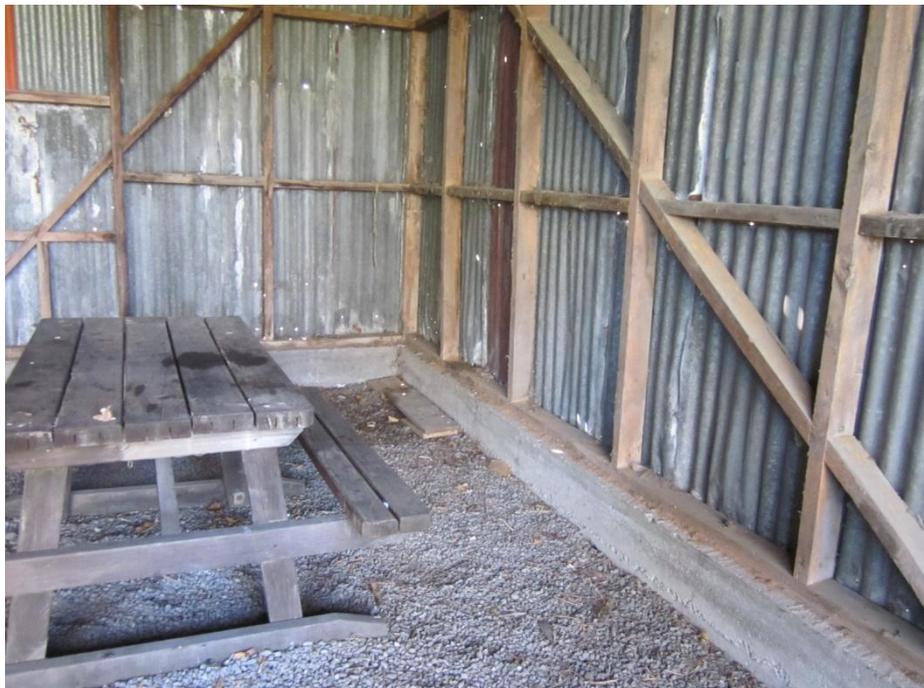
Photograph 8: Interior view of cross-braced timber walls and short concrete foundation walls.

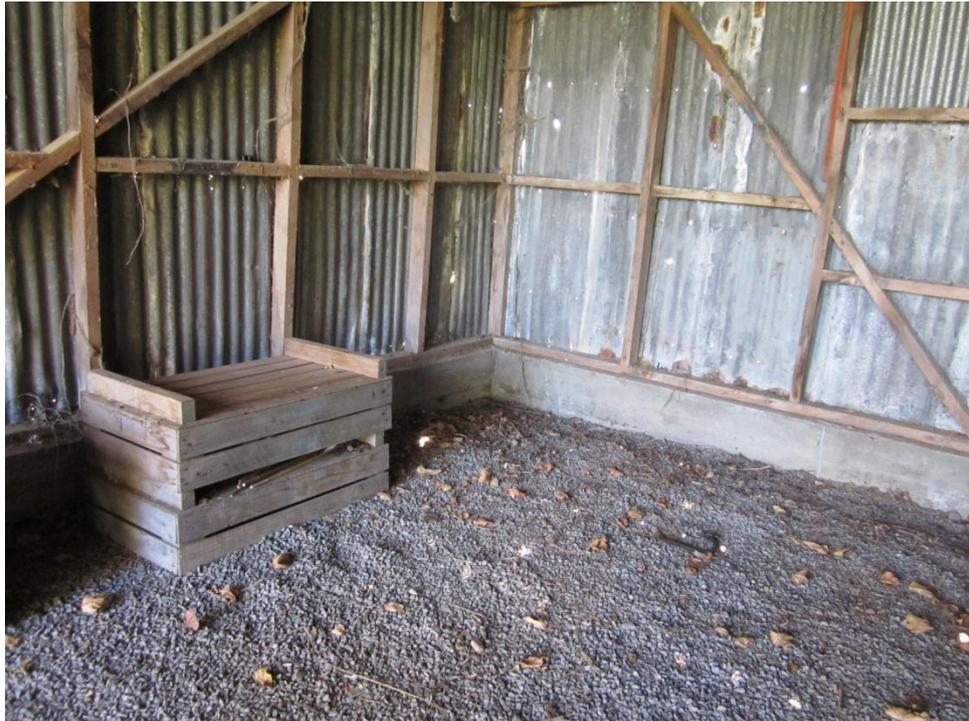
Photograph 9: Interior view of cross-braced timber walls and short concrete foundation walls.

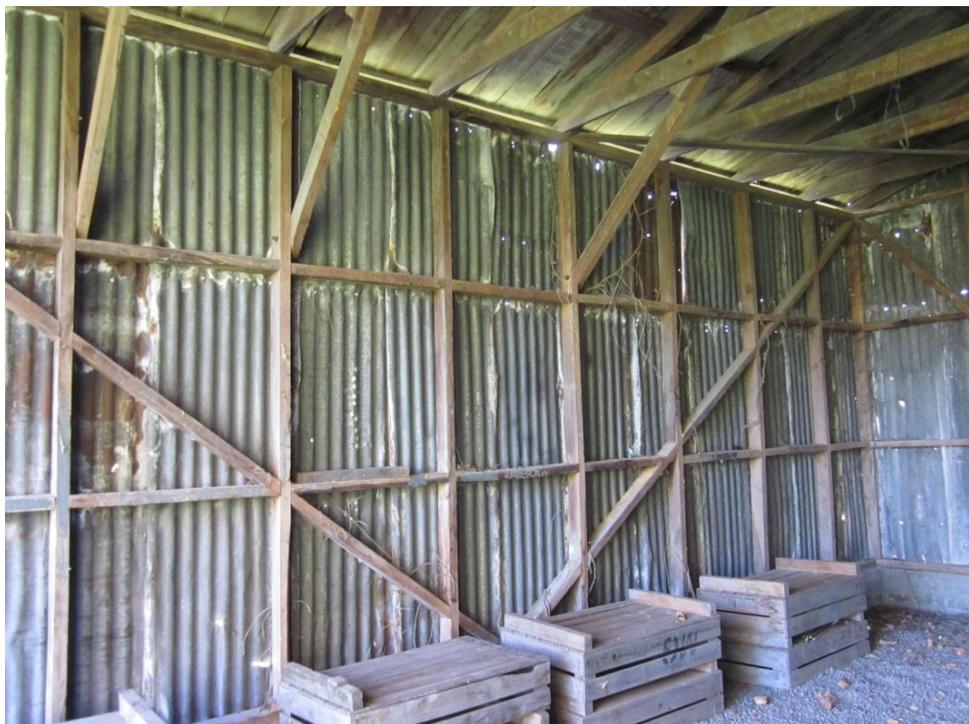
Photograph 10: Interior view of cross-braced timber walls and roof structure and short concrete foundation walls.

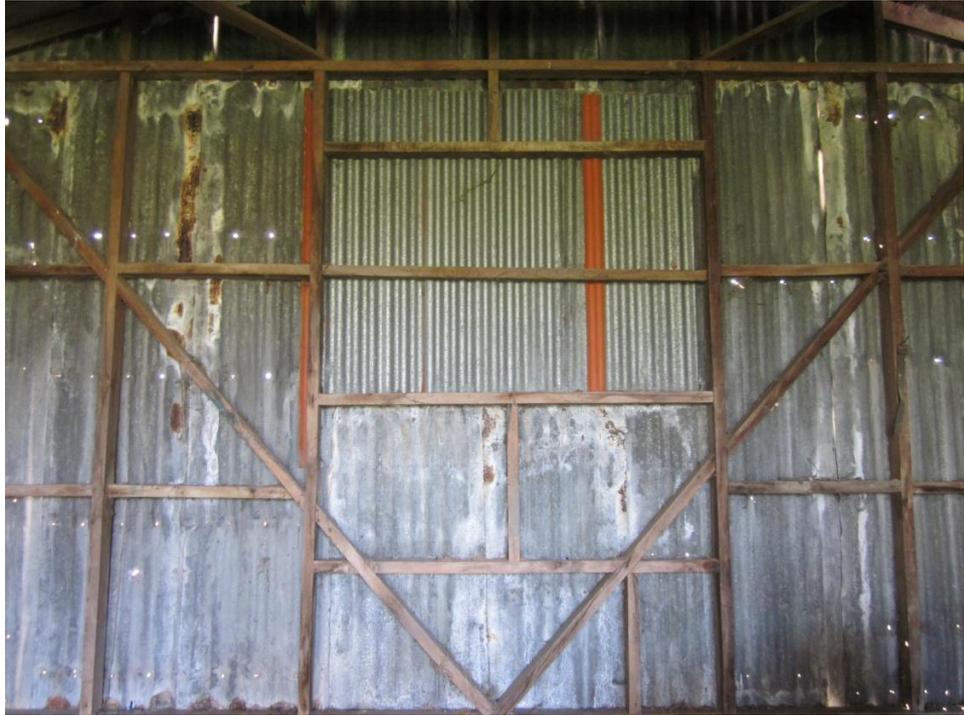
Photograph 11: Timber cross-bracing of north external wall.

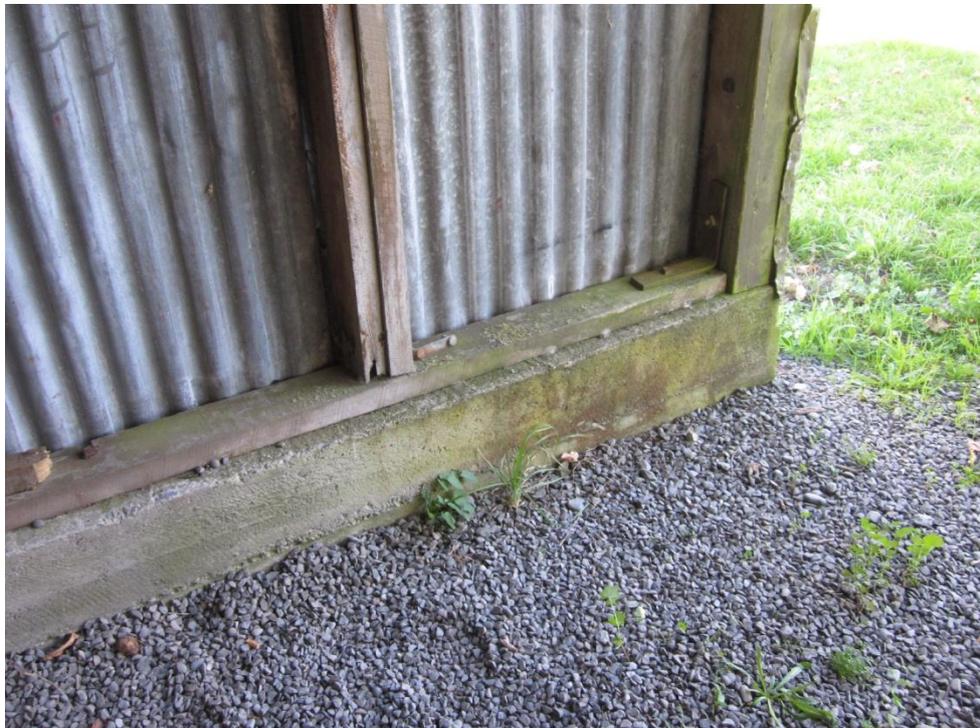
Photograph 12: Typical wall-to-foundation attachment.
