Shed - 002
Styx River Reserve #2
PRK 2546 BLDG 002-EQ2
Detailed Engineering Evaluation
Qualitative Report
FINAL Version

Styx River Reserve, 303 Radcliffe Road,
Belfast, Christchurch

Christchurch City Council

Date
17/09/13

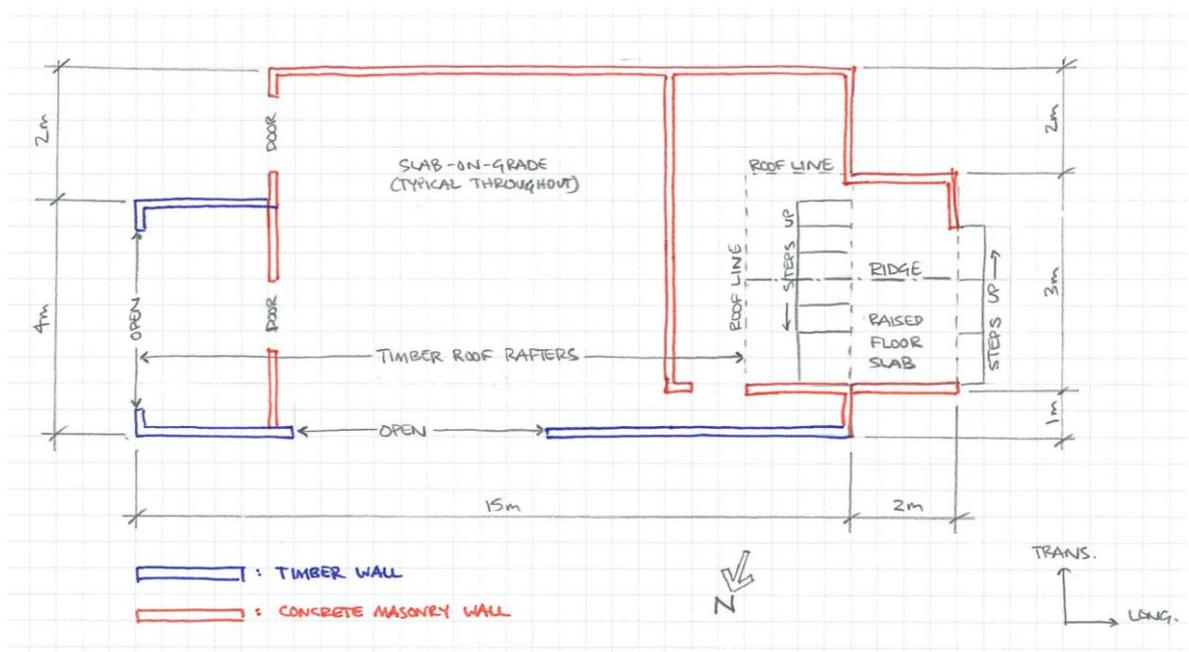
Figure 2 Plan Sketch Showing Key Structural Elements

A plan sketch is provided in the following Figure 2 to illustrate the main structural members of the building. The concrete and concrete masonry walls in red denote the original shed, with the timber walls in blue denoting the later addition.

The majority of the building is built at the same elevation on-grade. However, the western entry portion rises contains a floor at roughly 1.2m above grade, with stiff foundation walls and stairs to the exterior. As such, a significant critical structural weakness has been attributed to the structure in the form of Vertical Irregularity.

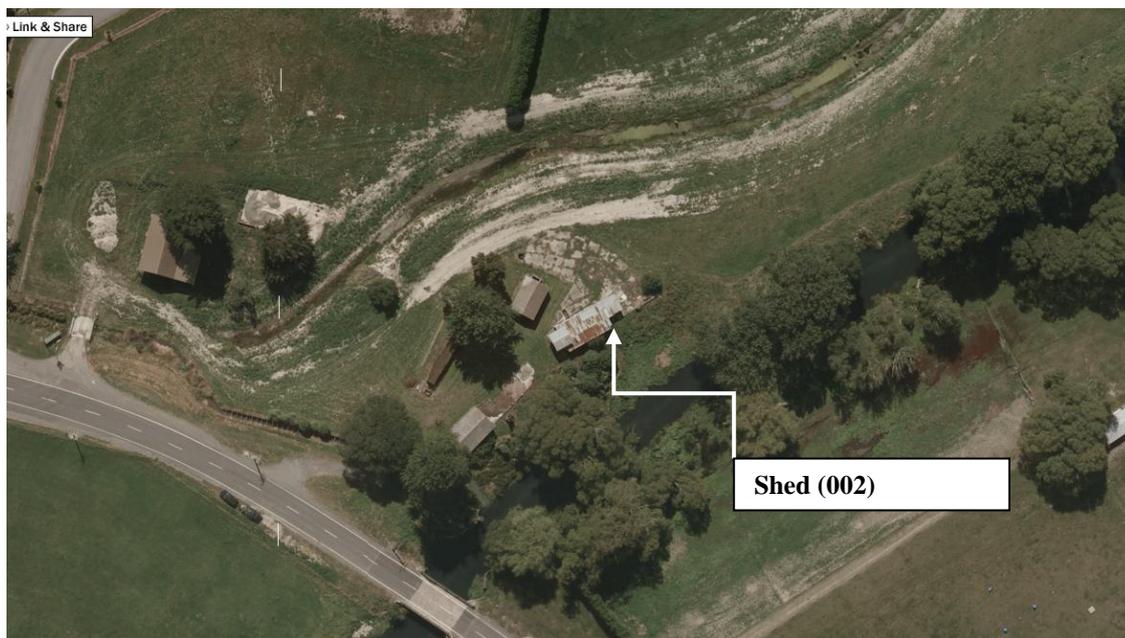
Figure 3 Post February 2011 Earthquake Aerial Photography²

Aerial photography taken following the 22 February 2011 earthquake shows a large amount of material on site (and properties adjacent) that maybe liquefaction as shown in Figure 3, although this material could also be evident on the surface due to a dry summer. However, lateral spreading is visible to the south along the Styx River. Material in the base of the drainage channel appears to be sand ejected from liquefaction.

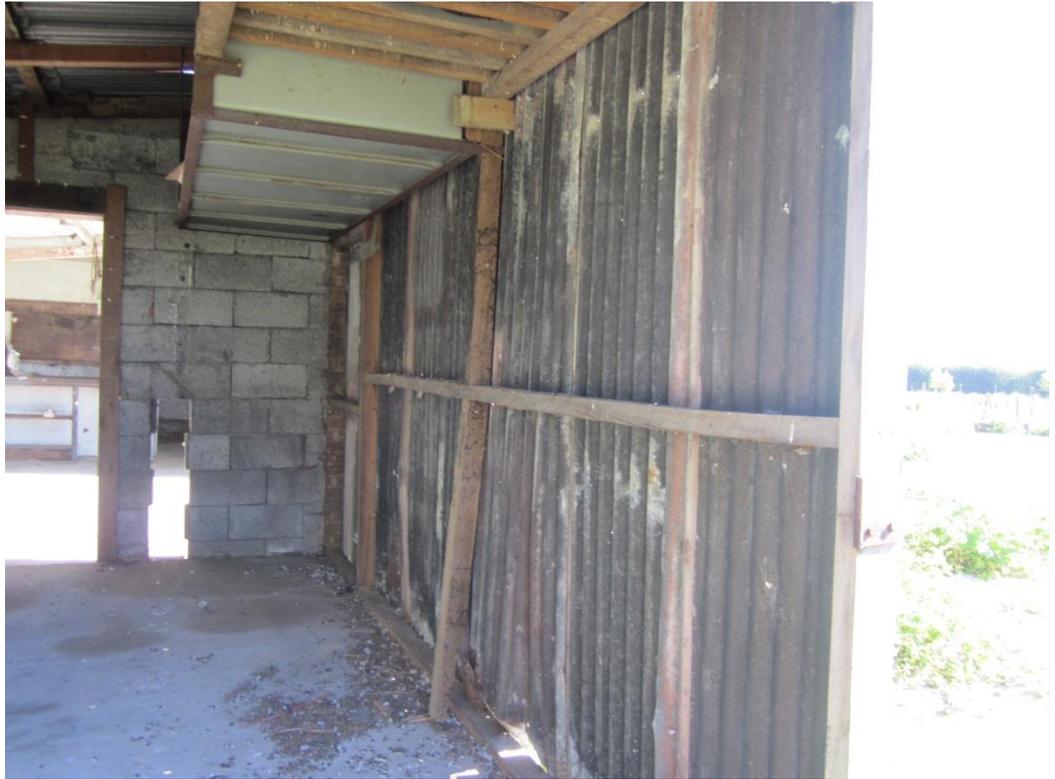
Photograph 9: Displaced timber wall and missing masonry at northern room.

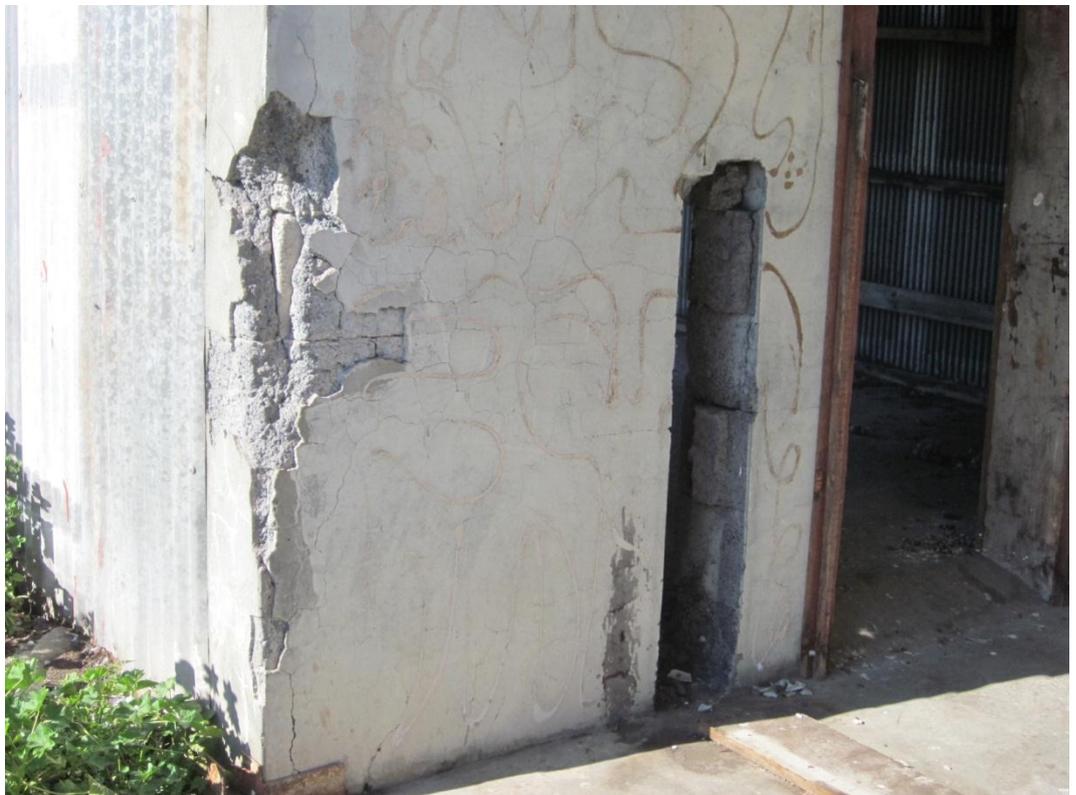
Photograph 10: Damaged masonry walls at southeast corner.

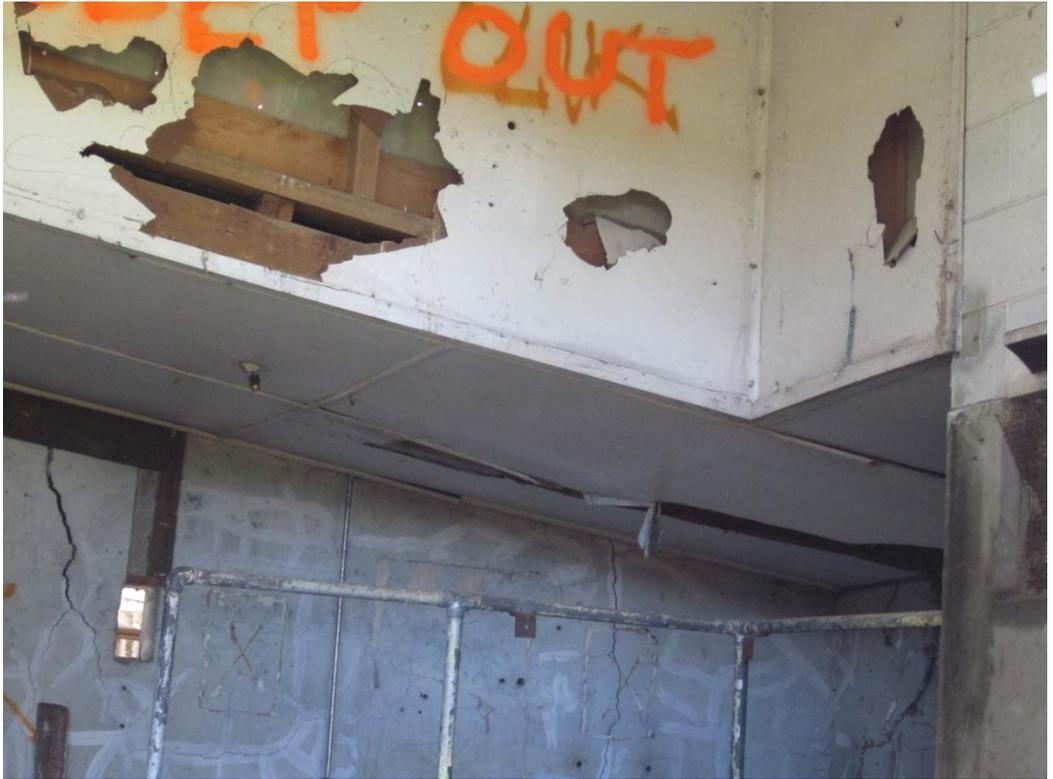
Photograph 11: Damaged linings and concrete walls at western entry area.

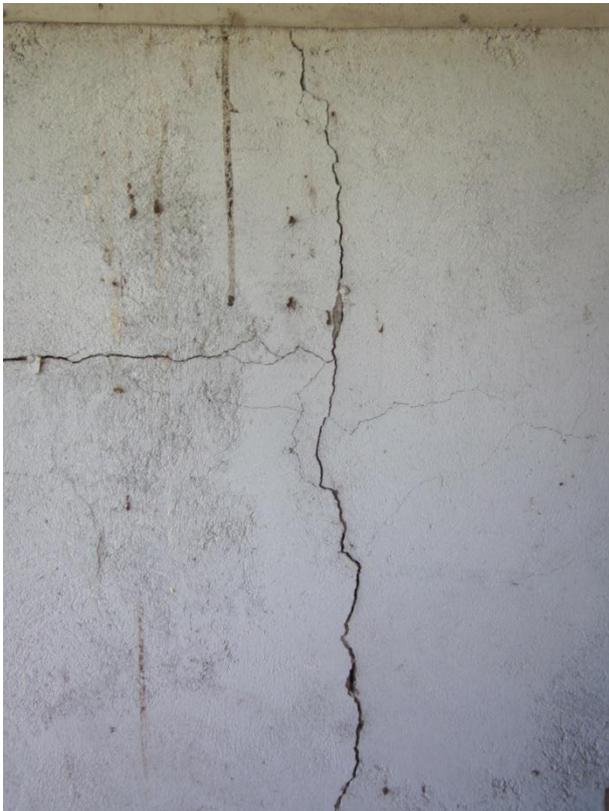
Photograph 12: Damaged masonry wall at western entry area.

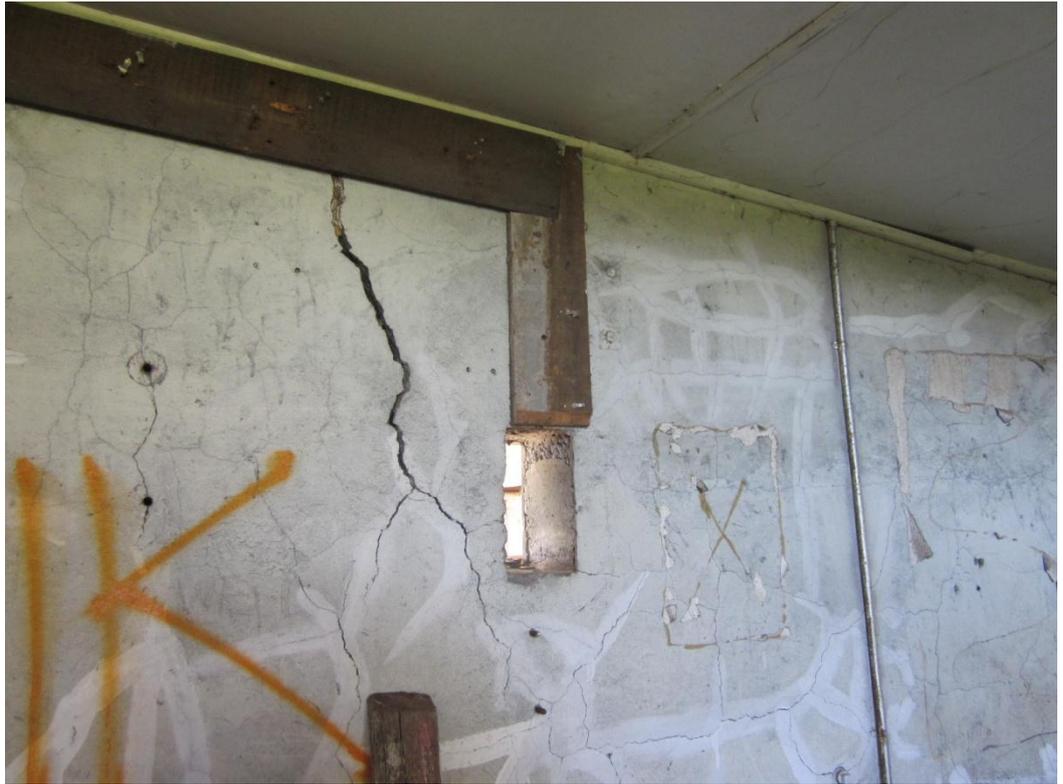
Photograph 13: Damaged masonry wall at western entry area.

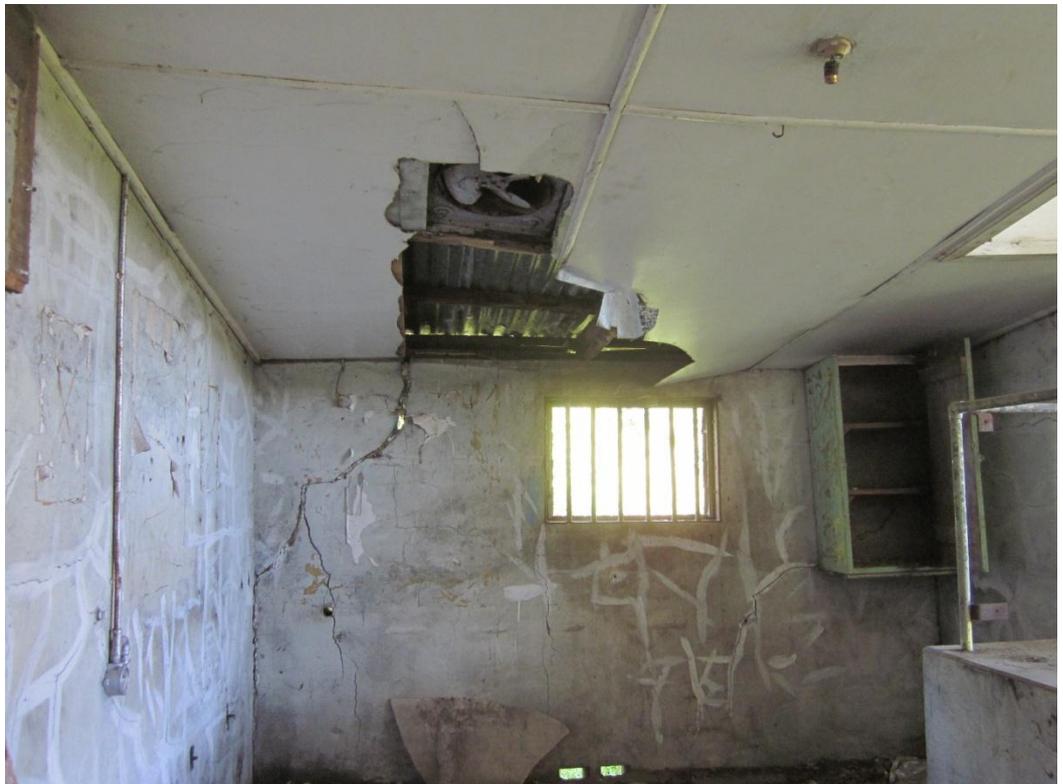
Photograph 10: Damaged walls, ceiling and roof at western entry area.
