House
Sumnervale Reserve
PRK 0528 BLDG 001
Detailed Engineering Evaluation
Qualitative Report
Version FINAL

45 Sumnervale Drive, Sumner,
Christchurch

Christchurch City Council

Prepared By
Simon Barker

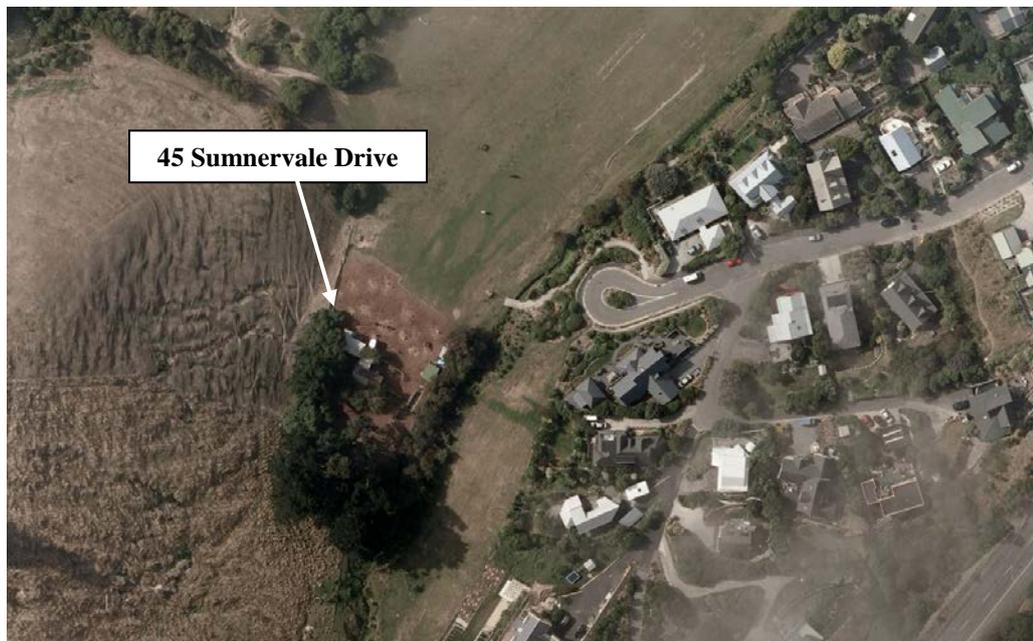
Figure 3 Post February 2011 Earthquake Aerial Photography³

Aerial photography taken following the 22 February 2011 earthquake shows no obvious signs of liquefaction in the vicinity of the site (see Figure 3).

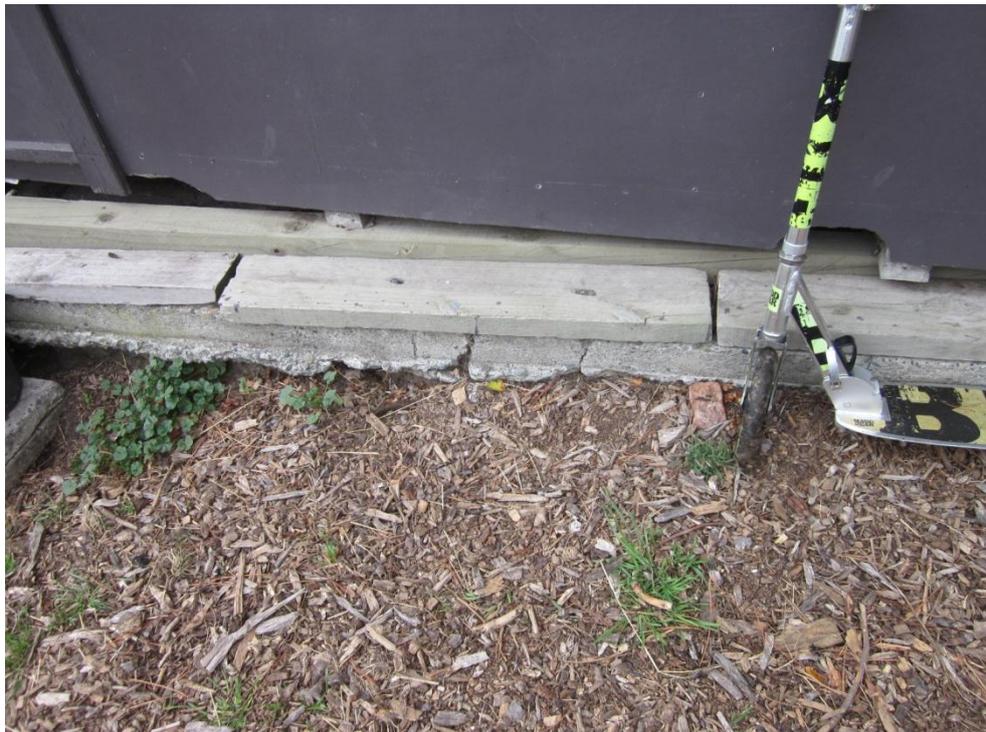
Photograph 8: Foundation under small shed structure.

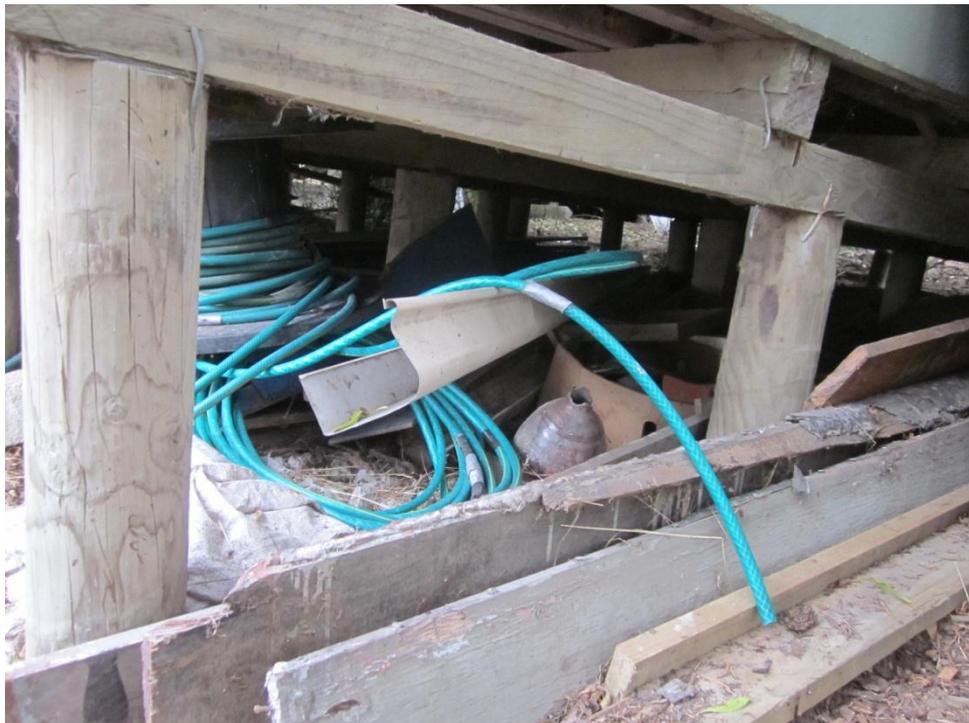
Photograph 10: Timber piles and floor structure under house.

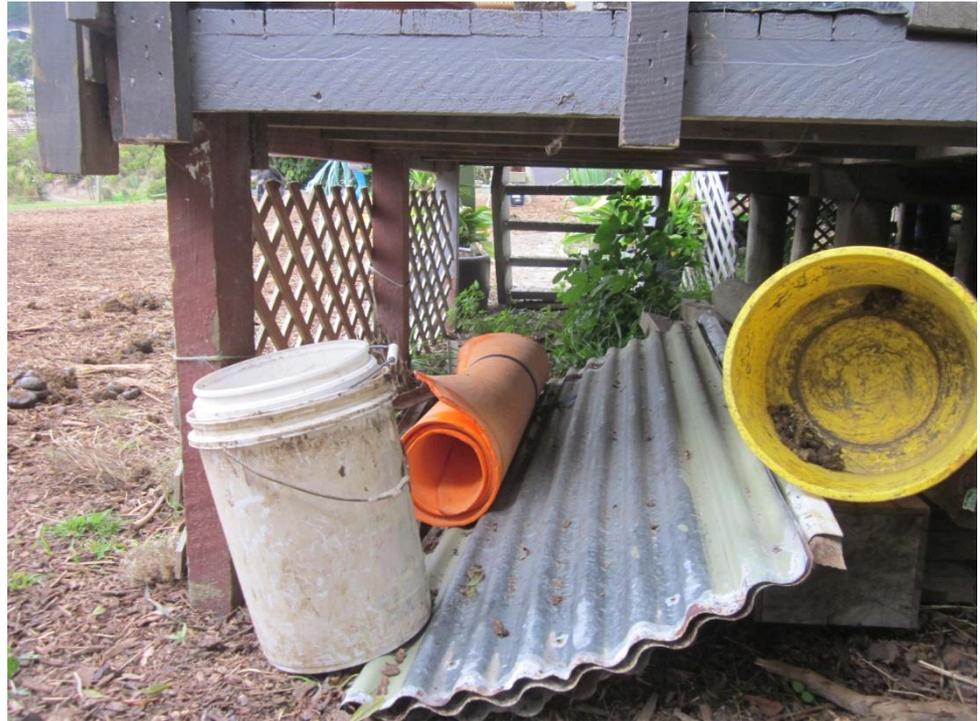
Photograph 11: Timber piles under entry landing at house.

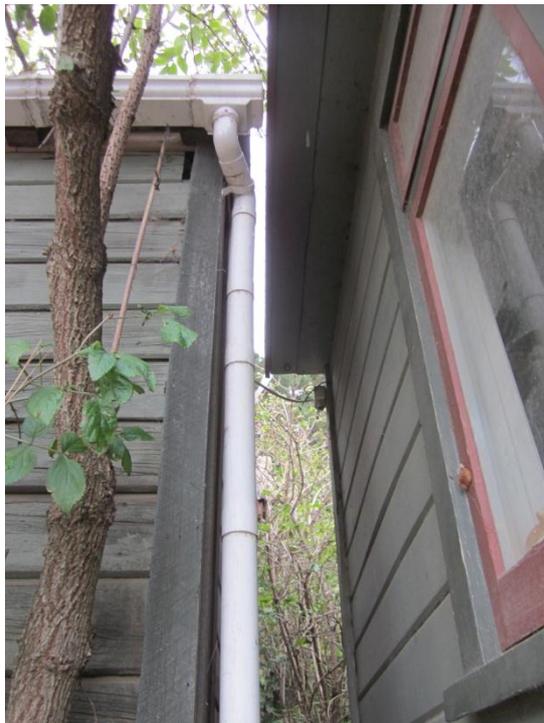
Photograph 12: Narrow gap between house structures.

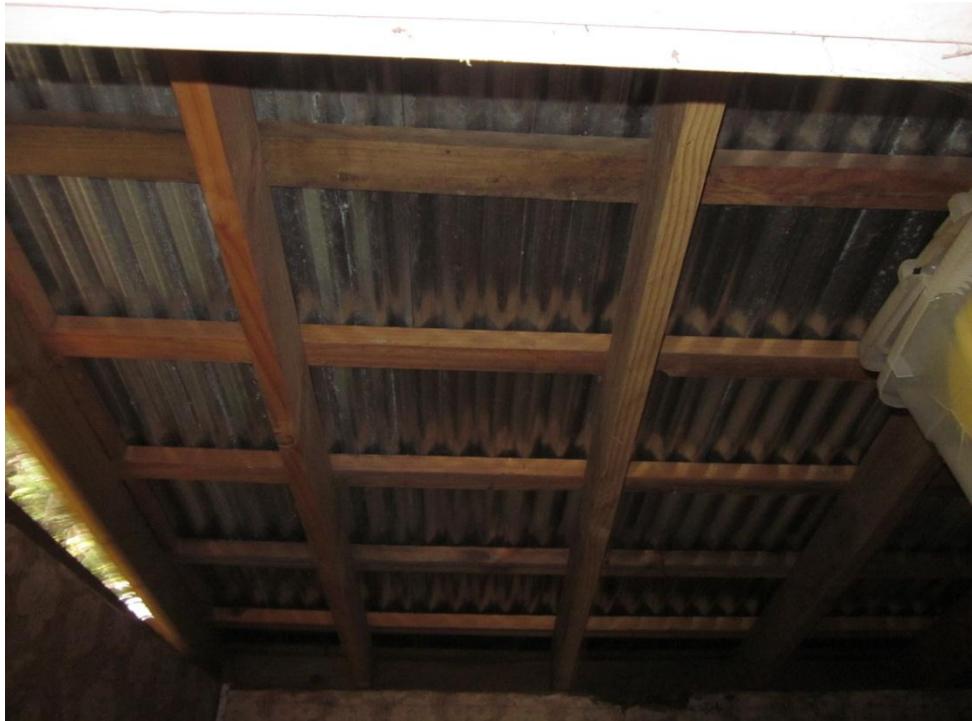
The house structures did not exhibit any signs of significant seismic damage, though they did show signs of poor maintenance. The roof structure at some sections of the house additions were never properly attached to external walls and clear openings exist between the roof and walls.

Photograph 14: Roof rafters and purlins at addition. Note lack of attachment to external wall.

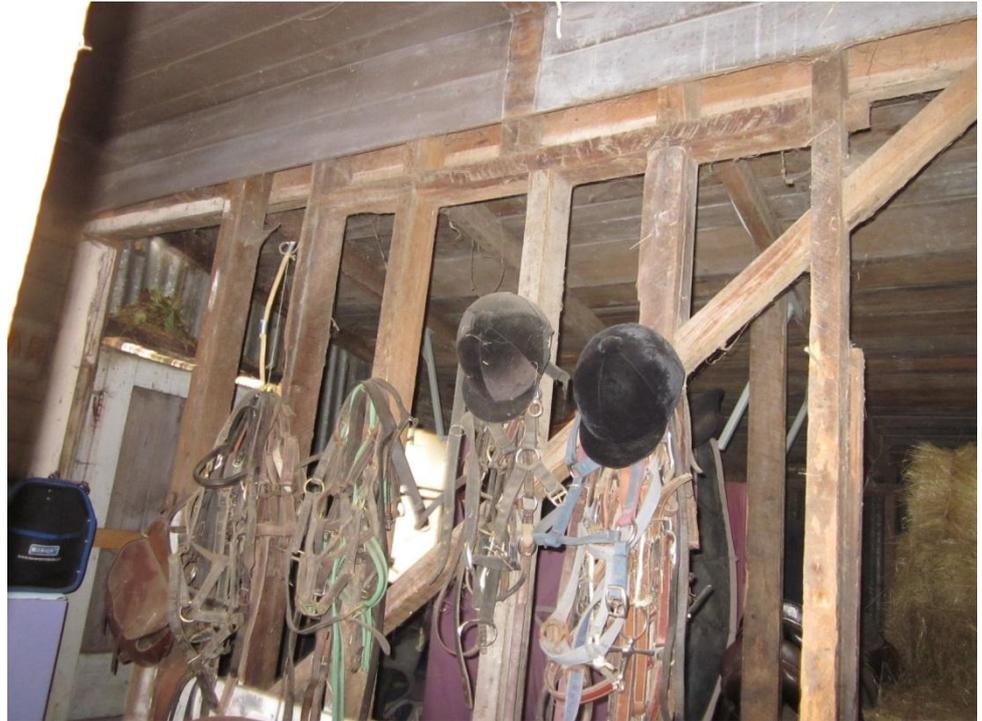
Photograph 15: Cross-braced internal wall (once external wall) at house, with addition beyond.

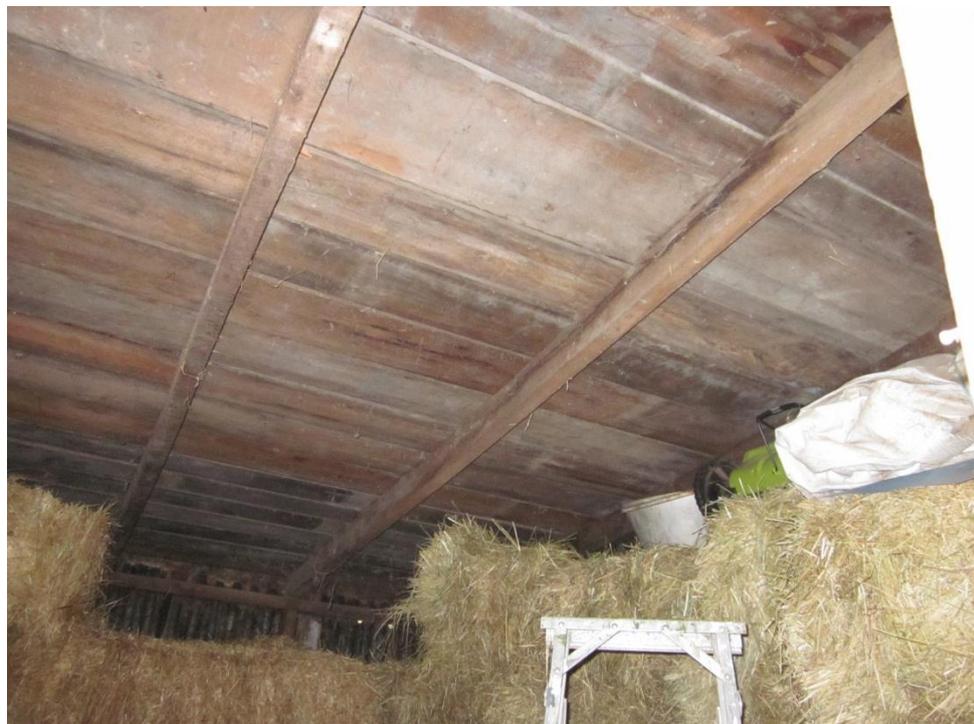
Photograph 16: Roof rafters and sarking at addition.
