Sydenham Park - Toilet Block
PRK 1143 BLDG 001 EQ2
Detailed Engineering Evaluation
Quantitative Report
Version FINAL

230 Brougham Street, Sydenham

Christchurch City Council

Date
28 January 2013

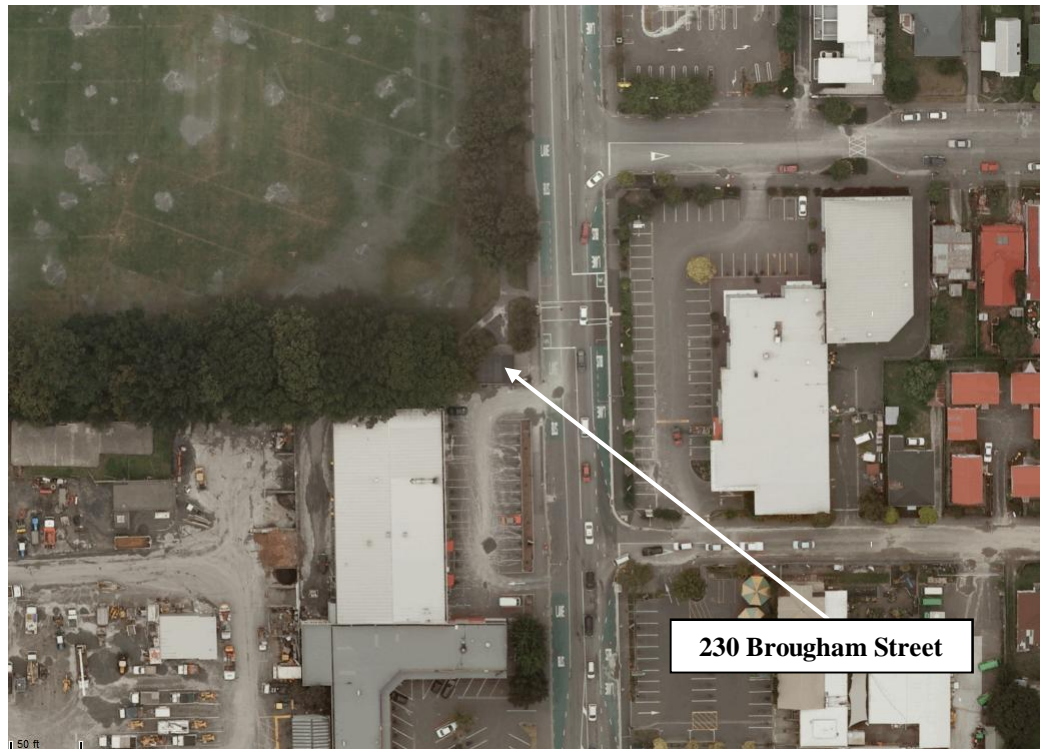
Figure 6-1 Post February 2011 Earthquake Aerial Photography⁴

- Evidence of liquefaction from the post-earthquake aerial photography.
- Neighbouring properties technical category is TC2 yellow. This means that moderate to significant land damage from liquefaction is possible in future significant earthquakes.
- Presence of predominately sands and silts beneath the site.

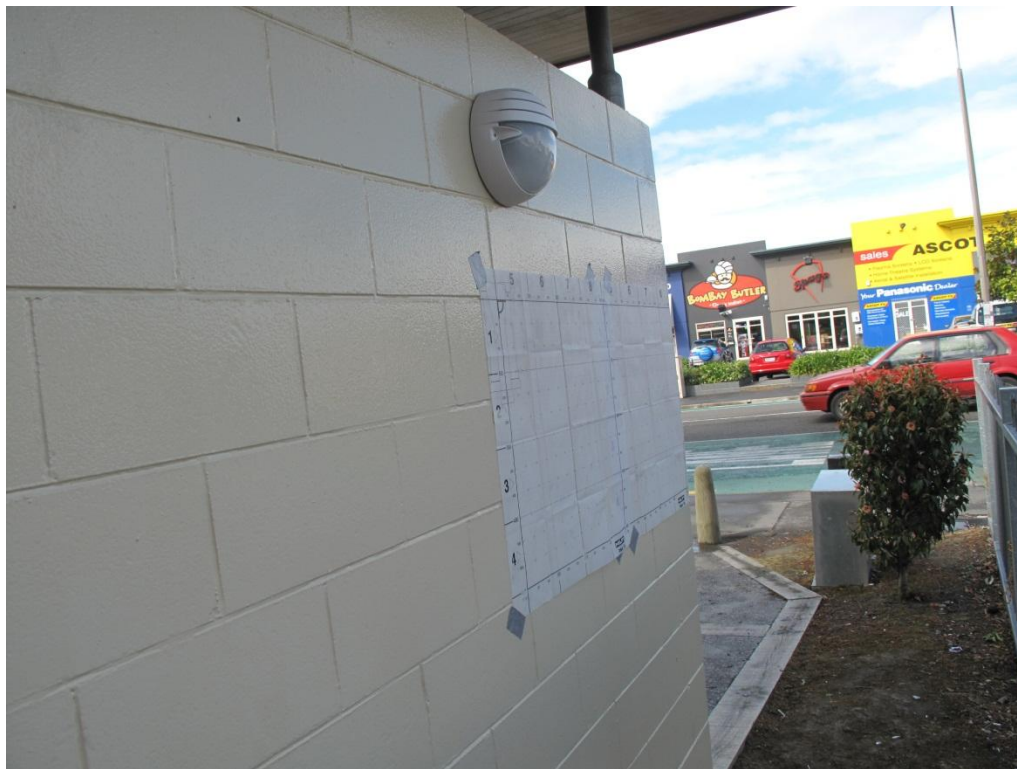
Photograph 4 One of the areas where wall reinforcement was checked.

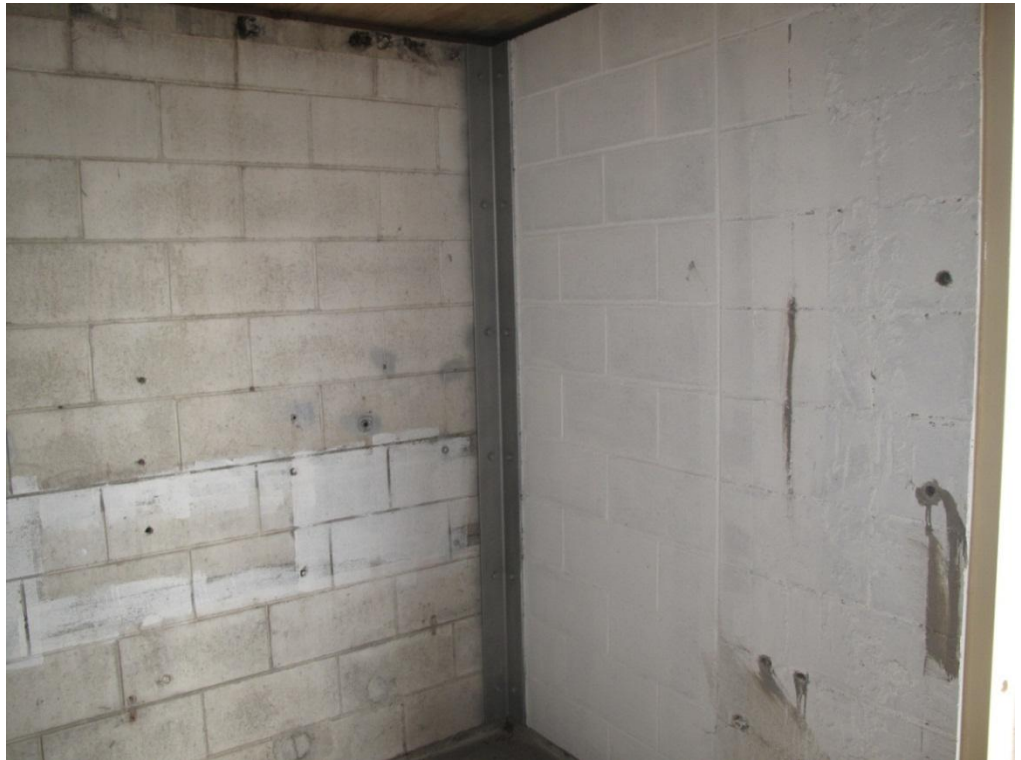
In the storage area on the western side of the structure metal bracing has been installed on the northwest corner of the structure and a steel plate has been bolted above the doorway. See photographs 5 and 6 in Appendix A. There is no visible cracking in the block work at either of these locations. It is unclear if this is seismic strengthening work. However as the steel bracing has only been installed in two places any effect on the structure will be negligible.

Photograph 5 Steel angle bolted to north west corner of the toilet block.

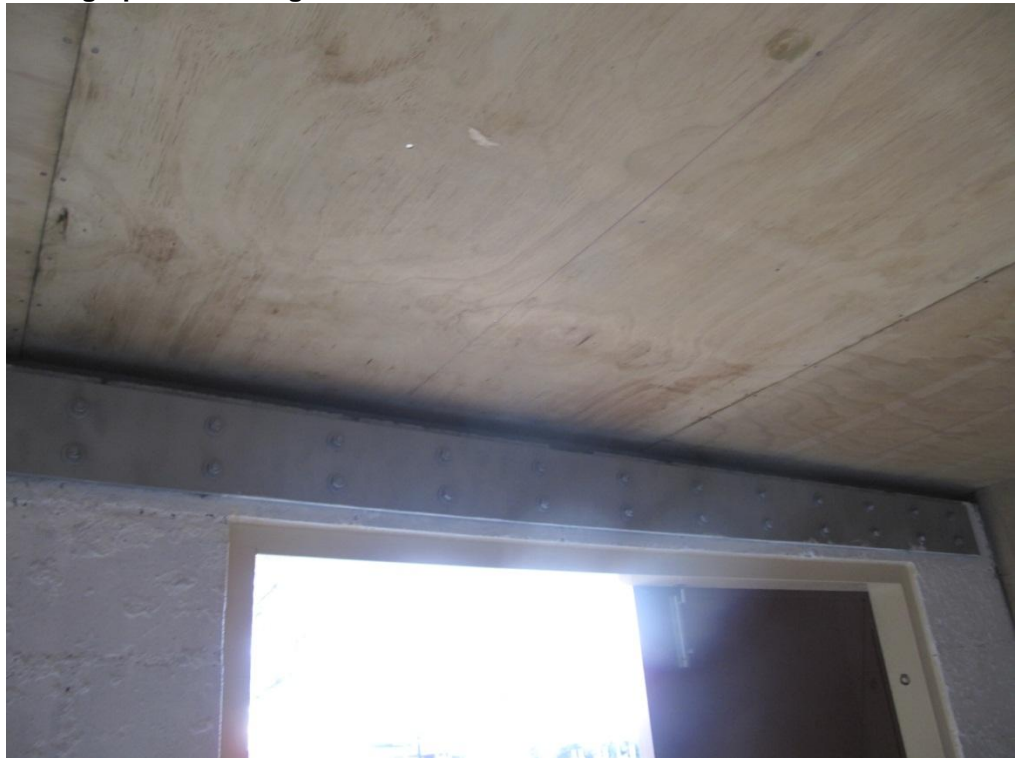
Photograph 6 Steel angle bolted to north west corner of the toilet block.

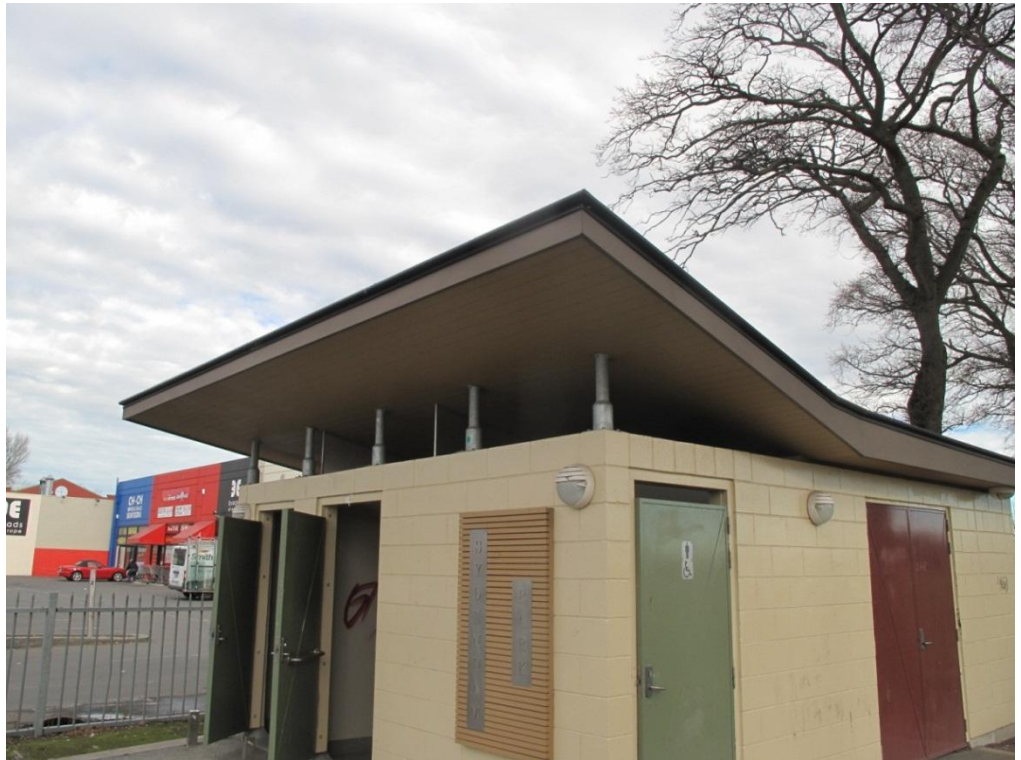
The structure appears to have been upgraded in the last 2 to 5 years. The toilets on the eastern side of the structure are lined with plaster on the walls. The roof over the toilets has been replaced with an angled roof cantilevering approximately 1.0m over the pedestrian access area. The rear storage area has plywood ceiling lining and a steel equal angle reinforcing one corner. The walls appear to be the original concrete masonry block walls.

Photograph 7 Raised roof structure on the eastern side of the toilet block.

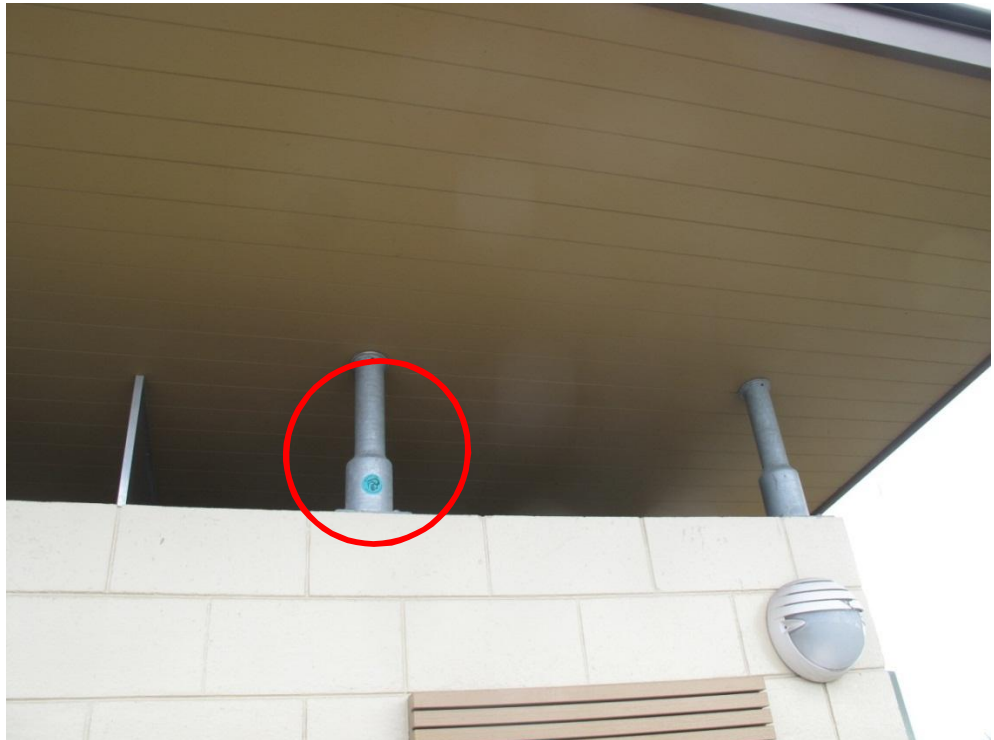
The roof consists of a timber frame. The connections at the eastern end of the building consist of circular hollow sections bolted to the top of the block walls. The connections for the remainders of the roof are not visible.

Photograph 8 Steel posts supporting roof beams on the eastern side of the structure.

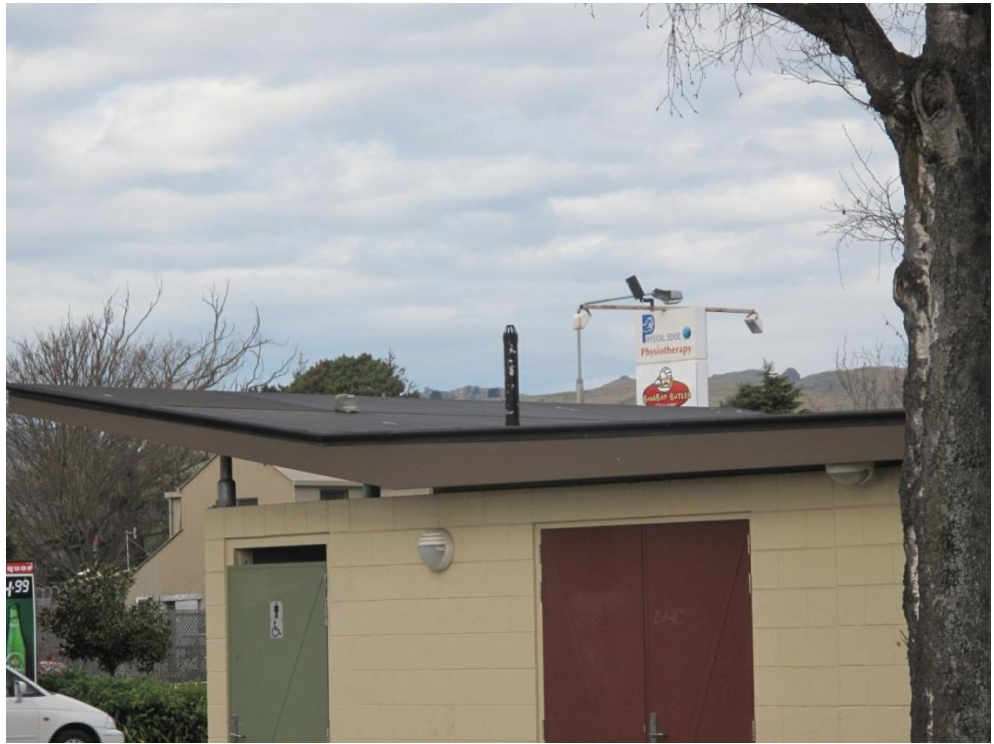
Photograph 9 Middle and western sections of the roof rest directly on the concrete block walls.

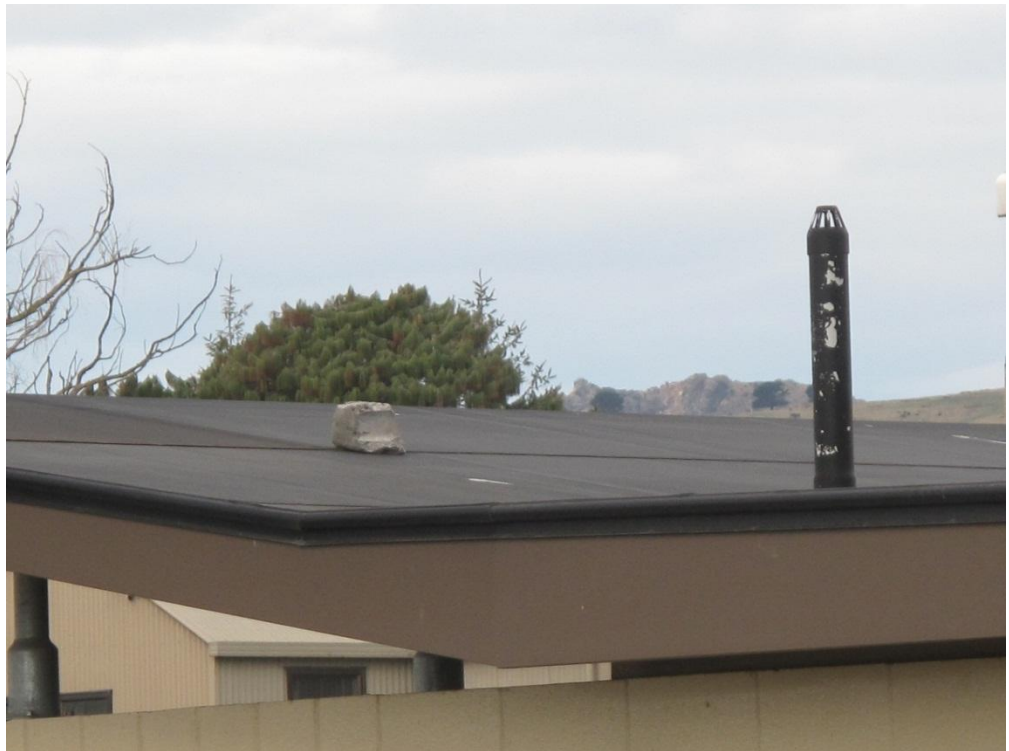
Photograph 10 The roof appears to be covered with asphalt sheets.
