Christchurch City Council

Sydenham Park Tool Shed

Detailed Engineering Evaluation

Quantitative Assessment Report

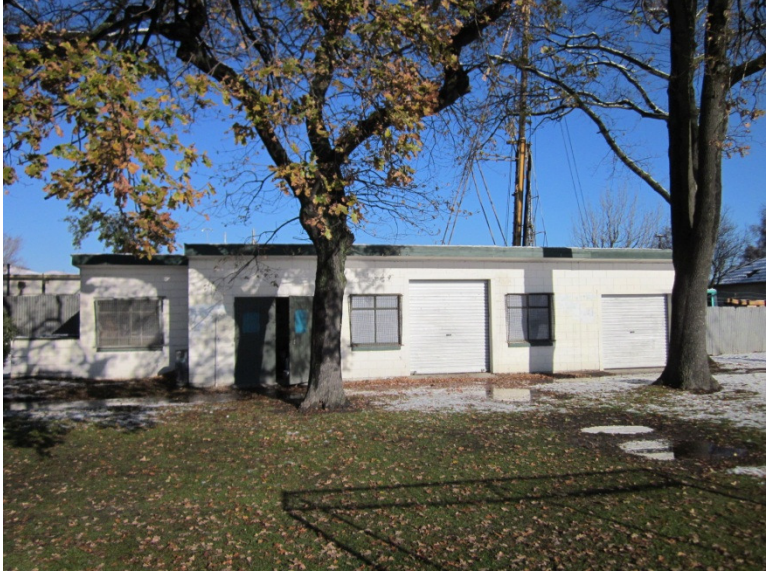
No.	Item description	Photo
General		
1.	Front view of building

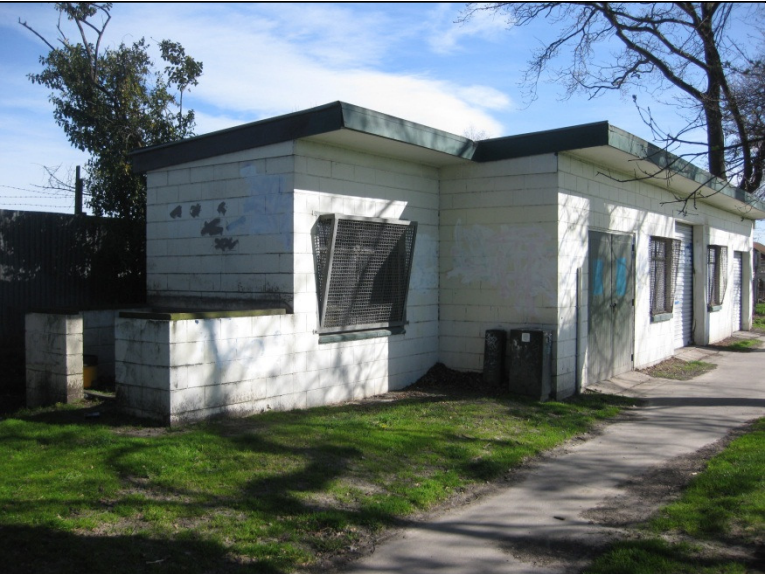
2.	North-east view of building

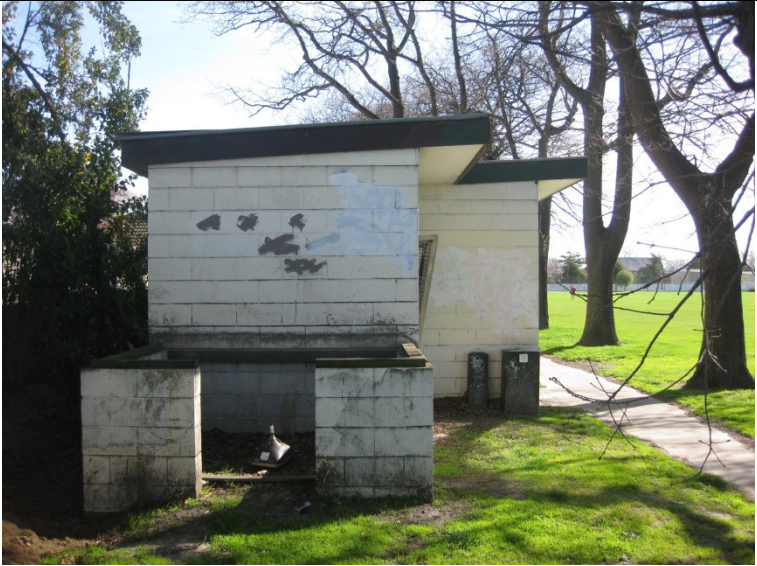
3.	Eastern view of building

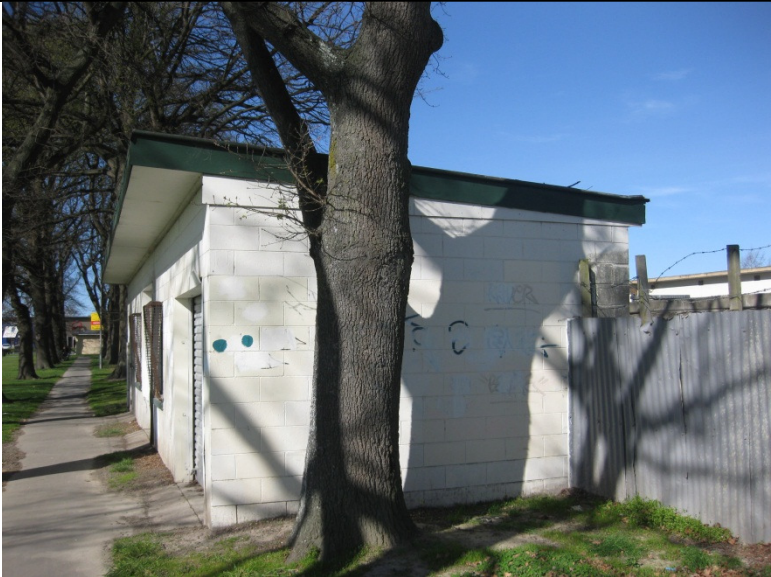
4.	Western view of the building

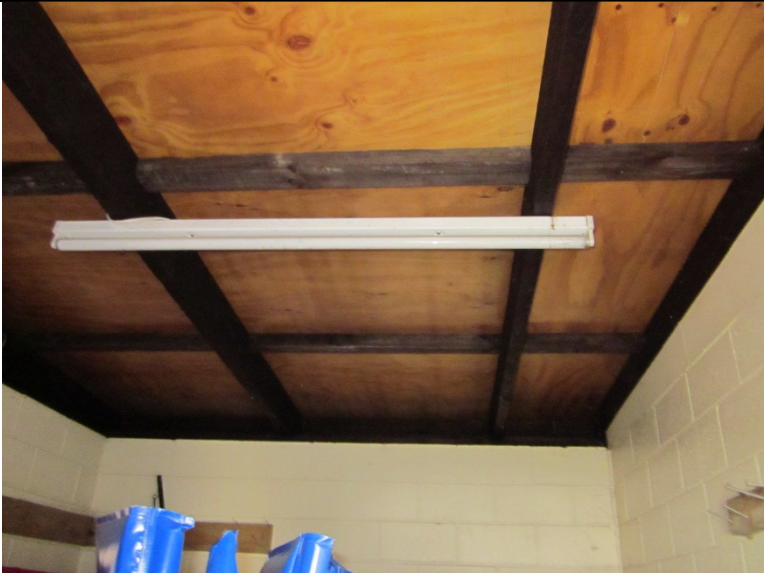
5.	Timber framed roof with plywood lined ceiling
