Christchurch City Council
PRK_1482_BLDG_002 EQ2
Taylors Mistake Bay -Toilets
Taylors Mistake Foreshore

QUALITATIVE ASSESSMENT REPORT
FINAL

- Rev B
- 08 November 2012

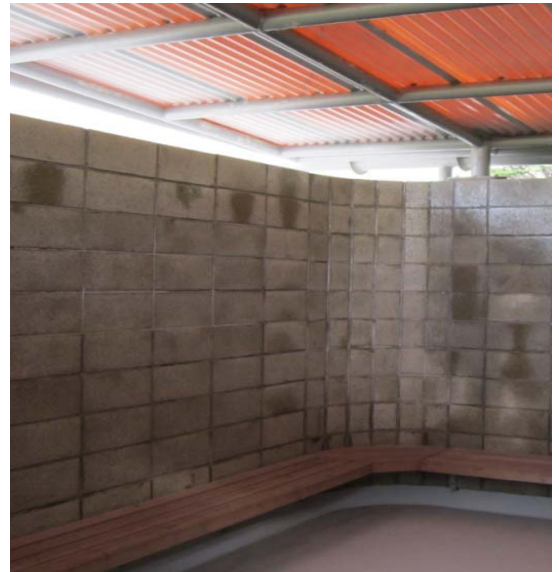
Photo 8: Typical corner detail with short blocks used to create a curve. Note blocks are stacked as opposed to staggered.

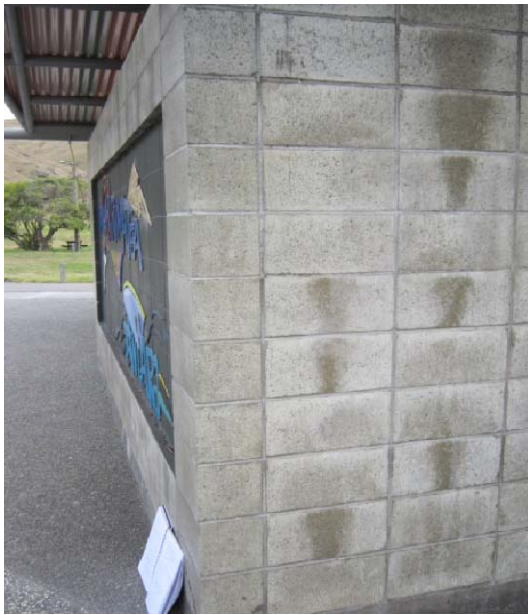
- 1) Separation of the stacked masonry block work from adjacent stacks
See photos : 9-12
- 2) Separation of the concrete footpaths from the masonry strip footings.
See photos: 13-16
- 3) Hairline cracking to concrete drainage unit on north west corner
See photos: 17-18

Photo 9: Separation of masonry along the mortar joint

Recommendations		Level of repair/strengthening required: minor non-structural	Describe: Re pointing of masonry
Building Consent required: no		Describe: _____	
Interim occupancy recommendations: full occupancy		Describe: Low risk of collapse	
Along	Assessed %NBS before: _____	Assessed %NBS after: 98%	%NBS from IEP below
Across	Assessed %NBS before: _____	Assessed %NBS after: 98%	%NBS from IEP below

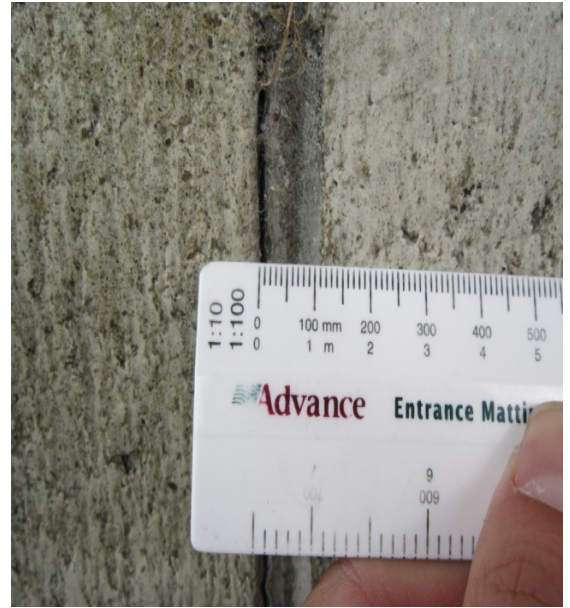
Photo 10: Cracking of approximately 1mm on north east corner

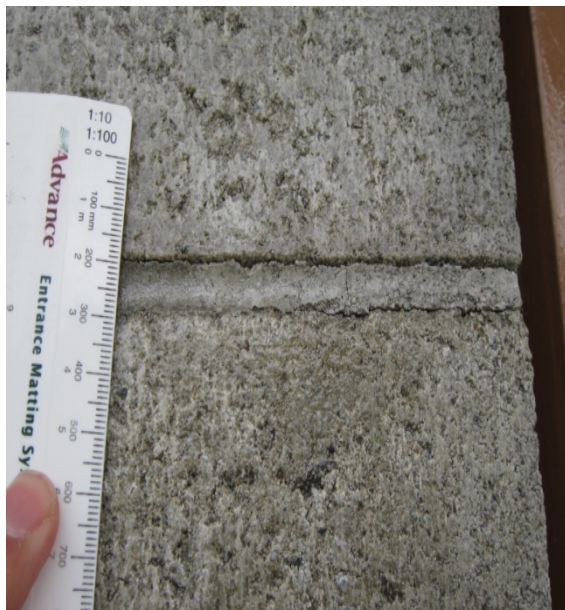
Photo 11: Separation of masonry along mortar joint approximately 0.3mm

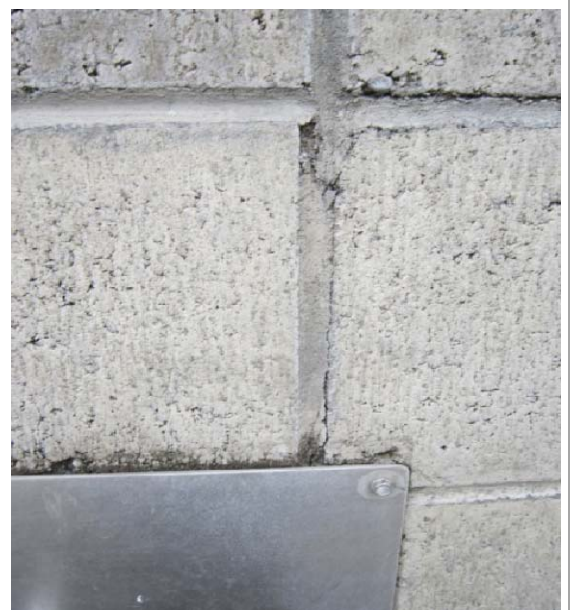
Photo 12: Separation of stacked masonry along mortar joint of approximately 0.4mm

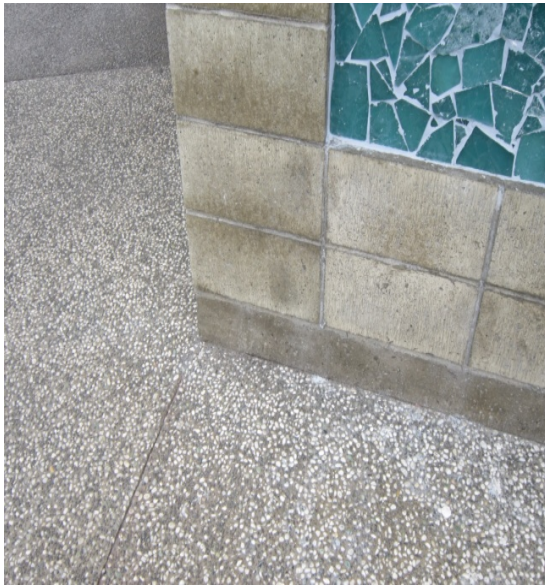
Photo 13: Corner of masonry structural walls

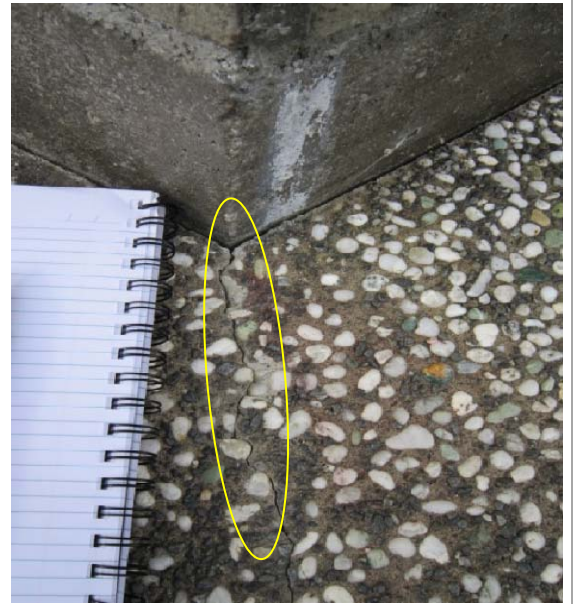
Photo 14: Separation of footpaths from the structure along joint lines and cracking from structural corners

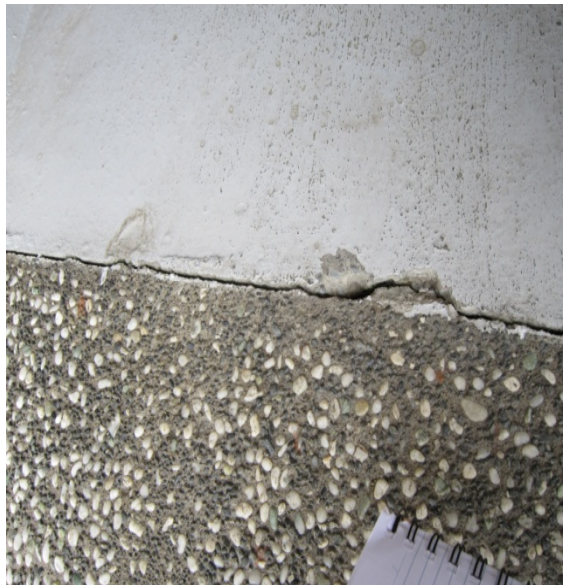
Photo 15: Separation of floor slabs from surrounding footpaths

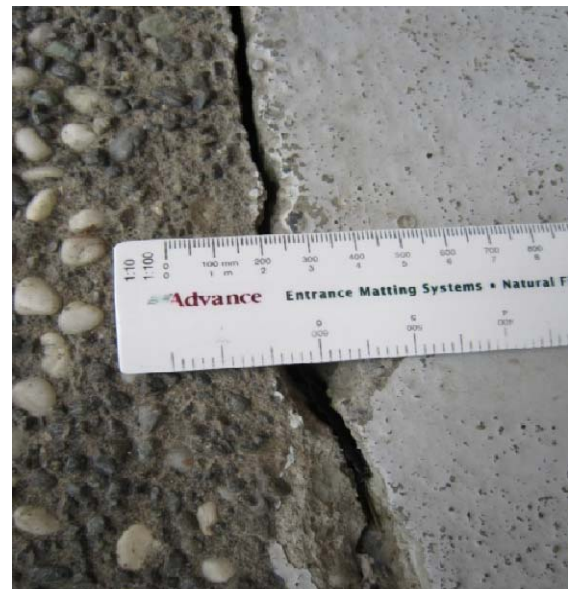
Photo 16: Separation of internal floor and adjacent footpath of approximately 3mm in places with spalled area of concrete

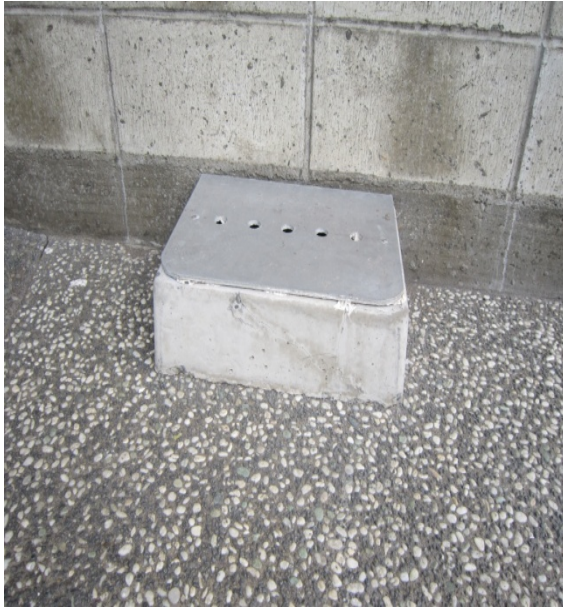
Photo 17: Concrete drain.

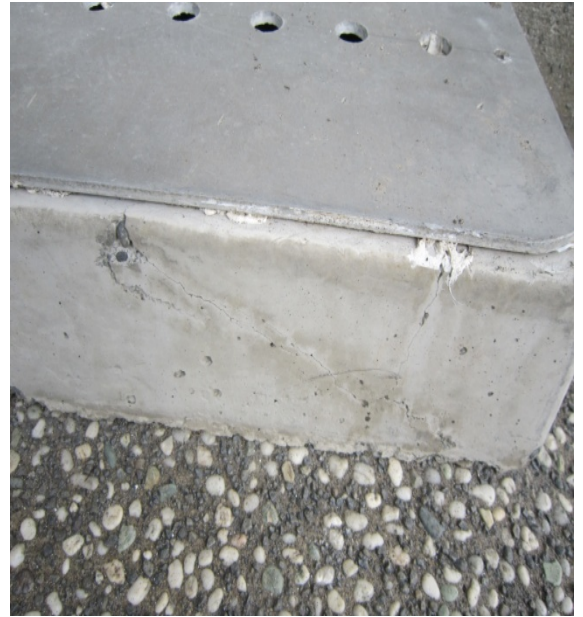
Photo 18: Hairline cracking through drainage pit.

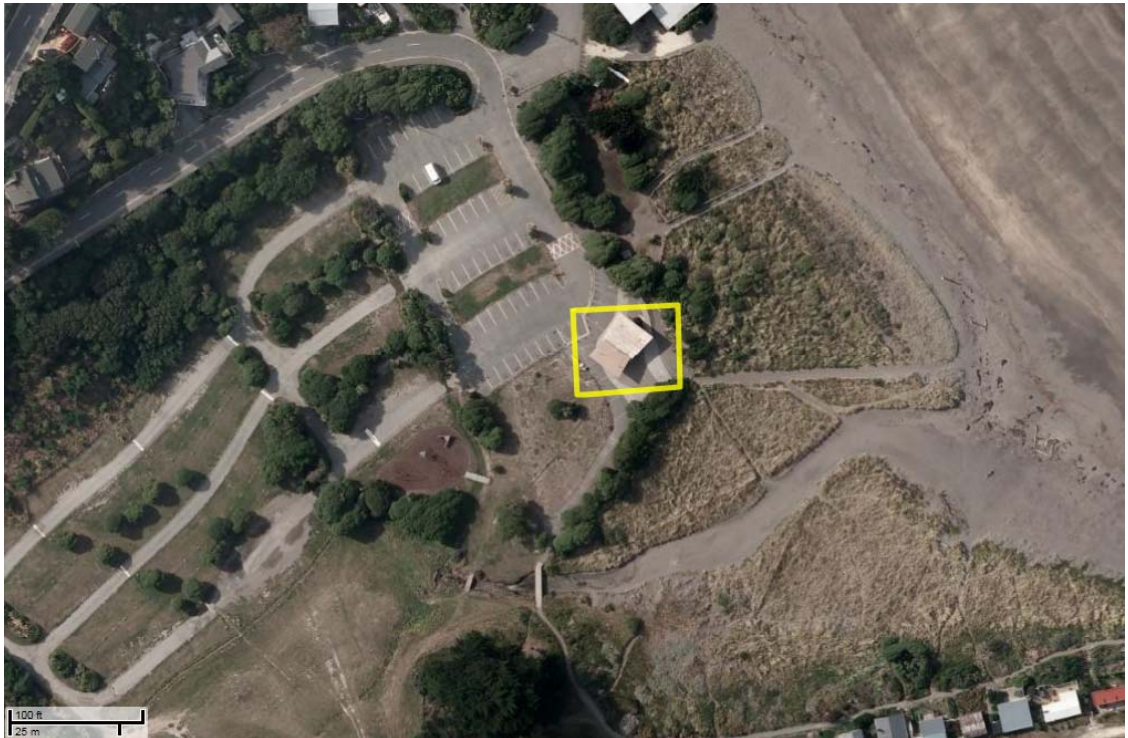
- **Figure 4 – Aerial photography from 24 Feb 2011 (<http://viewers.geospatial.govt.nz/>)**

Aerial photography shows relatively no land damage after the 22 Feb 2011 event. The area of grey wet ground located approximately 75m south west of the toilets/changing shed is likely to historical, not sand and silt ejecta.

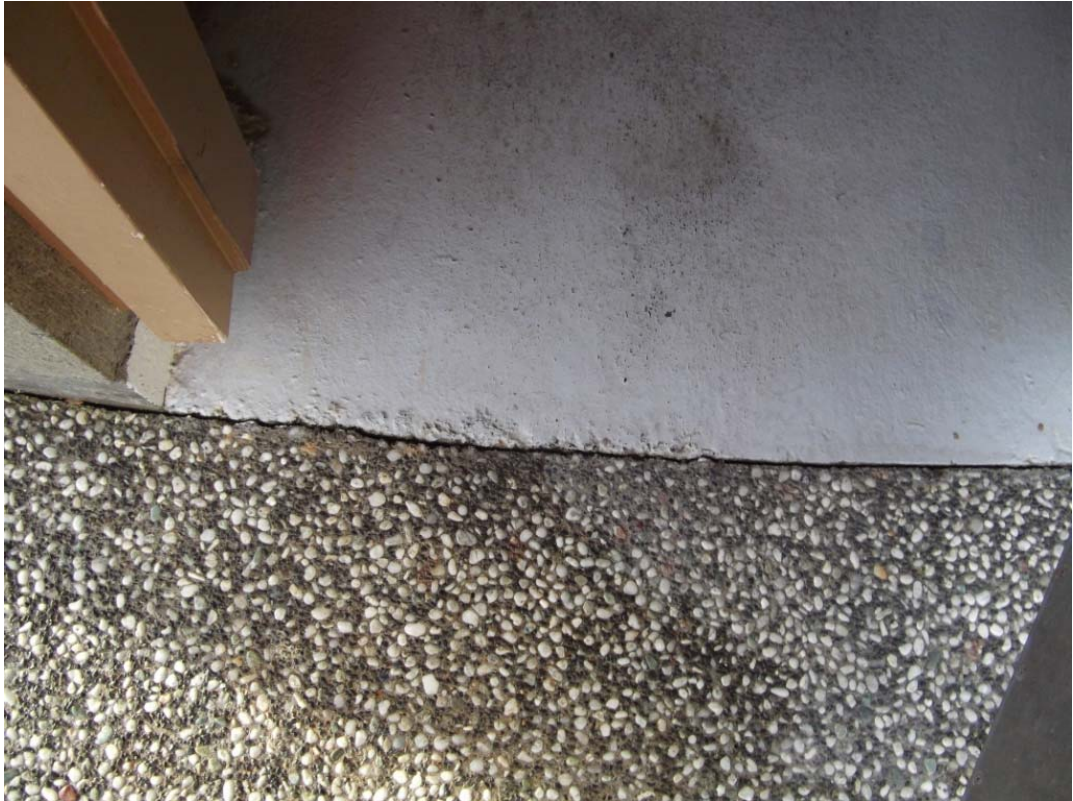
There is a 1-5mm crack between the building foundation and the concrete around the southwest corner of the building. There are multiple cracks, less than 1mm wide, in the concrete paths around the southwest corner of the building.

- **Figure 6 - 1 - 2mm crack between building foundation and concrete pathway around the building.**
