Templeton Community Centre
Qualitative Engineering Evaluation

Reference: 228611

Prepared for:
Christchurch City Council

Date: 9 April 2014

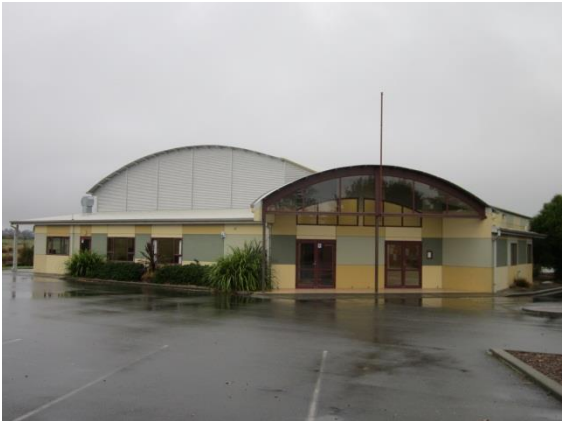
<p>Western elevation of the Templeton Community Centre.</p>

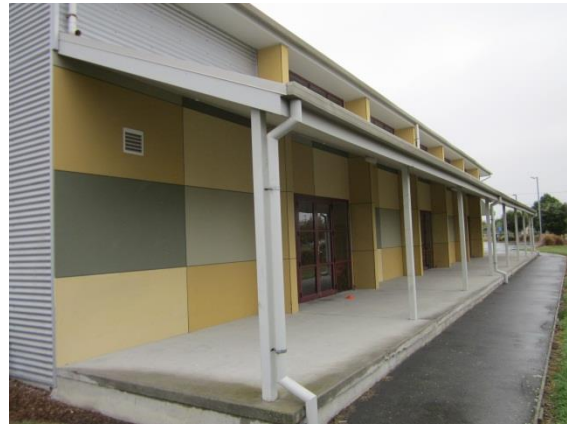
<p>South Eastern elevation of the Templeton Community Centre</p>

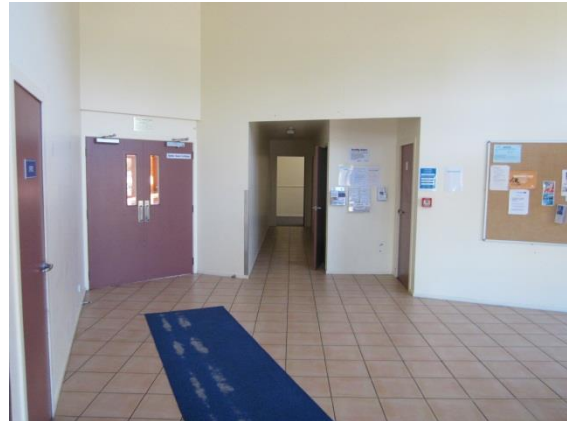
Interior view of the foyer.

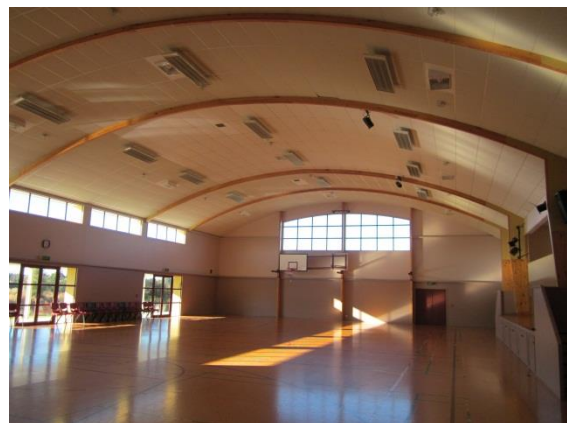
Interior view of the main hall.

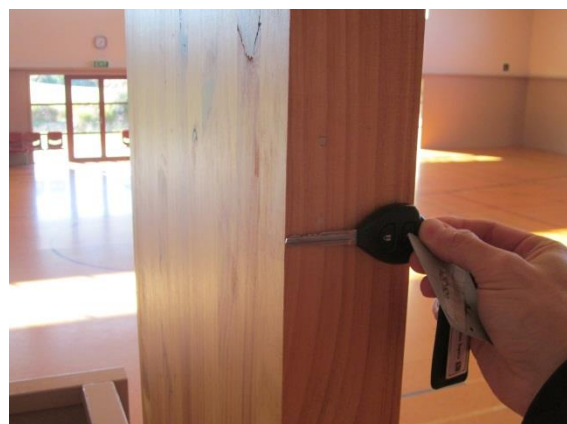
Close up of the glulam portal frame legs.

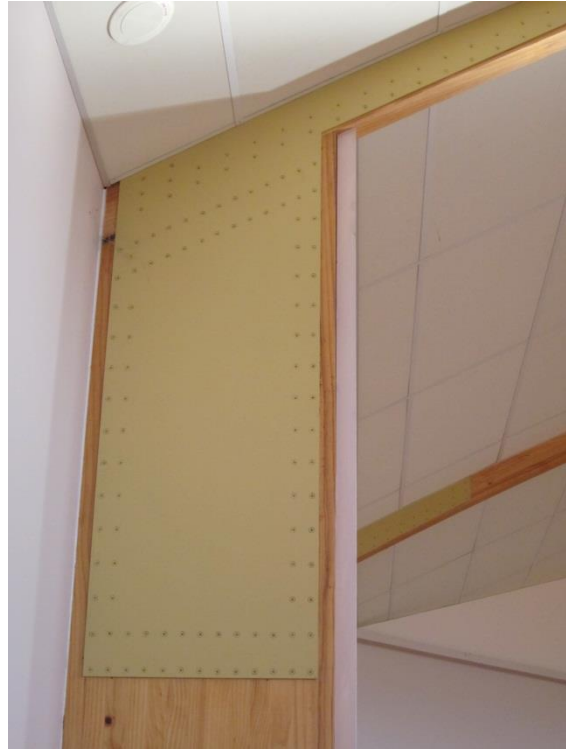
Close up of the glulam portal frame knee joint.

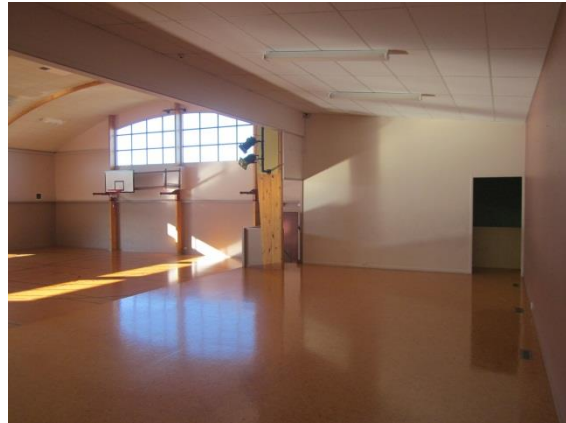
Interior view of the lean to gallery adjacent to the main hall.

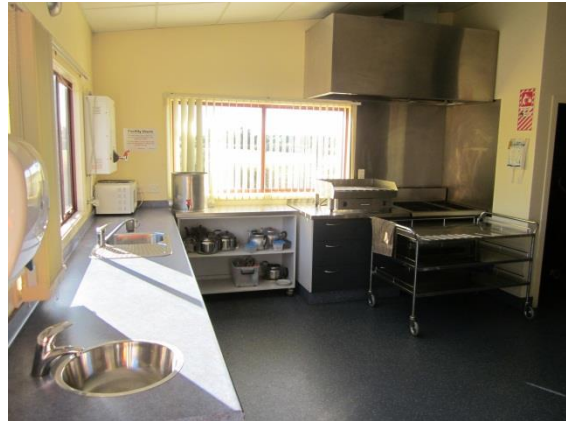
Interior view of the kitchen area.
