Templeton Pool Buildings  
Quantitative Engineering  
Evaluation

**Reference:** 235011

**Prepared for:**  
Christchurch City Council

**Address:** 62 Kirk Road, Templeton, Christchurch

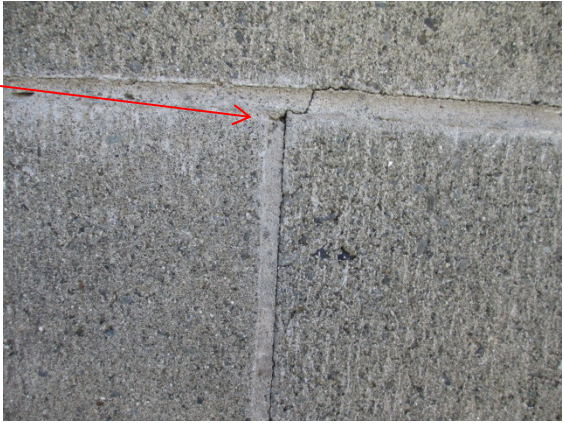
4	Some minor cracking to the blockwork walls.

It is recommended that the infill walls are strengthened out of plane. This can be achieved by adding timber framing with plywood sheeting to the inside face of the infill walls between the blockwork columns and installing screws/fixings to the blockwork infill and top timber chord.

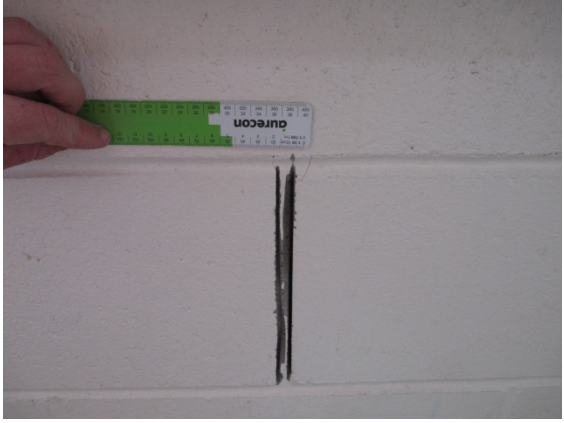
9	Deterioration of mortar between blocks in one section of the wall.

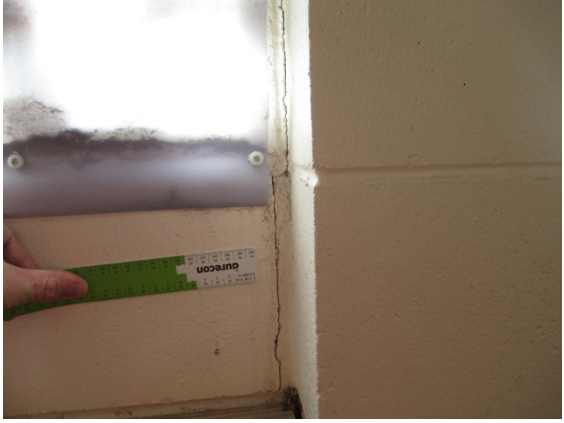
The stepped cracking in the blockwork walls and vertical cracking at intersections with the columns is considered to be minor. This minor cracking is not likely to have reduced the capacity of the buildings. It is recommended that the infill walls are strengthened out of plane. Cracking in the floor slab of the female changing rooms and along the footpaths is considered to be minor.

10	Example of vertical cracking between a column and the wall.

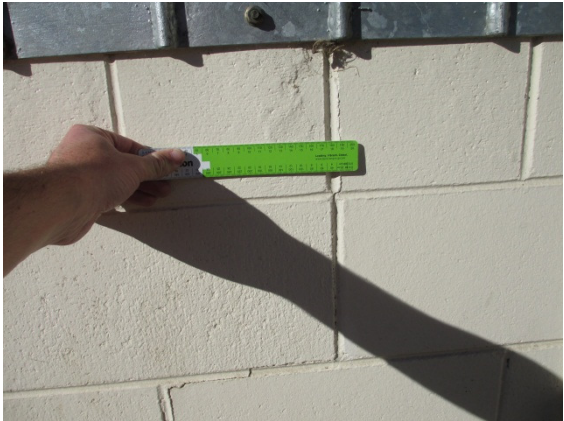
A photograph showing the exterior of the same building from a different angle. This view shows a side wall with a window and a 'WARNING' sign. A white downspout is visible on the right side of the building. The building is surrounded by a concrete pad and some grass.
15	Example of minor hairline cracking in the blockwork walls.

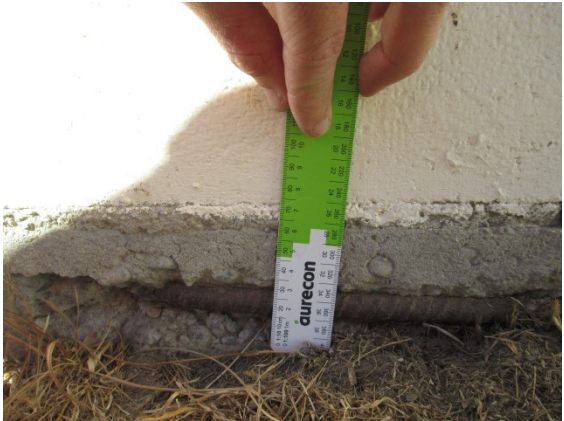
16	Exposed reinforcing in the concrete foundation wall on the north side of the office shop building.

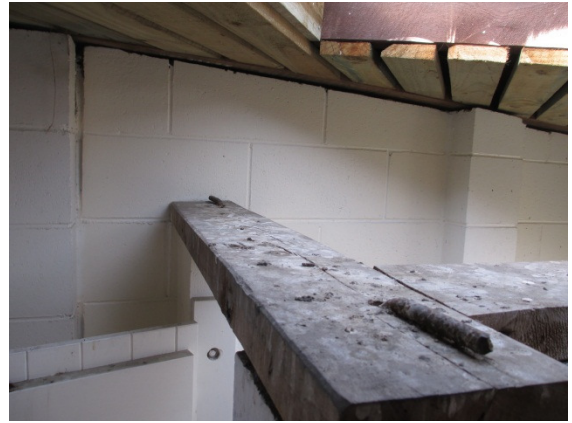
25

Example of the column bars bent over the timber top plates – assumed method for diaphragm connection.

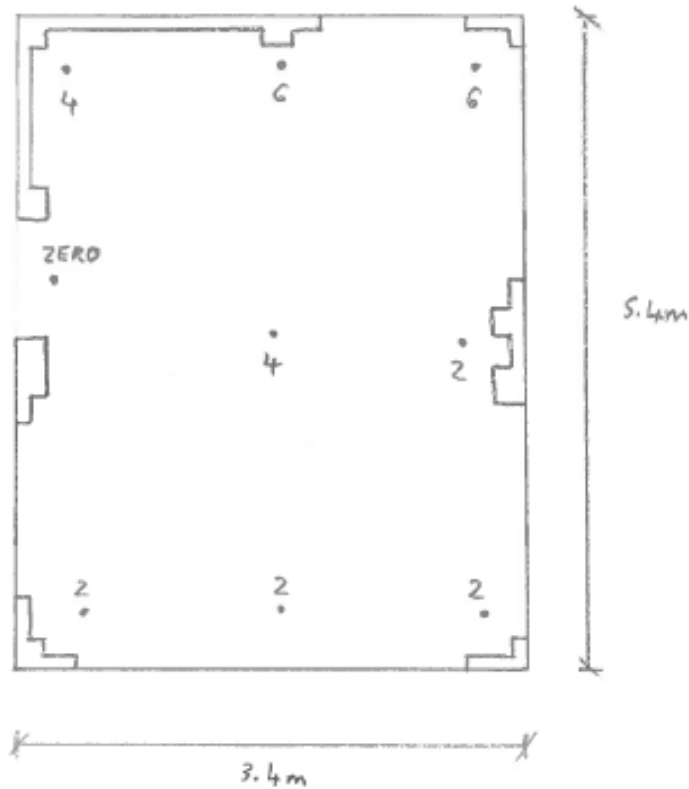
**Floor Level Survey for the Office Building**

The floor levels for the Templeton Pool Buildings are considered to be acceptable.
